**Report: TAB Report**  
**Function: Test, Adjust, & Balance**  
**Date: 02/16/2026**  
**Completed By: National TAB**

**PROJECT**  
**02-16-26 QT #1017 DENVER, NC**

7259 N CAROLINA 73 HWY

QUIKTRIP  
4705 SOUTH 129TH EAST AVENUE  
TULSA, OK 74134

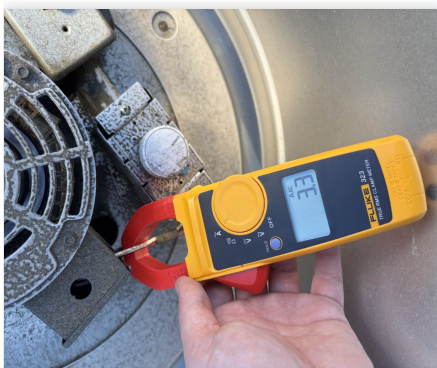
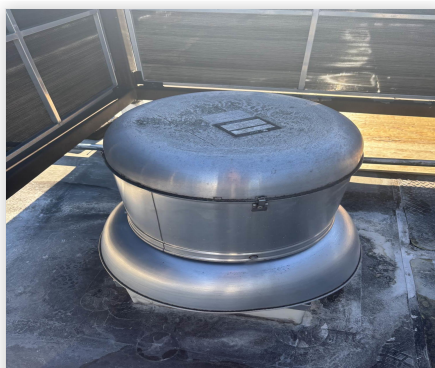
**Issue Name :** EF-2 overamping at design  
**Description :** EF-2 once sped up to design CFM is over amping at the motor. Combi oven grille is low on airflow, this issue needs to be fixed to bring that grille to design.  
**Created By :** National TAB                      **Assigned To :** National TAB - Dan Hertenstein  
**Status :** Open  
**Priority :** Urgent                                      **Asset Tag :** EF2  
**Originated Date :** 02/16/2026 - Christian Moller - National TAB

[1]Overramping at design. SEE ISSUES.

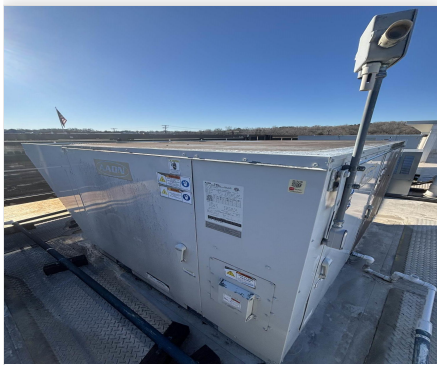
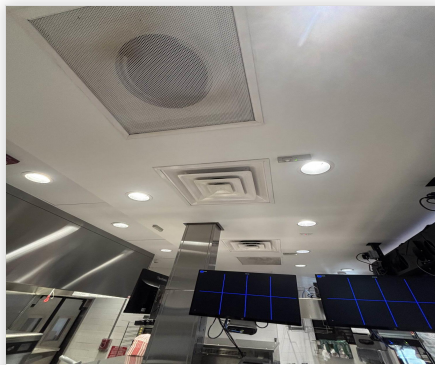
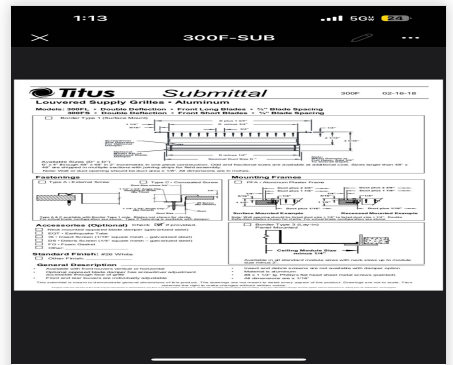
**Issue Name :** Wrong Cook Line Diffusers  
**Description :** The cook line diffusers for RTU 3 are the wrong models. The Louvered Supply Grilles with adjustable deflection blades are the correct diffusers.  
**Created By :** National TAB                      **Assigned To :** National TAB - Dan Hertenstein  
**Status :** Open  
**Priority :** High                                      **Asset Tag :** RT-3  
**Originated Date :** 02/16/2026 - Christian Moller - National TAB

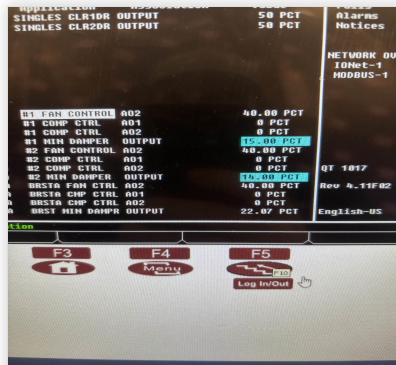
RTU's/AHU's

Evaporator coils are clean?

Pass

Condenser coils are clean?

Gas piping is installed and valves are turned on?

Unit free of noticeable noise and vibration

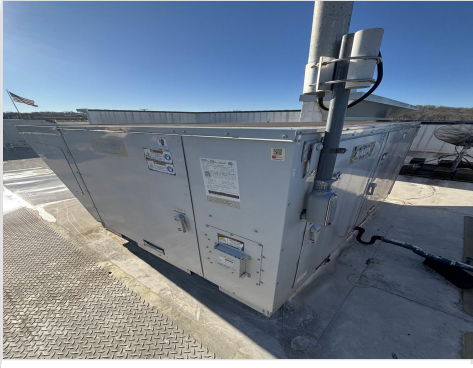
Asset: RT-1

Test Data		
	Design	Actual
SF CFM	4200	4387
SF RPM	-	DD
OA CFM (Hoods On)	800	820
OA CFM (Hoods Off)	350	381
RL Voltage	-	215/218/217
RL Amperage	-	4.0/4.6/4.8
VFD Max SetPt	-	33.6Hz
VFD Min SetPt	-	24Hz
OA Damper Position (Hoods On)	-	46%
OA Damper Position (Hoods Off)	-	15%

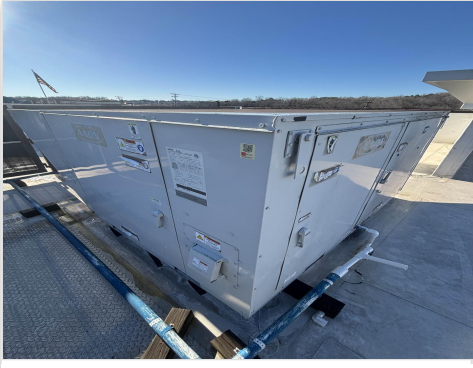
Asset: RT-2

Test Data		
	Design	Actual
SF CFM	4200	4170
SF RPM	-	DD
OA CFM (Hoods On)	800	845
OA CFM (Hoods Off)	350	358
RL Voltage	-	216/217/218
RL Amperage	-	3.5/4.7/4.9
VFD Max SetPt	-	32.4Hz
VFD Min SetPt	-	24Hz
OA Damper Position (Hoods On)	-	46%
OA Damper Position (Hoods Off)	-	14%

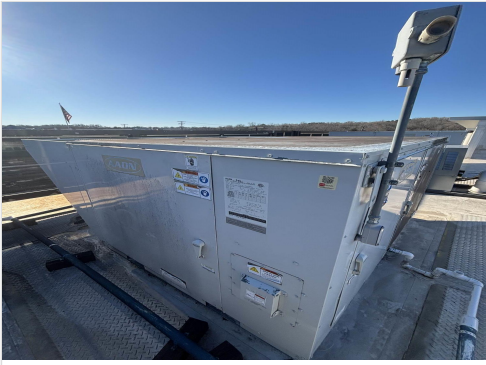
Asset: RT-3

Test Data		
	Design	Actual
SF CFM	4200	4260
SF RPM	-	DD
OA CFM (Hoods On)	800	763
OA CFM (Hoods Off)	350	367
RL Voltage	-	216/217/217
RL Amperage	-	3.7/4.9/5.1
VFD Max SetPt	-	34Hz
VFD Min SetPt	-	24Hz
OA Damper Position (Hoods On)	-	46%
OA Damper Position (Hoods Off)	-	22.07%

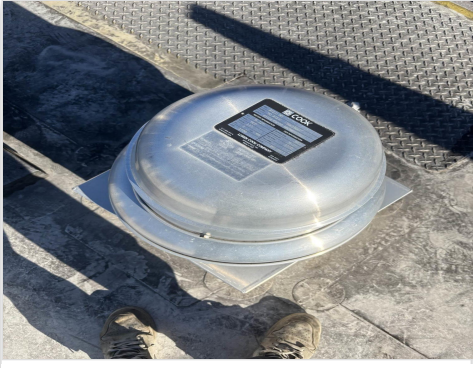
Asset: EF1

Test Data		
	Design	Actual
CFM	225	218
Fan RPM	-	DD
Fan Rotation	-	CORRECT
Motor RPM	-	DD
System SetPt	-	SPEED CONTROLLER / MEDIUM SPEED
RL Voltage	-	113
RL Amperage	-	0.6
Total ESP	-	0.24"
Fan Inlet SP	-	-0.24"
Fan Discharge SP	-	ATM

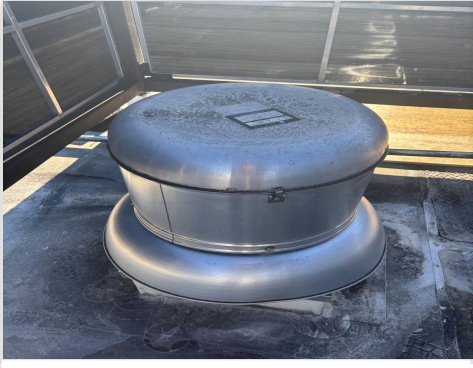
Asset: EF2

Test Data		
	Design	Actual
CFM	525	300
Fan RPM	-	DD
Fan Rotation	-	CORRECT
Motor RPM	-	DD
System SetPt	-	SPEED CONTROLLER / LOW SPEED
RL Voltage	-	114
RL Amperage	-	3.3
Total ESP	-	0.18"
Fan Inlet SP	-	-0.18"
Fan Discharge SP	-	ATM

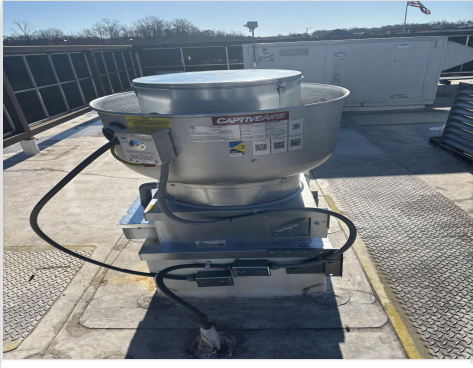
Asset: EF3

Test Data		
	Design	Actual
CFM	1350	1285
Fan RPM	-	DD
Fan Rotation	-	CORRECT
Motor RPM	-	DD
System SetPt	-	HMI/50.8Hz
RL Voltage	-	211
RL Amperage	-	2.4
Total ESP	0.75"	0.56"
Fan Inlet SP	-	-0.56"
Fan Discharge SP	-	ATM

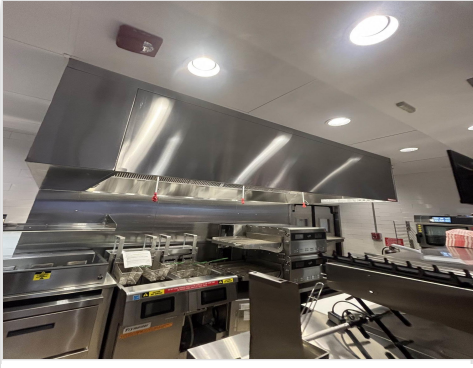
Asset: HD1

Test Data Exhaust		
	Design	Actual
Filter Type	CAPTRATE SOLO FILTER	BAFFLE FILTERS
Filter Size 1	20X16	20X16
Filter Qty 1	6	6
Filter AK factor size 1	2.08	2.08
Filter Total AK Area	12.48	12.48
Filter1 FPM	-	113
Filter2 FPM	-	103
Filter3 FPM	-	108
Filter4 FPM	-	98
Filter5 FPM	-	102
Filter6 FPM	-	98
Filter Ave FPM(corr)	-	103
CFM	1350	1285
