**National TAB
1329 E. KEMPER ROAD
SUITE 4210
CINCINNATI, OH 45246**

**Report: TAB REPORT
Function: Test, Adjust, & Balance
Date: 05/25/2023**

**PROJECT
05-22-23 FREDDY'S OGLETHORPE, GA**

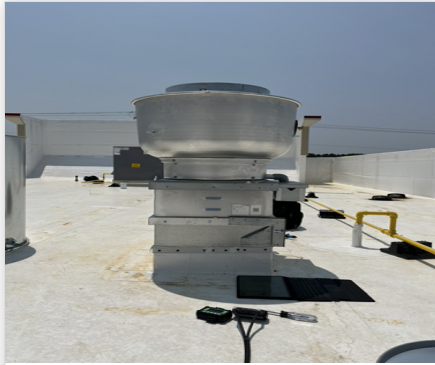
Issue Name : KEF-1 and KEF-2 Hinge Kits

Description : Hinge Kit was not operational on KEF-1 and KEF-2 due to a vented curb extension. This made it so a static pressure could not be safely measured. It is important the fans can be opened easily so that they can be properly maintained and grease ducts effectively cleaned.
