**Report: TAB REPORT  
Function: Test, Adjust, & Balance  
Date: 05/25/2023**

**PROJECT  
05-22-23 FREDDY'S OGLETHORPE, GA**

3561 Battlefield Parkway

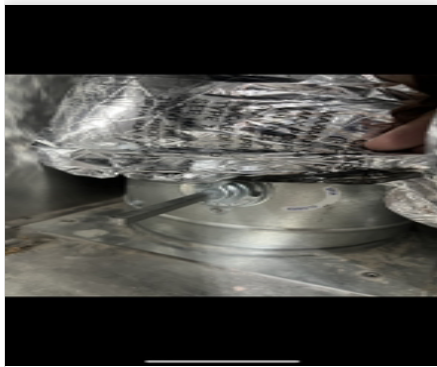
RTU2\_ACPSP\_HOOD1  
05/25/2023

**Issue Name :** HD-1 ACPSP Duct Disconnected  
**Description :** One of the Flex duct runs was not connected to HD-1 ACPSP. Technician temporarily attached to balance unit, but duct needs to be permanently attached.  
**Created By :** National TAB                      **Assigned To :** National TAB - William Patton  
**Status :** Open  
**Originated Date :** 05/25/2023 - William Patton - National TAB

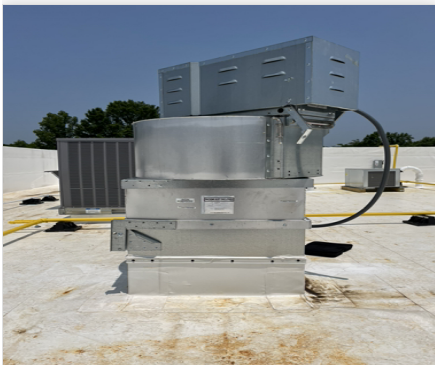
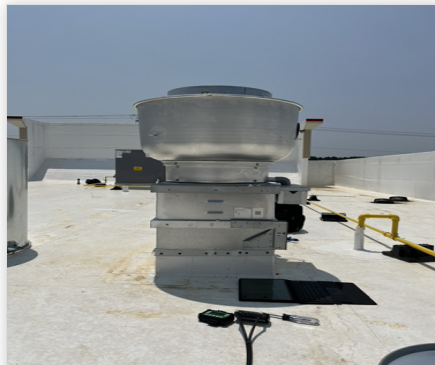
**Issue Name :** KEF-1 and KEF-2 Hinge Kits  
**Description :** Hinge Kit was not operational on KEF-1 and KEF-2 due to a vented curb extension. This made it so a static pressure could not be safely measured. It is important the fans can be opened easily so that they can be properly maintained and grease ducts effectively cleaned.  
**Created By :** National TAB                      **Assigned To :** National TAB - William Patton  
**Status :** Open  
**Originated Date :** 05/25/2023 - William Patton - National TAB

Rotation is correct?	Yes
Belts are tight?	N/A (direct drive)
Grease cup installed on hood fan?	Hood 1: Yes. Hood 2: Yes
Hinge kit installed installed on hood fan?	Yes, but can't be operated
Lean fan back. Is grease duct installation adequate and is duct ran all the way to the base of the fan?	Yes

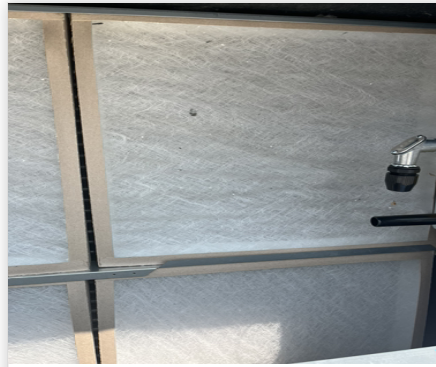
**Issue Name :** RTU Temporary Final Filters Still Installed.  
**Description :** Both RTUs still have throwaway construction filters installed. Recommend correct pleated final filters are installed.  
**Created By :** National TAB                      **Assigned To :** National TAB - William Patton  
**Status :** Open  
**Originated Date :** 05/26/2023 - Michael McDonnell - National TAB

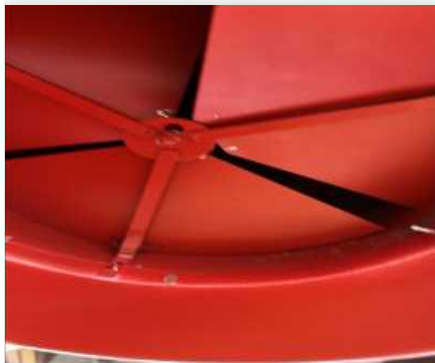
damper  
05/26/2023

**Issue Name :** RTU-1 Face Dampers Not Functional  
**Description :** RTU-1 total supply airflow is within design but diffusers are not fully balanced. Installed face dampers are not functional. Dampers are not holding their positions, only offer full open or full closed. This is not anticipated to cause any issues. We recommend the dampers are corrected and a return trip is scheduled to balance the diffusers.

Notes: [1] Diffusers Not Balanced due to inoperable face dampers installed. Dampers need to be corrected before diffusers can be balanced.
