Report: TAB REPORT
Function: Test, Adjust, & Balance
Date: 05/25/2023

PROJECT
05-22-23 FREDDY'S OGLETHORPE, GA

3561 Battlefield Parkway

Oglethorpe, GA

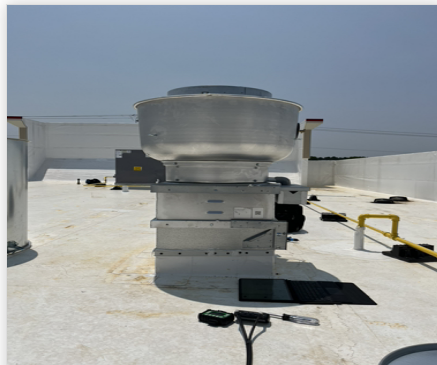
Issue Name : KEF-1 and KEF-2 Hinge Kits
Description : Hinge Kit was not operational on KEF-1 and KEF-2 due to a vented curb extension. This made it so a static pressure could not be safely measured. It is important the fans can be opened easily so that they can be properly maintained and grease ducts effectively cleaned.
Created By : National TAB **Assigned To :** National TAB - William Patton
Status : Open
Originated Date : 05/25/2023 - William Patton - National TAB

Rotation is correct?	Yes
Belts are tight?	N/A (direct drive)
Grease cup installed on hood fan?	Hood 1: Yes. Hood 2: Yes
Hinge kit installed installed on hood fan?	Yes, but can't be operated
Lean fan back. Is grease duct installation adequate and is duct ran all the way to the base of the fan?	Yes

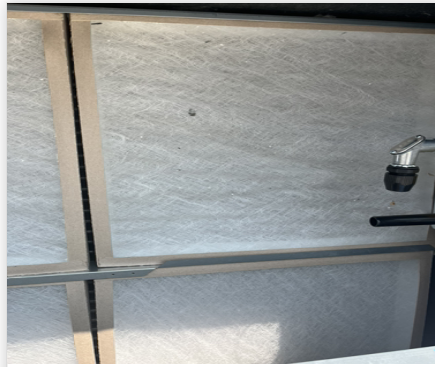
Issue Name : RTU Temporary Final Filters Still Installed.
Description : Both RTUs still have throwaway construction filters installed. Recommend correct pleated final filters are installed.
Created By : National TAB **Assigned To :** National TAB - William Patton
Status : Open
Originated Date : 05/26/2023 - Michael McDonnell - National TAB

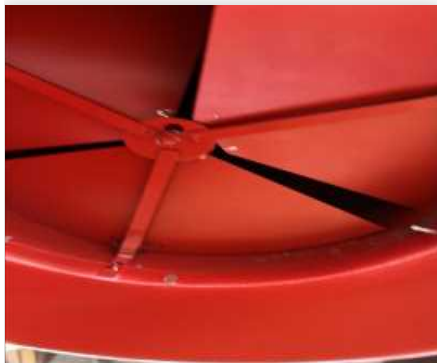
damper
05/26/2023

Issue Name : RTU-1 Face Dampers Not Functional
Description : RTU-1 total supply airflow is within design but diffusers are not fully balanced. Installed face dampers are not functional. Dampers are not holding their positions, only offer full open or full closed. This is not anticipated to cause any issues. We recommend the dampers are corrected and a return trip is scheduled to balance the diffusers.
