**Report: TAB REPORT
Function: Test, Adjust, & Balance
Date: 05/25/2023**

**PROJECT
05-22-23 FREDDY'S OGLETHORPE, GA**

3561 Battlefield Parkway

Oglethorpe, GA

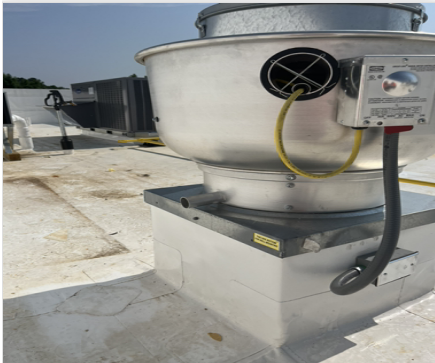
EF4_GREASE_CUP
05/24/2023

Issue Name : EF4 GREASE CUP
Description : EXHAUST FAN 4 GREASE CUP IS NIT INSTALLED
Created By : National TAB **Assigned To :** National TAB - Will Turnbough
Status : Open
Originated Date : 05/24/2023 - William Patton - National TAB

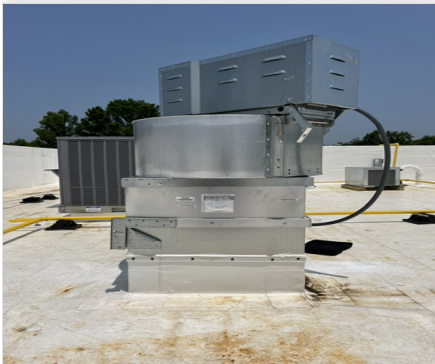
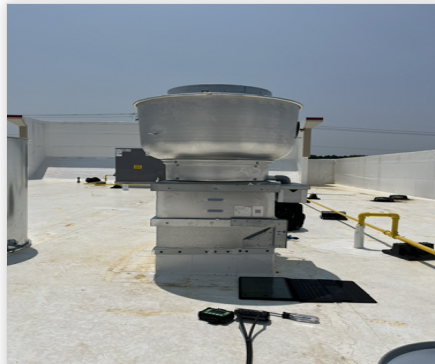
KEF1
05/25/2023

Issue Name : HINGE KITS/ EASE KF CLEANING
Description : EXHAUST FANS HINGE KITS WERE INSTALLED BEFORE ADAPTER AND NEED TO HE RELOCATED. THIS DID NOT AFFECT BALANCE BUT THEY WILL NEED TO BE RELOCATED TO PERFORM MAINTENANCE CLEANING.
Created By : National TAB **Assigned To :** National TAB - William Patton
Status : Open
Originated Date : 05/25/2023 - William Patton - National TAB

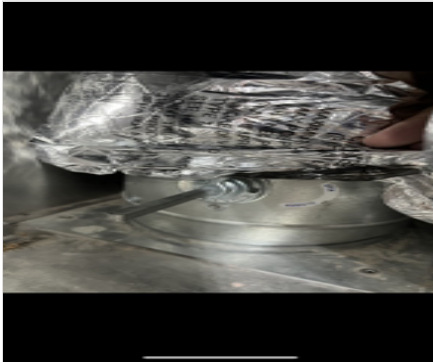
RTU2_ACPSP_HOOD1
05/25/2023

Issue Name : HOOD 1 ACPSP CONNECTION
Description : ONE OF THE FLEX DUCT RUNS WAS NOT CONNECTED TO HOOD 1 ACPSP. TECHNICIAN TEMPORARILY ATTACHED TO BALANCE UNIT BUT IT NEEDS TO BE PERMANENTLY ATTACHED.
Created By : National TAB **Assigned To :** National TAB - William Patton
Status : Open
Originated Date : 05/25/2023 - William Patton - National TAB
