**National TAB
1329 E. KEMPER ROAD
SUITE 4210
CINCINNATI, OH 45246**

**Report: TAB REPORT
Function: Test, Adjust, & Balance
Date: 05/25/2023**

**PROJECT
05-22-23 FREDDY'S OGLETHORPE, GA**

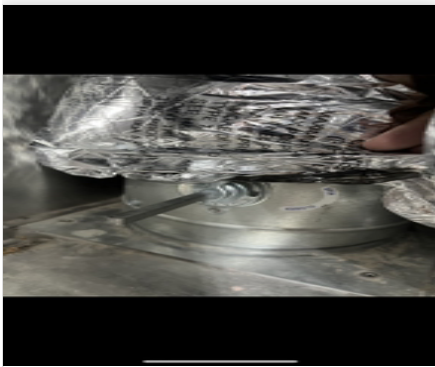
RTU2_ACPSP_HOOD1
05/25/2023

Issue Name : HD-1 ACPSP Duct Disconnected
Description : One of the Flex duct runs was not connected to HD-1 ACPSP. Technician temporarily attached to balance unit, but duct needs to be permanently attached.
Created By : National TAB **Assigned To :** National TAB - William Patton
Status : Open
Originated Date : 05/25/2023 - William Patton - National TAB

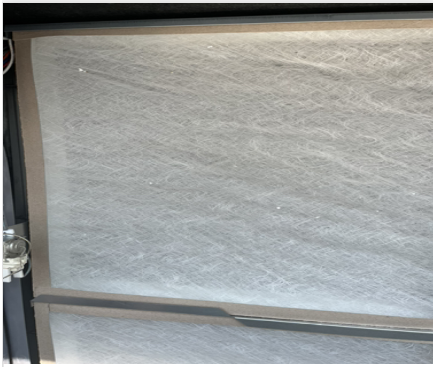
Issue Name : RTU Temporary Final Filters Still Installed.
Description : Both RTUs still have throwaway construction filters installed. Recommend correct pleated final filters are installed.
Created By : National TAB **Assigned To :** National TAB - William Patton
Status : Open
Originated Date : 05/26/2023 - Michael McDonnell - National TAB
