**National TAB  
1329 E. KEMPER ROAD  
SUITE 4210  
CINCINNATI, OH 45246**

**Report: TAB REPORT  
Function: Test, Adjust, & Balance  
Date: 05/25/2023**

**PROJECT  
05-22-23 FREDDY'S OGLETHORPE, GA**

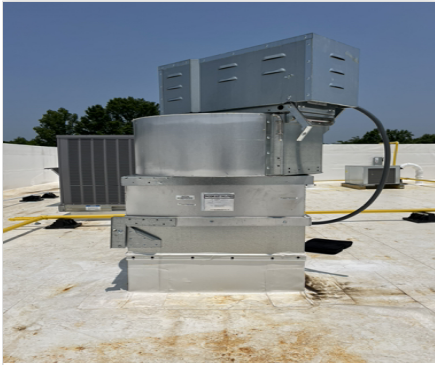
**KEF1**  
05/25/2023

**Issue Name :** KEF-1 and KEF-2 Hinge Kits  
**Description :** Hinge Kit was not operational on KEF-1 and KEF-2 due to a vented curb extension. This made it so a static pressure could not be safely measured. It is important the fans can be opened easily so that they can be properly maintained and grease ducts effectively cleaned.  
**Created By :** National TAB                      **Assigned To :** National TAB - William Patton  
**Status :** Open  
**Originated Date :** 05/25/2023 - William Patton - National TAB

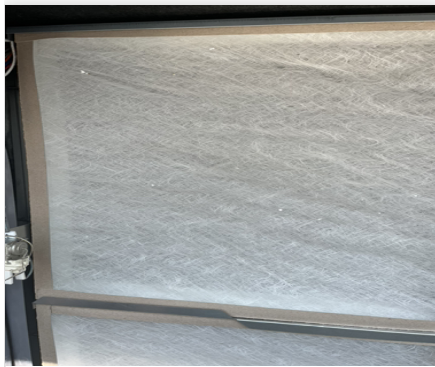
RTU-1  
05/26/2023

**Issue Name :** RTU Temporary Final Filters Still Installed.  
**Description :** Both RTUs still have throwaway construction filters installed.  
 Recommend correct pleated final filters are installed.
