**Report: TAB REPORT
Function: Test, Adjust, & Balance
Date: 05/25/2023**

**PROJECT
05-22-23 FREDDY'S OGLETHORPE, GA**

3561 Battlefield Parkway

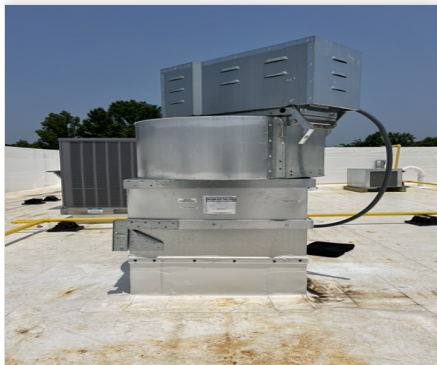
Issue Name : KEF-1 and KEF-2 Hinge Kits
Description : Hinge Kit was not operational on KEF-1 and KEF-2 due to a vented curb extension. This made it so a static pressure could not be safely measured. It is important the fans can be opened easily so that they can be properly maintained and grease ducts effectively cleaned.
Created By : National TAB **Assigned To :** National TAB - William Patton
Status : Open
Originated Date : 05/25/2023 - William Patton - National TAB

Rotation is correct?	Yes
Belts are tight?	N/A (direct drive)
Grease cup installed on hood fan?	Hood 1: Yes. Hood 2: Yes
Hinge kit installed installed on hood fan?	Yes, but can't be operated
Lean fan back. Is grease duct installation adequate and is duct ran all the way to the base of the fan?	Yes

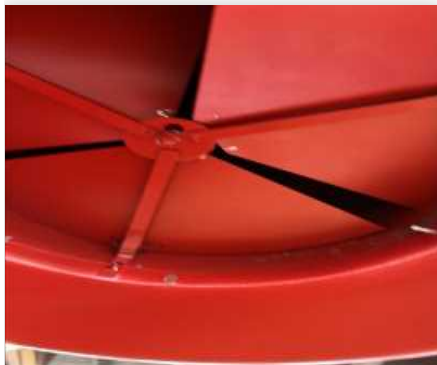
damper
05/26/2023

Issue Name : RTU-1 Face Dampers Not Functional
Description : RTU-1 total supply airflow is within design but diffusers are not fully balanced. Installed face dampers are not functional. Dampers are not holding their positions, only offer full open or full closed. We recommend the dampers are corrected and a return trip is scheduled to balance the diffusers.

Notes: [1] Diffusers Not Balanced due to inoperable face dampers installed. Dampers need to be corrected before diffusers can be balanced.

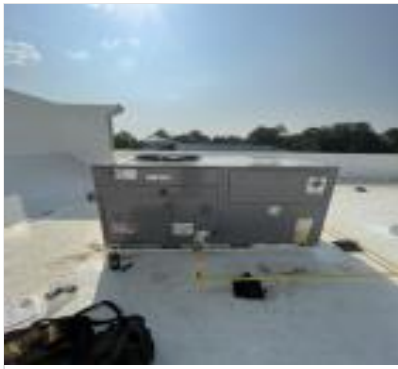
RTU1
05/26/2023

Unit Data		
	Design	Actual
MFG	CARRIER	CARRIER
Serial Num	-	1523P77402
Model Num	48FCEN14	48FCEN14
Type	RTU	RTU
Configuration	VERTICAL	VERTICAL
Num OA Filters 1	-	1
OA Filter Size 1	-	35X19.25
Num Final Filter 1	-	4
Final Filter Size 1	-	20X20X2

Test Data		
	Design	Actual
SF CFM	4850	4708
SF RPM	-	2125
RA CFM	3850	3665
OA CFM	1000	1043
RL Voltage	-	211/7/12.4/12.3
RL Amperage	-	12.3/11.0/12.1
SF Rotation	-	CCW
Min OA Damper Position	-	HIGH: 4.4V LOW: 5.8V
Min OA Damper Type	-	ECONOMIZER
OA Enthalpy Setpt	-	NA

Performance Data		
	Design	Actual
MA Plenum SP	-	-1.35
Fan Suction SP	-	-1.90
Fan Discharge SP	-	0.95
Total ESP	1.0"	2.30
Fan Total SP	-	2.85

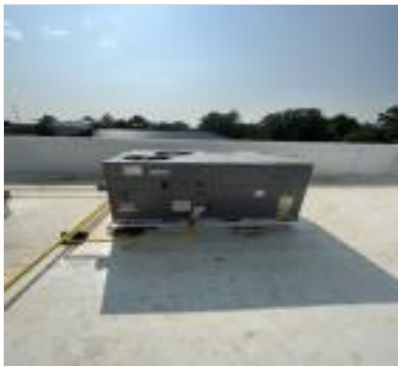
RTU2
05/26/2023

Unit Data		
	Design	Actual
MFG	CARRIER	CARRIER
Serial Num	-	1723P78576
Model Num	48FCEN08	48FCEN08
Type	RTU	RTU
Configuration	VERTICAL	VERTICAL
Num OA Filters 1	-	1
OA Filter Size 1	-	35X19.25
Num Final Filter 1	-	4
Final Filter Size 1	-	20X20X2

Test Data		
	Design	Actual
SF CFM	3000	3086
SF RPM	-	1795
RA CFM	2700	2758
OA CFM	300	328
RL Voltage	-	212.5/212.5/213.1
RL Amperage	-	4.9/5.1/5.4
SF Rotation	-	CCW
Min OA Damper Position	-	HIGH: 3.5V LOW: 4.0 V
Min OA Damper Type	-	3.5V
OA Enthalpy Setpt	-	NA

Performance Data		
	Design	Actual
MA Plenum SP	-	-0.64
Fan Suction SP	-	-1.06
Fan Discharge SP	-	0.86
Total ESP	1.0"	1.5
Fan Total SP	-	1.92

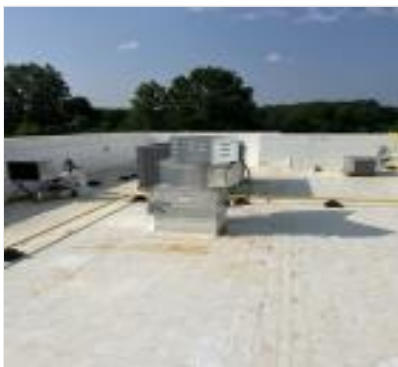
KEF1
05/26/2023

Unit Data		
	Design	Actual
MFG	CAPTIVEAIRE	CAPTIVEAIRE
Model Num	CASRE18DD	CASRE18DD
Serial Num	-	5516907
Type	UTILITY	UTILITY
Configuration	VERTICAL	VERTICAL

Test Data		
	Design	Actual
CFM	1600	1620
Fan RPM	1107	1108
Fan Rotation	-	CCW
Motor RPM	-	1108
System SetPt	-	57.8 HZ
RL Voltage	-	168 @ VFD
RL Amperage	-	3.1 @ VFD
Total ESP	1.5"	NR 1
Fan Inlet SP	-	NR 1
Fan Discharge SP	-	ATM

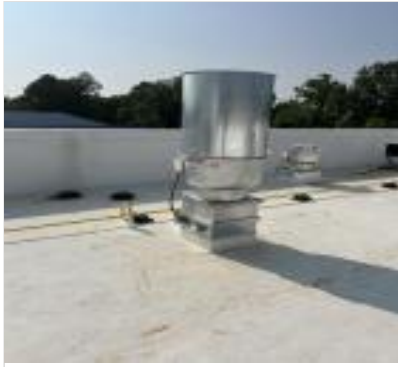
KEF2
05/26/2023

Unit Data		
	Design	Actual
MFG	CAPTIVEAIRE	CAPTIVEAIRE
Model Num	DU50HFA	DU50HFA
Serial Num	-	5516907
Type	UPBLAST	UPBLAST
Configuration	VERTICAL	VERTICAL

Test Data		
	Design	Actual
CFM	775	831
Fan RPM	1532	1062
Fan Rotation	-	CCW
Motor RPM	-	1062
System SetPt	-	59%
RL Voltage	-	122.9
RL Amperage	-	2.4
Total ESP	1.250"	NR [1]
Fan Inlet SP	-	NR [1]
Fan Discharge SP	-	ATM

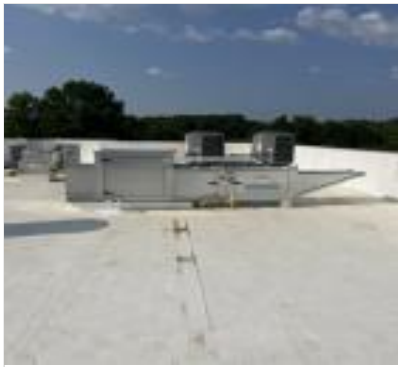
MUA1
05/26/2023

Unit Data		
	Design	Actual
MFG	CAPTIVEAIRE	CAPTIVEAIRE
Model Num	A1-D.250-15D-MPU	A1-D.250-15D-MPU
Serial Num	-	5516907
Type	MUA	MUA
Configuration	VERTICAL	VERTICAL

Gas Heat		
	Design	Actual
Heater Operates (y/n)	-	Y
Flame Status (pass/fail)	-	PASS
Inlet Air Temp SetPt	55	55
Discharge Air Temp SetPt	60	60
Air Flow Switch SP Actual	-	0.39"

Test Data		
	Design	Actual
CFM	1980	1988
SF RPM	2245	1763
Motor RPM	-	1763
SF System SetPt	-	30.4HZ
RL Voltage	-	98 @VFD
RL Amperage	-	5.1 @VFD
Total ESP	-	0.71"
Fan Discharge SP	-	0.71"

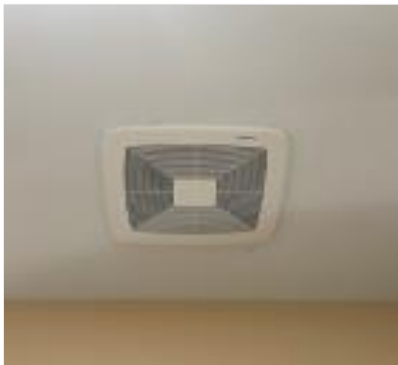
EF1
05/26/2023

Unit Data		
	Design	Actual
MFG	COOK	BROAN
Model Num	GC-168	QTXE110-E
Serial Num	-	NL

Test Data		
	Design	Actual
CFM	75	71

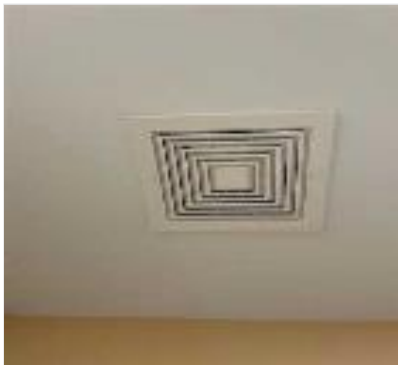
EF_2
05/26/2023

Unit Data		
	Design	Actual
MFG	COOK	BROAN
Model Num	GC-168	L200

Test Data		
	Design	Actual
CFM	150	158

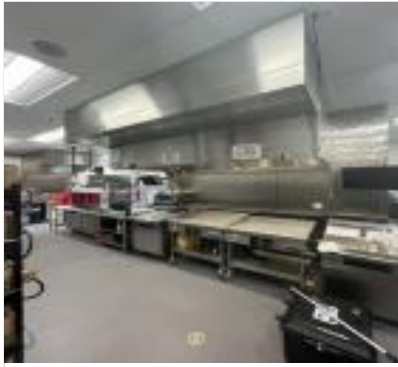
Hood1
05/26/2023

Unit Data		
	Design	Actual
MFG	CAPTIVEAIRE	CAPTIVEAIRE
Model Num	5424 ND-2-ACPSP-F	5424 ND-2-ACPSP-F
Job / Serial Num	-	5516907
Type	TYPE I CANOPY	TYPE I C
Hood length	96	96
Hood Width	54	54
Supply Plenum Type	-	ACPSP
Supply Plenum Width	14	14
Supply Plenum Length	108	108

Test Data Exhaust		
	Design	Actual
Filter Type	CAPTRATE SOLO	CAPTRATE SOLO
Filter Size 1	16X16	16X16
Filter Qty 1	5	5
Filter AK factor size 1	1.62	1.62
Filter Total AK Area	8.1	8.1
Filter1 FPM	-	194
Filter2 FPM	-	211
Filter3 FPM	-	210
Filter4 FPM	-	199
Filter5 FPM	-	188
Filter Ave FPM(corr)	-	200
CFM	1600	1620

Test Data Supply		
	Design	Actual
Total AK Area	10.5	10.5
Kv factor (Vel)	0.89	0.89
Num of Readings	-	8
Reading1 FPM	-	150
Reading2 FPM	-	166
Reading3 FPM	-	162
Reading4 FPM	-	133
Reading5 FPM	-	145
Reading6 FPM	-	121
Reading7 FPM	-	124
Reading8 FPM	-	121
Ave FPM(corr)	-	140
CFM	1280	1308

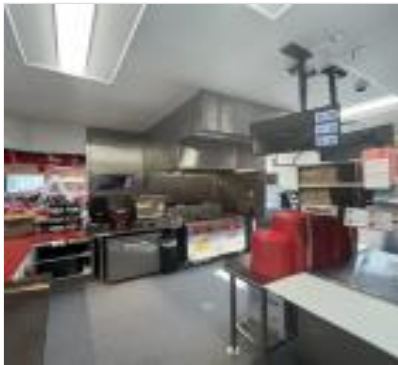
Hood2
05/26/2023

Unit Data		
	Design	Actual
MFG	CAPTIVEAIRE	CAPTIVEAIRE
Model Num	5424 ND-2-ACPSP-F	5424 ND-2-ACPSP-F
Job / Serial Num	-	5516907
Type	TYPE I CANOPY	TYPE 1 C
Hood length	60	60
Hood Width	54	54
Supply Plenum Type	-	ACSPSP
Supply Plenum Width	14	14
Supply Plenum Length	60	60

Test Data Supply		
	Design	Actual
Total AK Area	5.83	5.83
Kv factor (Vel)	0.89	0.89
Num of Readings	-	4
Reading1 FPM	-	123
Reading2 FPM	-	139
Reading3 FPM	-	146
Reading4 FPM	-	116
Ave FPM(corr)	-	131
CFM	700	680

Test Data Exhaust		
	Design	Actual
Filter Type	CAPTRATE SOLO	CAPTRATE SOLO
Filter Size 1	16X16	16X16
Filter Qty 1	3	3
Filter AK factor size 1	1.62	1.62
Filter Total AK Area	4.86	4.86
Filter1 FPM	-	173
Filter2 FPM	-	172
Filter3 FPM	-	168
Filter Ave FPM(corr)	-	171
CFM	875	831
