**Report: TAB REPORT
Function: Test, Adjust, & Balance
Date: 05/25/2023**

**PROJECT
05-22-23 FREDDY'S OGLETHORPE, GA**

3561 Battlefield Parkway

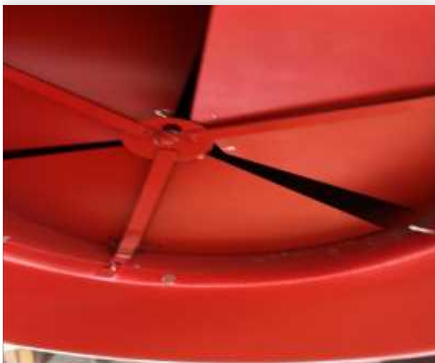
damper
05/26/2023

Issue Name : RTU-1 Face Dampers Not Functional

Description : RTU-1 total supply airflow is within design but diffusers are not fully balanced. Installed face dampers are not functional. Dampers are not holding their positions, only offer full open or full closed. This is not anticipated to cause any issues. We recommend the dampers are corrected and a return trip is scheduled to balance the diffusers.
