**Report: TAB Report**  
**Function: Test, Adjust, & Balance**  
**Date: 10/31/2025**  
**Completed By: National TAB**

**PROJECT**  
**11-17-25 QT #1178 CLINTON, SC**

QUIKTRIP  
4705 SOUTH 129TH EAST AVENUE  
TULSA, OK 74134

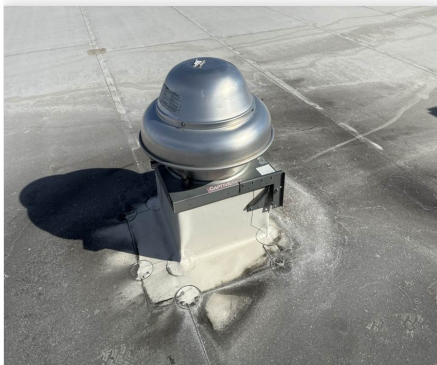
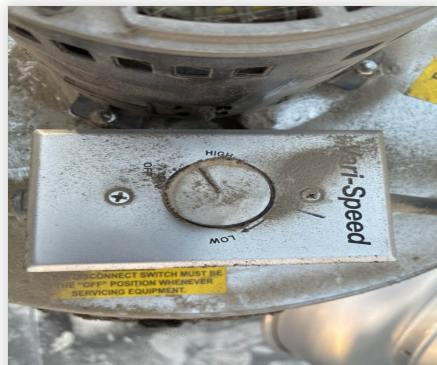
**Issue Name :** EF-1 Low Flow  
**Description :** The EF-1 speed dial is set to MAX and the air being exhausted is not enough.  
**Created By :** National TAB                      **Assigned To :** National TAB - Dan Hertenstein  
**Status :** Open  
**Priority :** Low    **Asset Tag :** EF1  
**Originated Date :** 11/20/2025 - Alex Bauer - National TAB

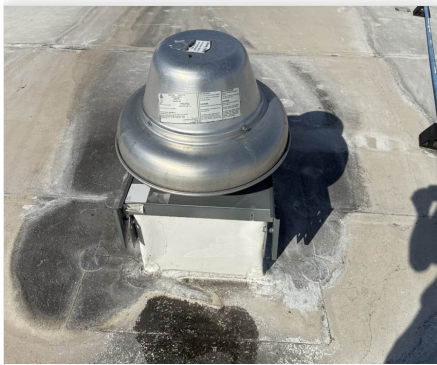
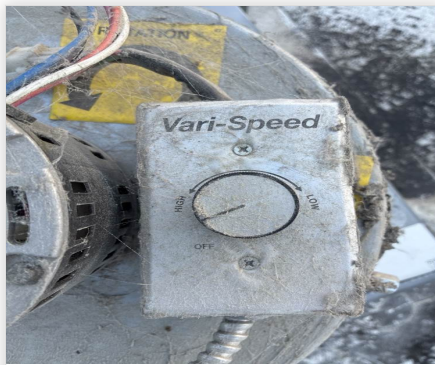
**Issue Name :** EF-2 Low Flow  
**Description :** The EF-2 speed dial is set to MAX and the air being exhausted is not enough.  
**Created By :** National TAB                      **Assigned To :** National TAB - Dan Hertenstein  
**Status :** Open  
**Priority :** Low                                      **Asset Tag :** EF2  
**Originated Date :** 11/20/2025 - Alex Bauer - National TAB

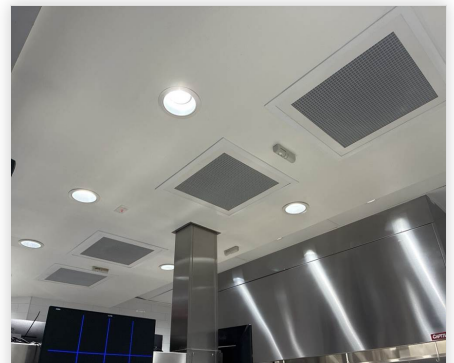
**Issue Name :** Incorrect Kitchen Diffusers  
**Description :** The kitchen diffusers 3-1 through 3-4 are the incorrect type. They need to be the Titus S1 diffusers with the pre-installed dampers.  
**Created By :** National TAB                      **Assigned To :** National TAB - Dan Hertenstein  
**Status :** Open  
**Priority :** InfoOnly                              **Asset Tag :** RT-3  
**Originated Date :** 11/20/2025 - Alex Bauer - National TAB

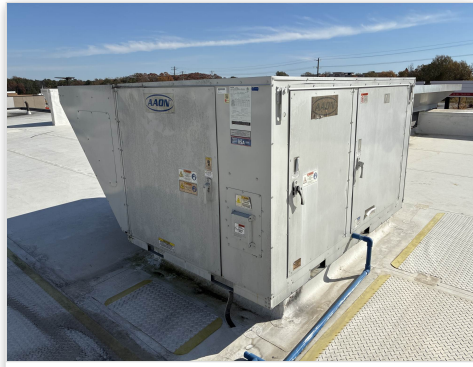
## Unit Data - PHOTO LOG

RTU-1 (RTU-3 ON SITE), HAS CONSIDERABLE NOISE COMING FROM THE FAN FARTHEST FROM THE ECONOMIZER WHEN RUNNING.

Notes:  
RTU-1 on Facilibuild is RTU-3 in the field.

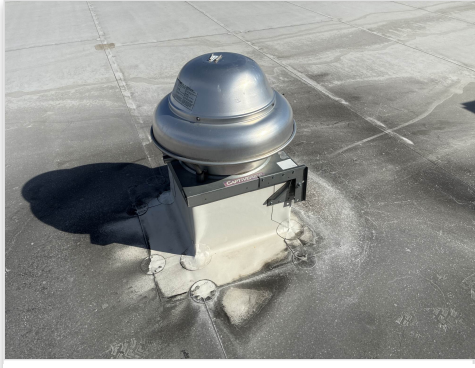
## Unit Data - PHOTO LOG

Test Data		
	Design	Actual
CFM	650	452
Fan RPM	-	DD
Fan Rotation	-	CCW
Motor RPM	-	DD
System SetPt	-	MAX
RL Voltage	-	NA
RL Amperage	-	NA
Total ESP	-	0.16"
Fan Inlet SP	-	-0.16"
Fan Discharge SP	-	ATMO

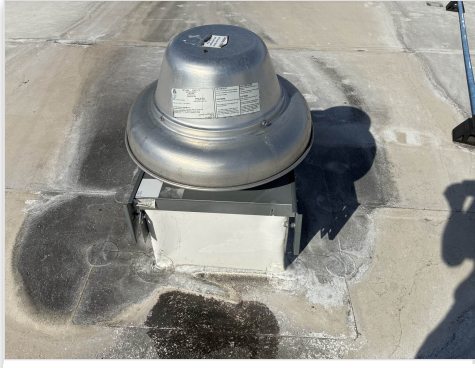
**Unit Data - PHOTO LOG**

Test Data		
	Design	Actual
CFM	350	172
Fan RPM	-	DD
Fan Rotation	-	CCW
Motor RPM	-	DD
System SetPt	-	MAX
RL Voltage	-	NA
RL Amperage	-	NA
Total ESP	-	0.11"
Fan Inlet SP	-	-0.11"
Fan Discharge SP	-	ATMO

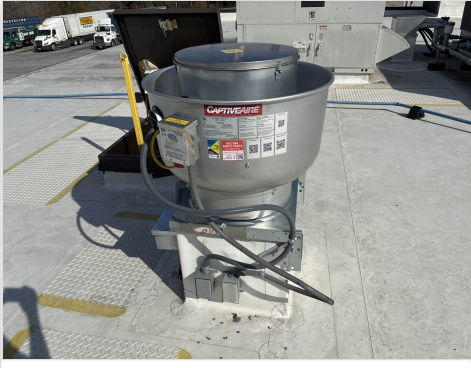
## Unit Data - PHOTO LOG

Test Data		
	Design	Actual
CFM	1350	1373
Fan RPM	-	DD
Fan Rotation	-	CCW
Motor RPM	-	DD
System SetPt	-	60.8 Hz
RL Voltage	-	NA
RL Amperage	-	NA
Total ESP	-	0.81"
Fan Inlet SP	-	-0.81"
Fan Discharge SP	-	ATMO

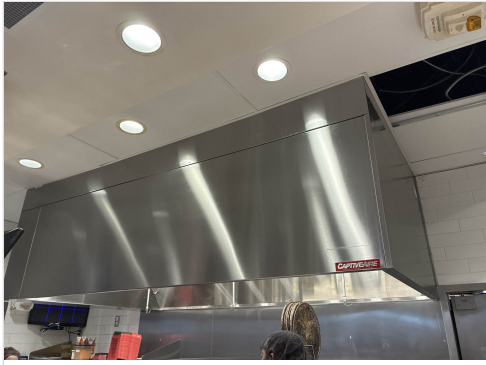
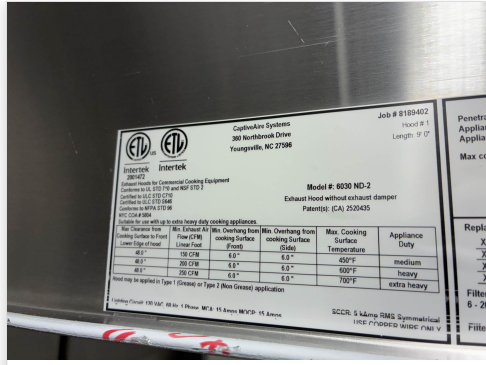
# Unit Data - PHOTO LOG

Test Data Exhaust		
	Design	Actual
Filter Type	-	BAFFLE FILTERS
Filter Size 1	-	16X20
Filter Qty 1	-	6
Filter AK factor size 1	-	2.08
Filter Total AK Area	-	12.48
Filter1 FPM	-	113
Filter2 FPM	-	111
Filter3 FPM	-	105
Filter4 FPM	-	113
Filter5 FPM	-	114
Filter6 FPM	-	108
Filter Ave FPM(corr)	-	110
CFM	1350	1373
