Report: Test and Balance  
Date: 3/6/2020

**FREDDY'S HCI - DURHAM, NC (3201) - RENEW 1F (1)**

3303 Watkins RD.  
Durham, NC

The purpose of the visit is to perform preventative maintenance for the store. We change belts and filters, clean evaporators and condenser, and check refrigeration and heating cycle where possible. We also, check and set exhaust, outside air, and make up air coming in out of the build to the engineer's design and/or to make the space as comfortable and healthy as possible. All of this ensures a healthy and comfortable space, extends service life of units, and reduces the number of future repairs by prevention.

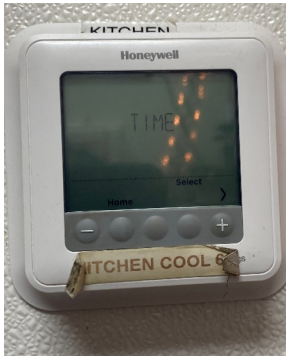
KITCHEN AREA THERMOSTAT  
UNPROGRAMMABLE

RECOMMENDATION (CLEAN/REPAIR/REPLACE/INFO)	
REPAIR	The penetration of the refrigeration lines and the insulation on them need to be investigated. One of them is allowing moisture in the space and causing ice to be building up in the freezer.
REPLACE	Kitchen thermostat can't program a schedule. It is more energy efficient if the thermostat can control the RTU on a schedule. Also, not having a programable thermostat increases the chance of the staff changing the fan setting from fan "ON" to Fan "Auto". NT recommends upgrading to a programable thermostat. The Honeywell WIFI Vision PRO is an easy thermostat to operate and allows the schedule to be locked. Then the staff can only have a 3 hours override. The energy savings from the upgrade will cover the costs of the thermostat upgrade.
REPLACE	MAU outside air filters need to be replaced. The internals are significantly damaged. They can be ordered and NT and install them next visit.

(1) KITCHEN THERMOSTATE NOT PROGRAMABLE

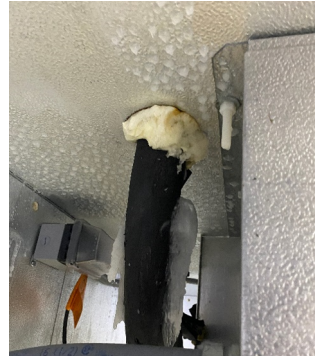
WALK-IN FREEZER  
ICE BUILD UP ON PENETRATION PIPE

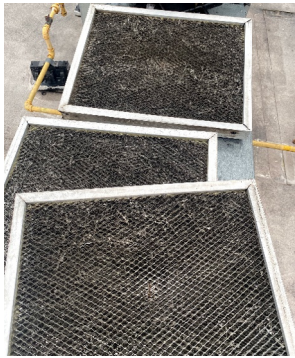
MAU  
DIRTY OUTSIDE AIR FILTERS

MAU: The intake filters had slight dirt accumulation. They were washed.

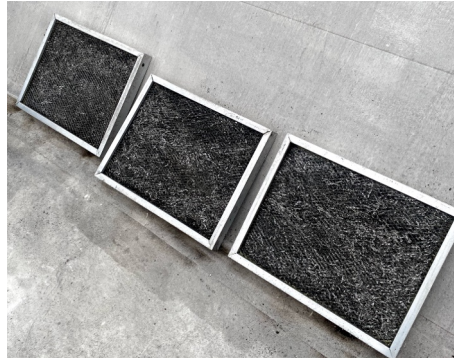
MAU  
CLEAN OUTSIDE AIR FILTERS

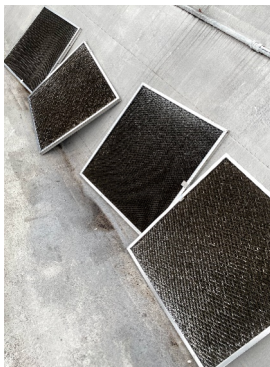
RTU-2 (DINING)  
DIRTY OUTSIDE AIR FILTERS

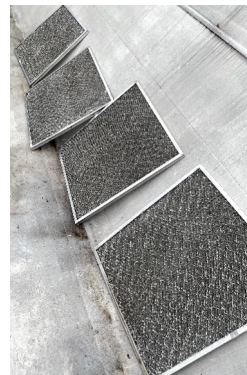
RTU-2 (DINING)  
CLEAN OUTSIDE AIR FILTERS

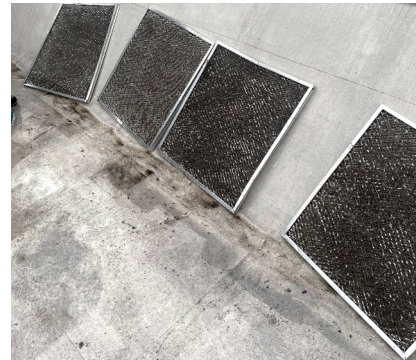
RTU-3 (KITCHEN)  
CLEAN OUTSIDE AIR FILTERS

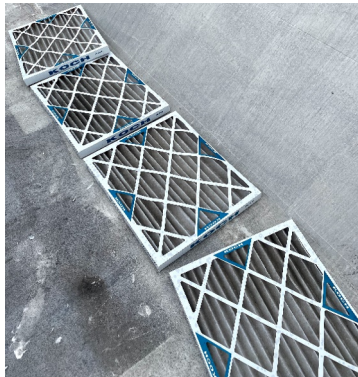
RTU-1 (DINING)  
DIRTY EVAPORATOR FILTERS

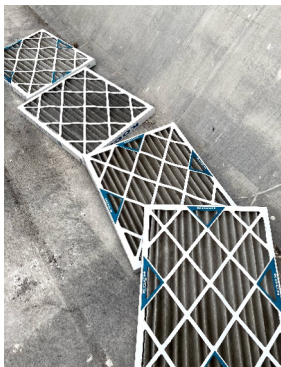
RTU-2 (DINING)  
DIRTY EVAPORATOR FILTERS

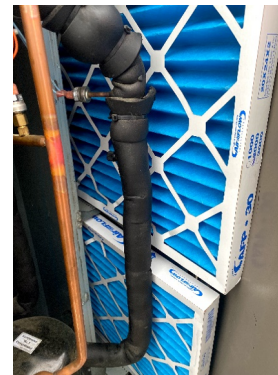
RTU-2 (DINING)  
CLEAN EVAPORATOR FILTERS

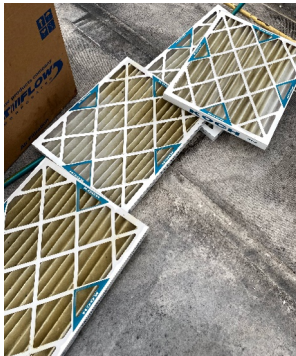
RTU-3 (KITCHEN)  
DIRTY EVAPORATOR FILTERS

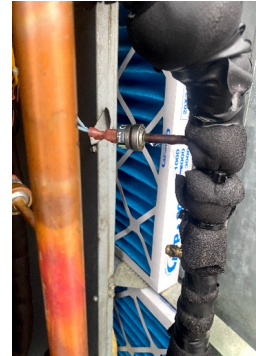
RTU-3 (KITCHEN)  
DIRTY EVAPORATOR FILTERS

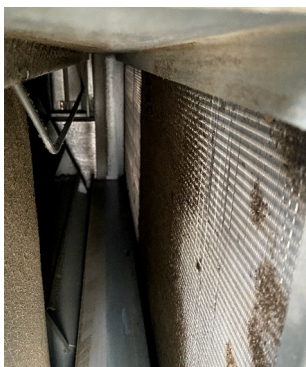
RTU-2 (DINING)  
DIRTY EVAPORATOR

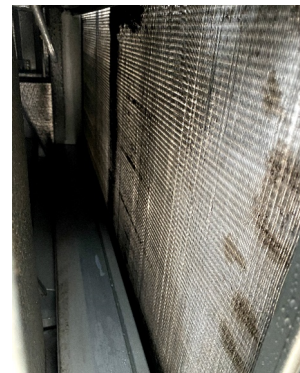
RTU-2 (DINING)  
CLEAN EVAPORATOR

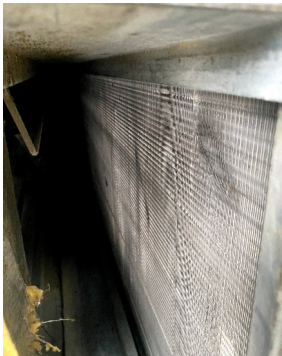
RTU-3 (KITCHEN)  
DIRTY EVAPORATOR

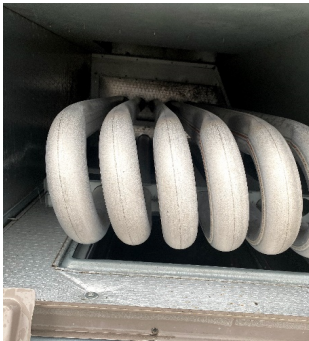
RTU-1 (DINING)  
BURNER TUBE INSPECTION

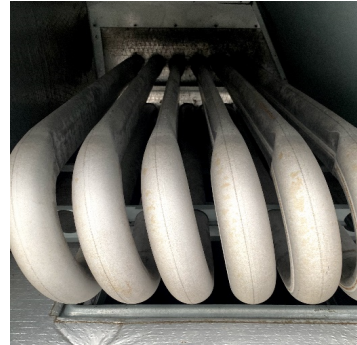
RTU-2 (DINING)  
BURNER TUBE INSPECTION

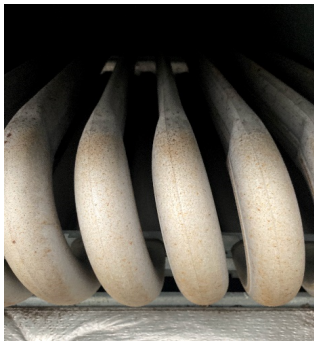
RTU-3 (KITCHEN)  
BURNER TUBE INSPECTION

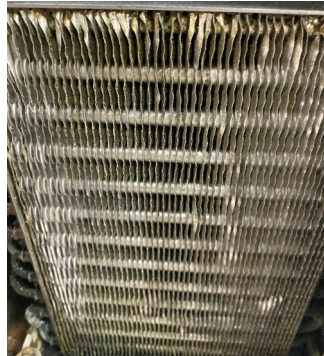
**DXC-3 (MEAT COOLER)  
CLEAN CONDENSER**

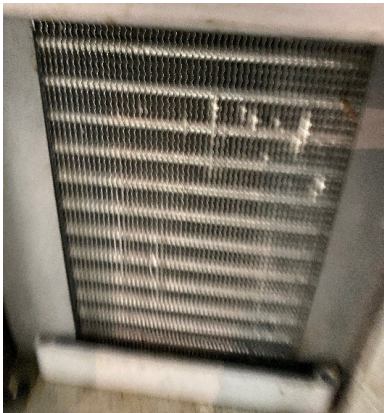
**DXC-4 (PREP TABLE)  
DIRTY CONDENSER**

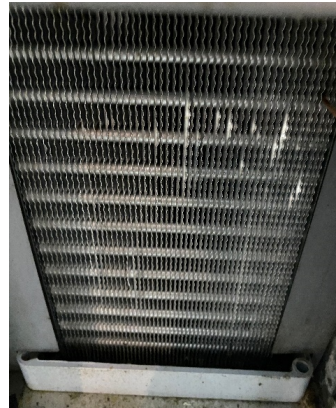
**DXC-4 (PREP TABLE)  
CLEAN CONDENSER**

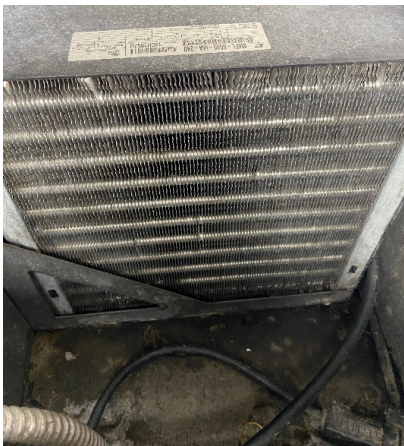
**DXC-5 (FRYER FREEZER)  
DIRTY CONDENSER**

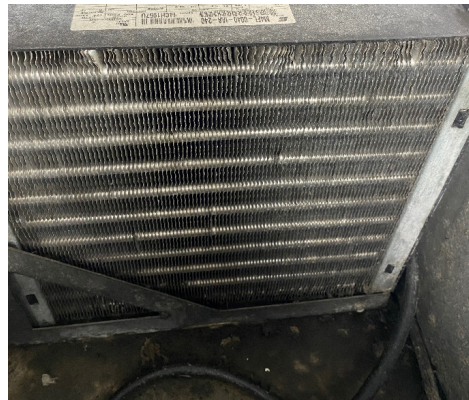
**DXC-5 (FRYER FREEZER)  
CLEAN CONDENSER**

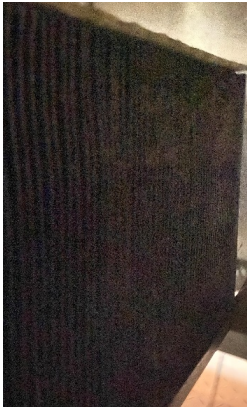
DXC-6 (SUNDAE PREP)  
DIRTY CONDENSER

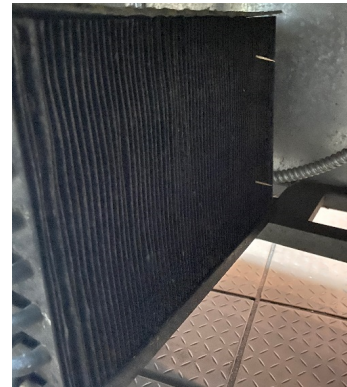
DXC-6 (SUNDAE PREP)  
CLEAN CONDENSER

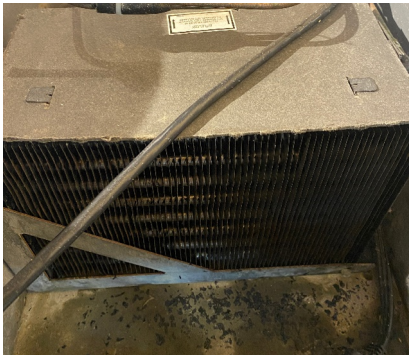
DXC-7 (TOPPING COOLER)  
DIRTY CONDENSER

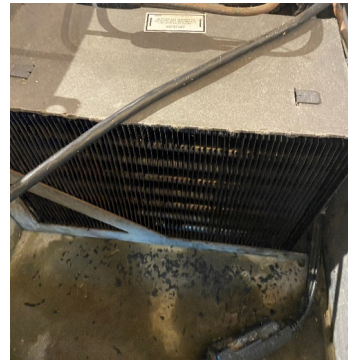
DXC-7 (TOPPING COOLER)  
CLEAN CONDENSER

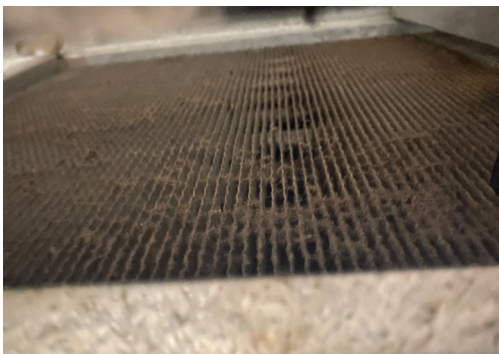
DXC-1 (WALK-IN COOLER)  
DIRTY EVAPORATOR

Notes: PENETRATION PIPES MAKE CLEANING HALF OF THE EVAPORATOR COILS DIFFICULT. (BRING THAT CAN GET INBETWEEN SMALL SPACES WITHOUT DAMAGEING COILS.

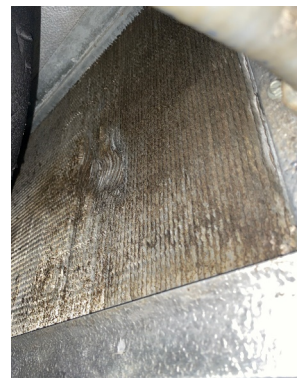
DXC-1 (WALK-IN COOLER)  
CLEAN EVAPORATOR

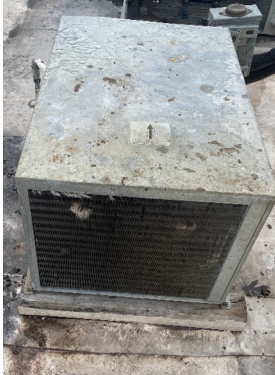
DXC-1 (WALK-IN COOLER)  
DIRTY CONDENSER

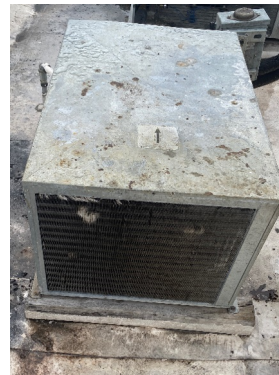
DXC-1 (WALK-IN COOLER)  
CLEAN CONDENSER

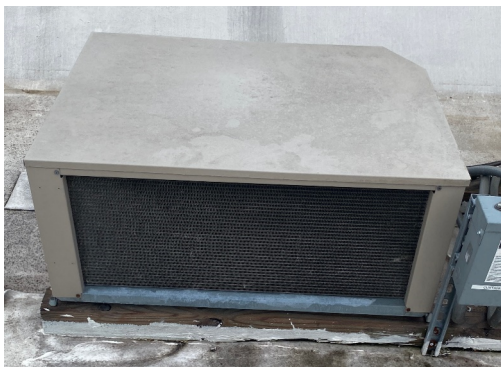
DXC-1 (WALK-IN COOLER)  
DIRTY CONDENSER

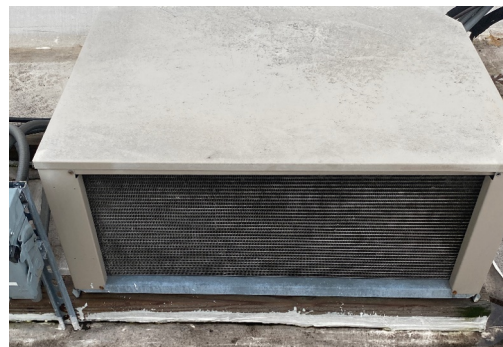
DXC-1 (WALK-IN COOLER)  
CLEAN CONDENSER
