**Report: TAB Report**  
**Function: Test, Adjust, & Balance**  
**Date: 04/15/2024**

**PROJECT**  
**04-08-24 CHUY'S - MUELLER, TX**

Project: 04-08-24 CHUY'S - MUELLER, TX

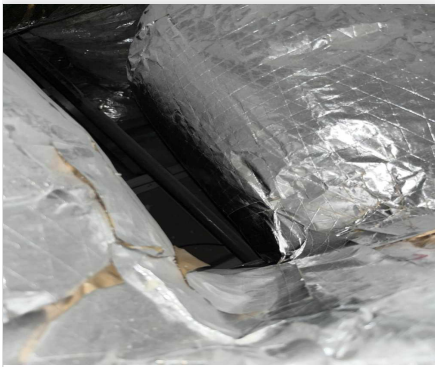
**MissingDampers  
04/16/2024**

**Issue Name :** AHU-1 Dampers Not Located  
**Description :** Volume dampers could not be located for diffusers 1-5, and 7 on AHU-1. Only unit totals were set to design.  
**Created By :** National TAB                      **Assigned To :** National TAB - Will Turnbough  
**Status :** Open  
**Priority :** High                                      **Asset Tag :**  
**Originated Date :** 04/10/2024 - Stephen Tassinaro - National TAB

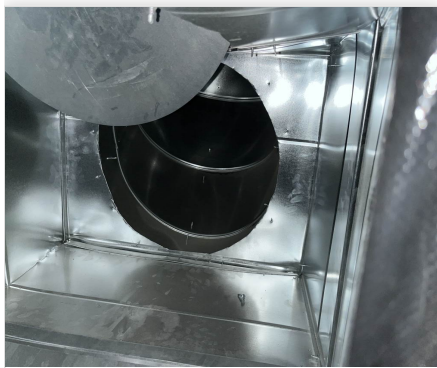
OA\_Damper  
04/16/2024

**Issue Name :** AHU-11 OA Damper Not Located  
**Description :** The outside air damper could not be located for AHU-11. When inspecting the interior of the duct it appears there is a damper present, but after much investigation no exterior handle could be located. The handle is potentially not installed or buried in insulation. The OA and Return has not been balanced as a result.  
**Created By :** National TAB                      **Assigned To :** National TAB - Will Turnbough  
**Status :** Open  
**Priority :** Urgent                                      **Asset Tag :**  
**Originated Date :** 04/16/2024 - Stephen Tassinaro - National TAB

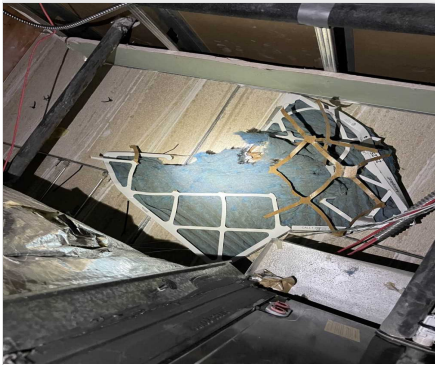
**DamagedFilter**  
**04/16/2024**

**Issue Name :** AHU-2 Final Filter  
**Description :** The AHU-2 final filter was significantly damaged and pulled into the evaporator coil. NTi removed damaged filter and left it out for balancing. A new 20x25x1 filter will need to be installed.  
**Created By :** National TAB                      **Assigned To :** National TAB - Will Turnbough  
**Status :** Open  
**Priority :** High                                      **Asset Tag :**  
**Originated Date :** 04/10/2024 - Stephen Tassinaro - National TAB

NO OUTSIDE AIR DAMPER HANDLE ACCESSIBLE. // FINAL FILTER WAS DAMAGED, REMOVED FOR TAB. NEW FILTER WILL NEED TO BE INSTALLED. // DIFFUSER LOCATIONS DO NOT EXACTLY MATCH MECHANICAL PLANS. SEE GRD MARKUP ON LAST PAGE OF REPORT.

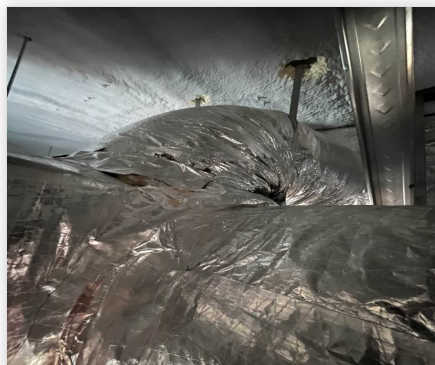
AHU3\_No\_OA\_Damper  
04/09/2024

**Issue Name :** AHU-3 OA Damper Not Located  
**Description :** The outside air damper could not be located for AHU-3. When inspecting the interior of the duct it appears there is a damper present, but after much investigation no exterior handle could be located. The handle is potentially not installed or buried in insulation. The OA and Return has not been balanced as a result.  
**Created By :** National TAB                      **Assigned To :** National TAB - Will Turnbough  
**Status :** Open  
**Priority :** Urgent                                      **Asset Tag :**  
**Originated Date :** 04/09/2024 - Stephen Tassinaro - National TAB

Notes:  
NO ACCESSIBLE OA DAMPER LOCATED.

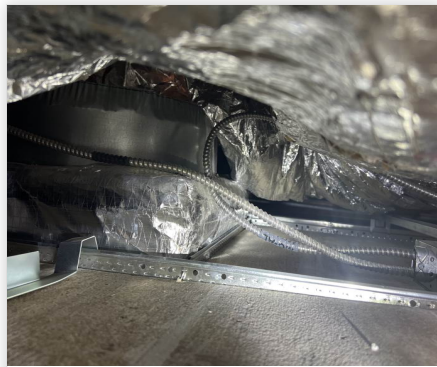
AHU6\_Return  
04/09/2024

**Issue Name :** AHU-6 Return Not Complete  
**Description :** AHU-6 return is not completed. The duct is not connected to the return grille and there is also a restriction in the system (potentially a damper that has not been located). The unit will not output any airflow unless the outside air damper is opened.  
**Created By :** National TAB                      **Assigned To :** National TAB - Will Turnbough  
**Status :** Open  
**Priority :** Urgent                                      **Asset Tag :**  
**Originated Date :** 04/09/2024 - Stephen Tassinaro - National TAB

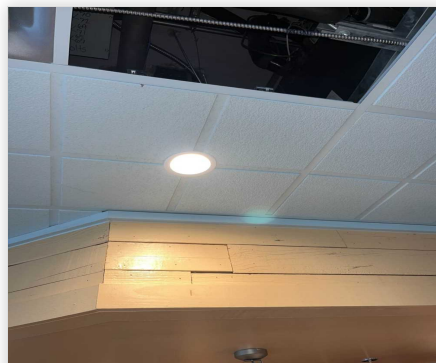
**InaccessbleAHU  
04/09/2024**

**Issue Name :** AHUs 5,6, and 7 Not Accessible  
**Description :** AHUs 5,6 and 7 are not accessible. They are located partially above a hard ceiling and partially above a light fixtures. NTi cannot access the electrical compartments to make speed adjustments, or gather voltage/amperage data. The light would need to be removed or potentially an access panel installed in order to access this part of the unit.

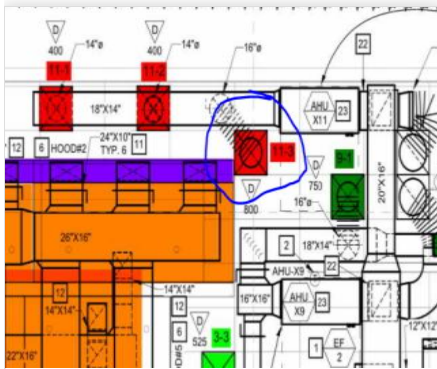
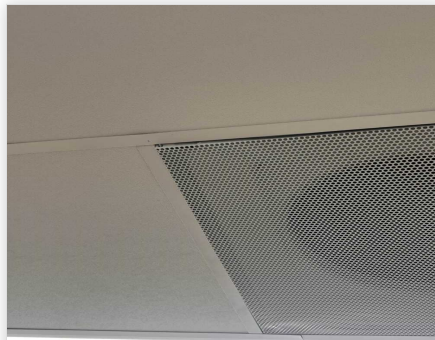
**Diffuser11\_3  
04/08/2024**

**Issue Name :** Diffuser 11-3 Damaged  
**Description :** Diffuser 11-3 is damaged and the perforated cover is falling off as a result. NTi reinstalled the cover several times throughout the day. Recommend repair/replacement.  
**Created By :** National TAB                      **Assigned To :** National TAB - Will Turnbough  
**Status :** Open  
**Priority :** Low                                      **Asset Tag :**  
**Originated Date :** 04/08/2024 - Stephen Tassinaro - National TAB

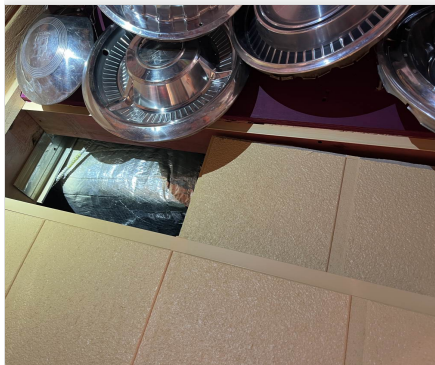
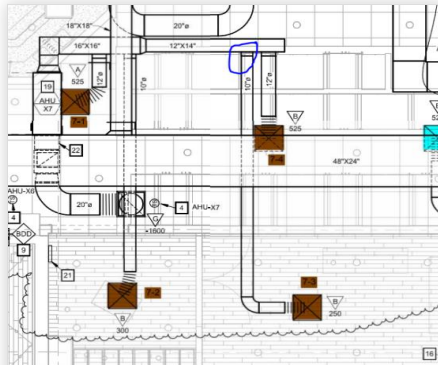
**Diffuser7\_3**  
**04/09/2024**

**Issue Name :** Diffuser 7-3 Damper Not Accessible  
**Description :** The volume damper is not accessible on diffuser 7-3. There is a damper installed but it is located above the hard ceiling and cannot be reached. Airflow is currently 329CFM out of 250CFM design (131%).  
**Created By :** National TAB                      **Assigned To :** National TAB - Will Turnbough  
**Status :** Open  
**Priority :** Urgent                                      **Asset Tag :**  
**Originated Date :** 04/09/2024 - Stephen Tassinaro - National TAB

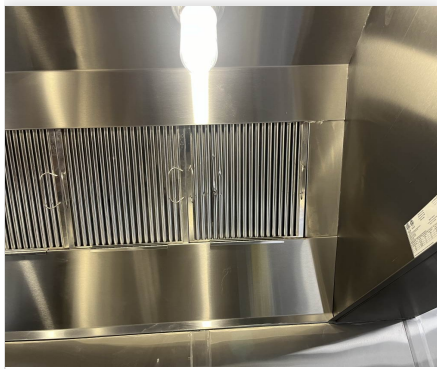
IMG\_2596  
04/08/2024

**Issue Name :** Hood 1 Damaged Filter  
**Description :** Hood 1 has a damaged grease filter, it is not effecting performance in any way.  
**Created By :** National TAB                      **Assigned To :** National TAB - Will Turnbough  
**Status :** Open  
**Priority :** InfoOnly                                      **Asset Tag :**  
**Originated Date :** 04/08/2024 - Stephen Tassinaro - National TAB
