Report: Inspection Report
Function: Test, Adjust, & Balance
Date: 02/09/2026
Completed By: National TAB

PROJECT
02-09-26 QT #1425 PEORIA, AZ

Project: 02-09-26 QT #1425 PEORIA, AZ

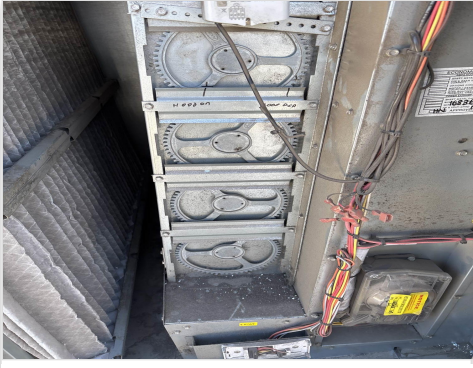
Asset: RT-1

Test Data		
	Design	Actual
SF CFM	4200	4115
SF RPM	-	1337
OA CFM (Hoods On)	800	799
OA CFM (Hoods Off)	350	347
RL Voltage	-	155@VFD
RL Amperage	-	7.4@VFD
VFD Max SetPt	-	45.6HZ
VFD Min SetPt	-	24HZ
OA Damper Position (Hoods On)	-	46%
OA Damper Position (Hoods Off)	-	19%

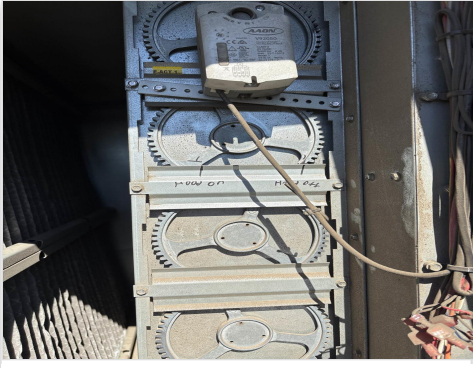
Asset: RT-2

Test Data		
	Design	Actual
SF CFM	4200	4314
SF RPM	-	1320
OA CFM (Hoods On)	800	806
OA CFM (Hoods Off)	350	375
RL Voltage	-	151@VFD
RL Amperage	-	7.7@VFD
VFD Max SetPt	-	45HZ
VFD Min SetPt	-	24HZ
OA Damper Position (Hoods On)	-	46%
OA Damper Position (Hoods Off)	-	21%

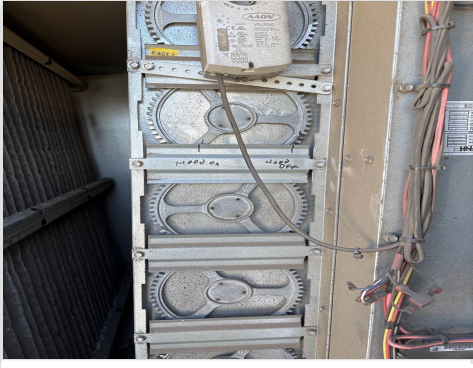
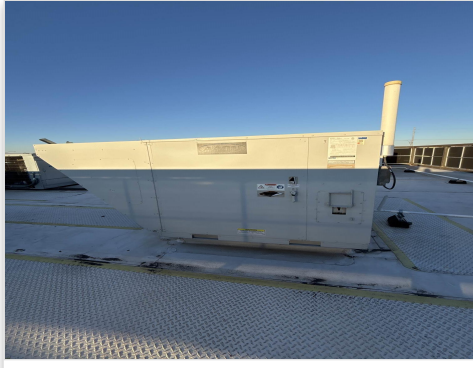
Asset: RT-3

Test Data		
	Design	Actual
SF CFM	4200	4263
SF RPM	-	1584
OA CFM (Hoods On)	800	813
OA CFM (Hoods Off)	350	368
RL Voltage	-	208@VFD
RL Amperage	-	9.7@VFD
VFD Max SetPt	-	54HZ
VFD Min SetPt	-	24HZ
OA Damper Position (Hoods On)	-	46%
OA Damper Position (Hoods Off)	-	24%

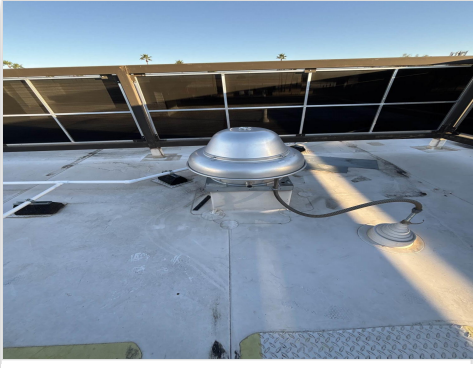
Asset: EF1

Test Data		
	Design	Actual
CFM	750	779
Fan RPM	-	NA
Fan Rotation	-	CCW
Motor RPM	-	NA
System SetPt	-	LOW
RL Voltage	-	NA
RL Amperage	-	4.3
Total ESP	-	0.31"
Fan Inlet SP	-	-0.31"
Fan Discharge SP	-	ATMS

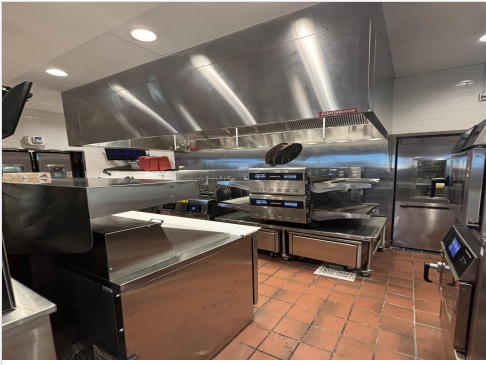
Asset: HD1

Test Data Exhaust		
	Design	Actual
Filter Type	-	BAFFLE
Filter Size 1	-	20X16
Filter Qty 1	-	6
Filter AK factor size 1	-	2.08
Filter Total AK Area	-	12.48
Filter1 FPM	-	105
Filter2 FPM	-	119
Filter3 FPM	-	113
Filter4 FPM	-	117
Filter5 FPM	-	114
Filter6 FPM	-	96
Filter Ave FPM(corr)	-	110
CFM	1350	1372
