**Report: TAB Report**  
**Function: Test, Adjust, & Balance**  
**Date: 12/11/2025**  
**Completed By: National TAB**

**PROJECT**  
**12-08-25 QT #1417 GOODYEAR, AZ**

1540 N BULLARD AVE

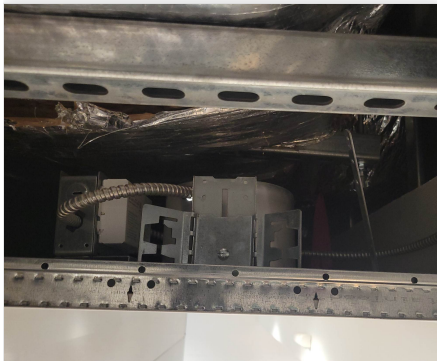
**Issue Name :** KITCHEN DAMPERS INACCESSIBLE  
**Description :** Only 1 damper was able to be reached. These ceiling tiles have light canisters installed which make them almost immobile due to proximity of steel support rails. They cannot be moved enough to access dampers. Recommend not installing tiles until kitchen is properly balanced.  
**Created By :** National TAB                      **Assigned To :** National TAB - Dan Hertenstein  
**Status :** Open  
**Priority :** High                                      **Asset Tag :** RT-3  
**Originated Date :** 12/11/2025 - Christine Weale - National TAB

I ADJUSTED THE ONLY ACCESSIBLE DAMPER TO GET INDIVIDUAL GRILLES AS CLOSE TO DESIGN AS POSSIBLE.
