**Report: TAB Report**  
**Function: Test, Adjust, & Balance**  
**Date: 12/11/2025**  
**Completed By: National TAB**

**PROJECT**  
**12-08-25 QT #1417 GOODYEAR, AZ**

1540 N BULLARD AVE

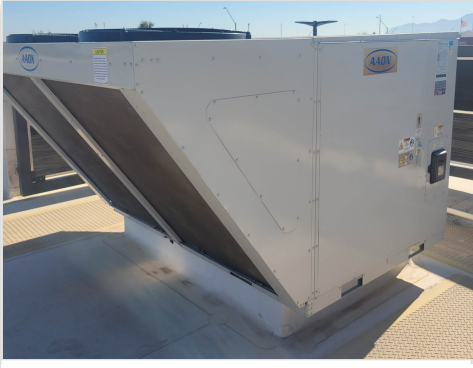
Asset: RT-1

Unit Data	
	Actual
MFG	AAON
Serial Num	202212-ANEK26094
Model Num	RN-013-8-0-EA0A-152
Num OA Filters 1	1
OA Filter Size 1	45X22
Num Final Filter 1	2
Final Filter Size 1	46X19.5

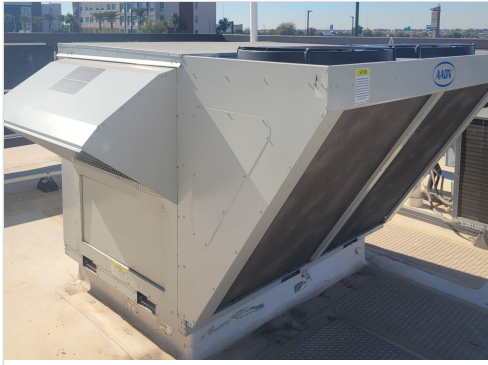
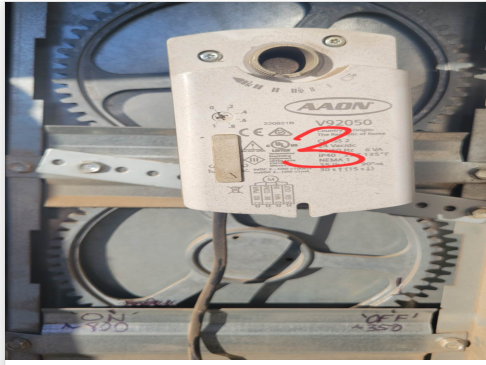
Asset: RT-3

Unit Data	
	Actual
MFG	AAON
Serial Num	202212-ANEK26096
Model Num	RN-013-8-0-EA0A-152
Num OA Filters 1	1
OA Filter Size 1	45X22
Num Final Filter 1	2
Final Filter Size 1	46X19.5

I ADJUSTED THE ONLY ACCESSIBLE DAMPER TO GET INDIVIDUAL GRILLES AS CLOSE TO DESIGN AS POSSIBLE.

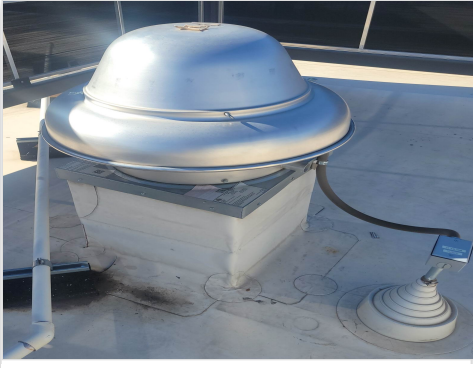
Asset: EF1

Unit Data		
	Design	Actual
MFG	NA	CAPTIVEAIRE
Model Num	NA	DR50HFA
Serial Num	-	5776925
Type	-	DOWNBLAST
Configuration	-	VERTICAL

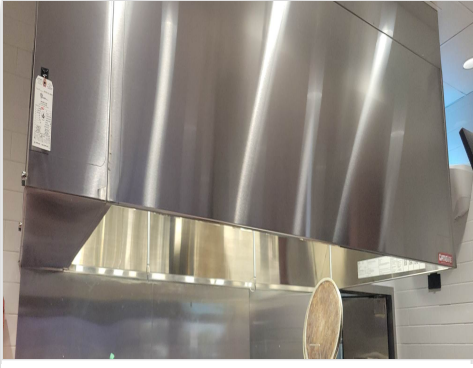
Asset: HD1

Design	Actual
MFG	CAPTIVEAIRE	CAPTIVEAIRE
Model Num	6030ND-2-F	6030ND-2-F
Job / Serial Num	-	7644820
Type	-	TYPE II CANOPY
Hood length	-	108"
Hood Width	-	60"
