**Report: TAB Report**  
**Function: Test, Adjust, & Balance**  
**Date: 10/28/2025**  
**Completed By: National TAB**

**PROJECT**  
**09-22-25 QT #0579 OMAHA, NE**

1704 SOUTH 72ND STREET

QUIKTRIP  
4705 SOUTH 129TH EAST AVENUE  
TULSA, OK 74134

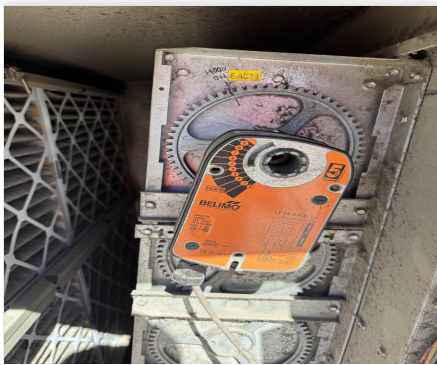
**Issue Name :** RT-3: Damper Motor not Properly Functioning  
**Description :** The motor for the OA damper does not open/close all the way. Had to loosen actuator bolts and manually set OA.  
**Created By :** National TAB                      **Assigned To :** National TAB - Dan Hertenstein  
**Status :** Open  
**Priority :** High                                      **Asset Tag :**  
**Originated Date :** 09/26/2025 - Kalen Kemp - National TAB

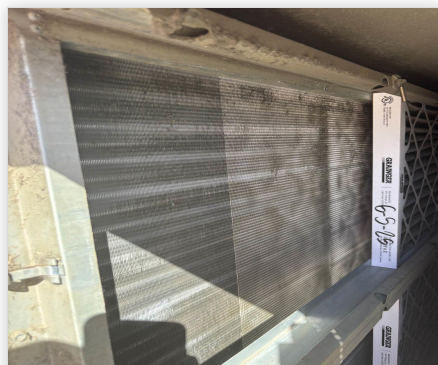
**Issue Name :** RTUs: Dirty Coils  
**Description :** The coils inside of the RTUs are dirty. Recommend cleaning.  
**Created By :** National TAB                      **Assigned To :** National TAB - Dan Hertenstein  
**Status :** Open  
**Priority :** Medium                                      **Asset Tag :**  
**Originated Date :** 09/30/2025 - Kalen Kemp - National TAB

ALL RTs: Dirty Coils

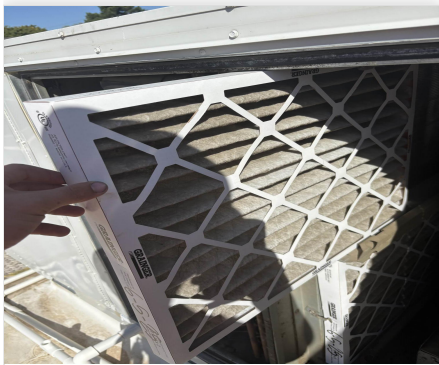
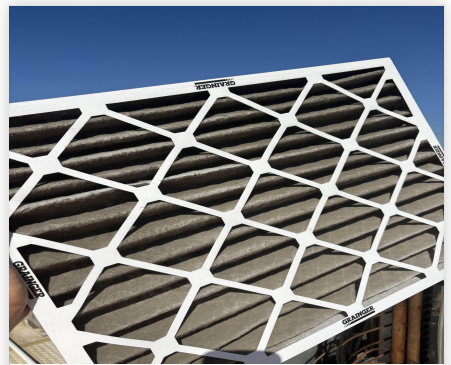
**Issue Name :** RTUs: Dirty Filters  
**Description :** The filters in the RTUs are dirty. The inside of the filter compartment is very dirty as well. Recommend Cleaning.  
**Created By :** National TAB                      **Assigned To :** National TAB - Dan Hertenstein  
**Status :** Open  
**Priority :** Medium                                      **Asset Tag :**  
**Originated Date :** 09/26/2025 - Kalen Kemp - National TAB

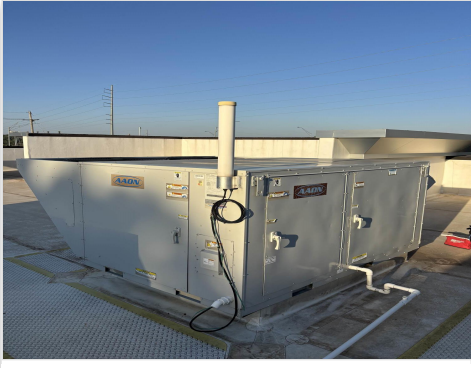
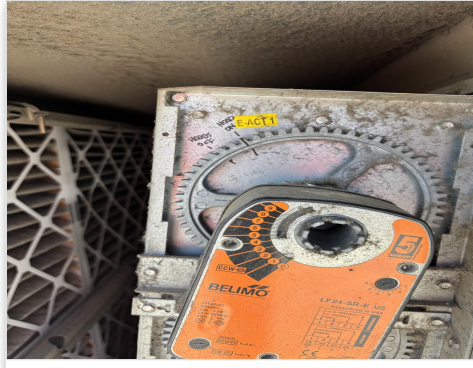
## Unit Data - PHOTO LOG

Asset: RT-1

General	
	Actual
Fan Rotation Correct	NA
Unit Filters Clean	NO
Condensate Drain Installed	YES

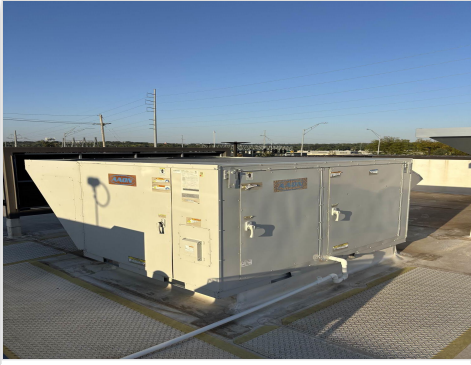
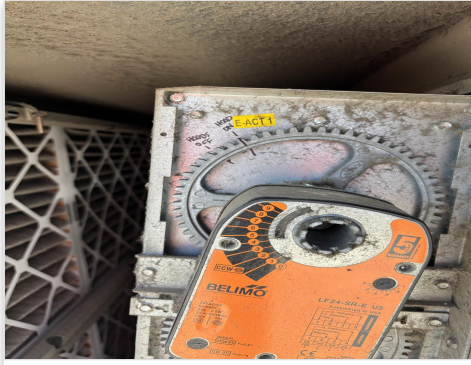
## Unit Data - PHOTO LOG

Asset: RT-2

General	
	Actual
Fan Rotation Correct	YES
Unit Filters Clean	NO
Condensate Drain Installed	YES

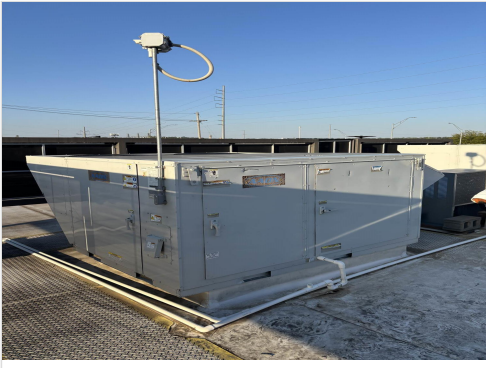
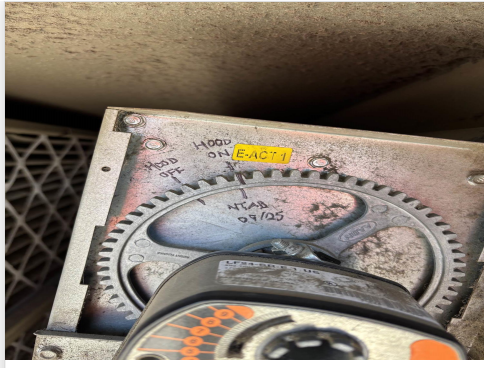
## Unit Data - PHOTO LOG

Asset: RT-3

General	
	Actual
Fan Rotation Correct	YES
Unit Filters Clean	NO
Condensate Drain Installed	YES

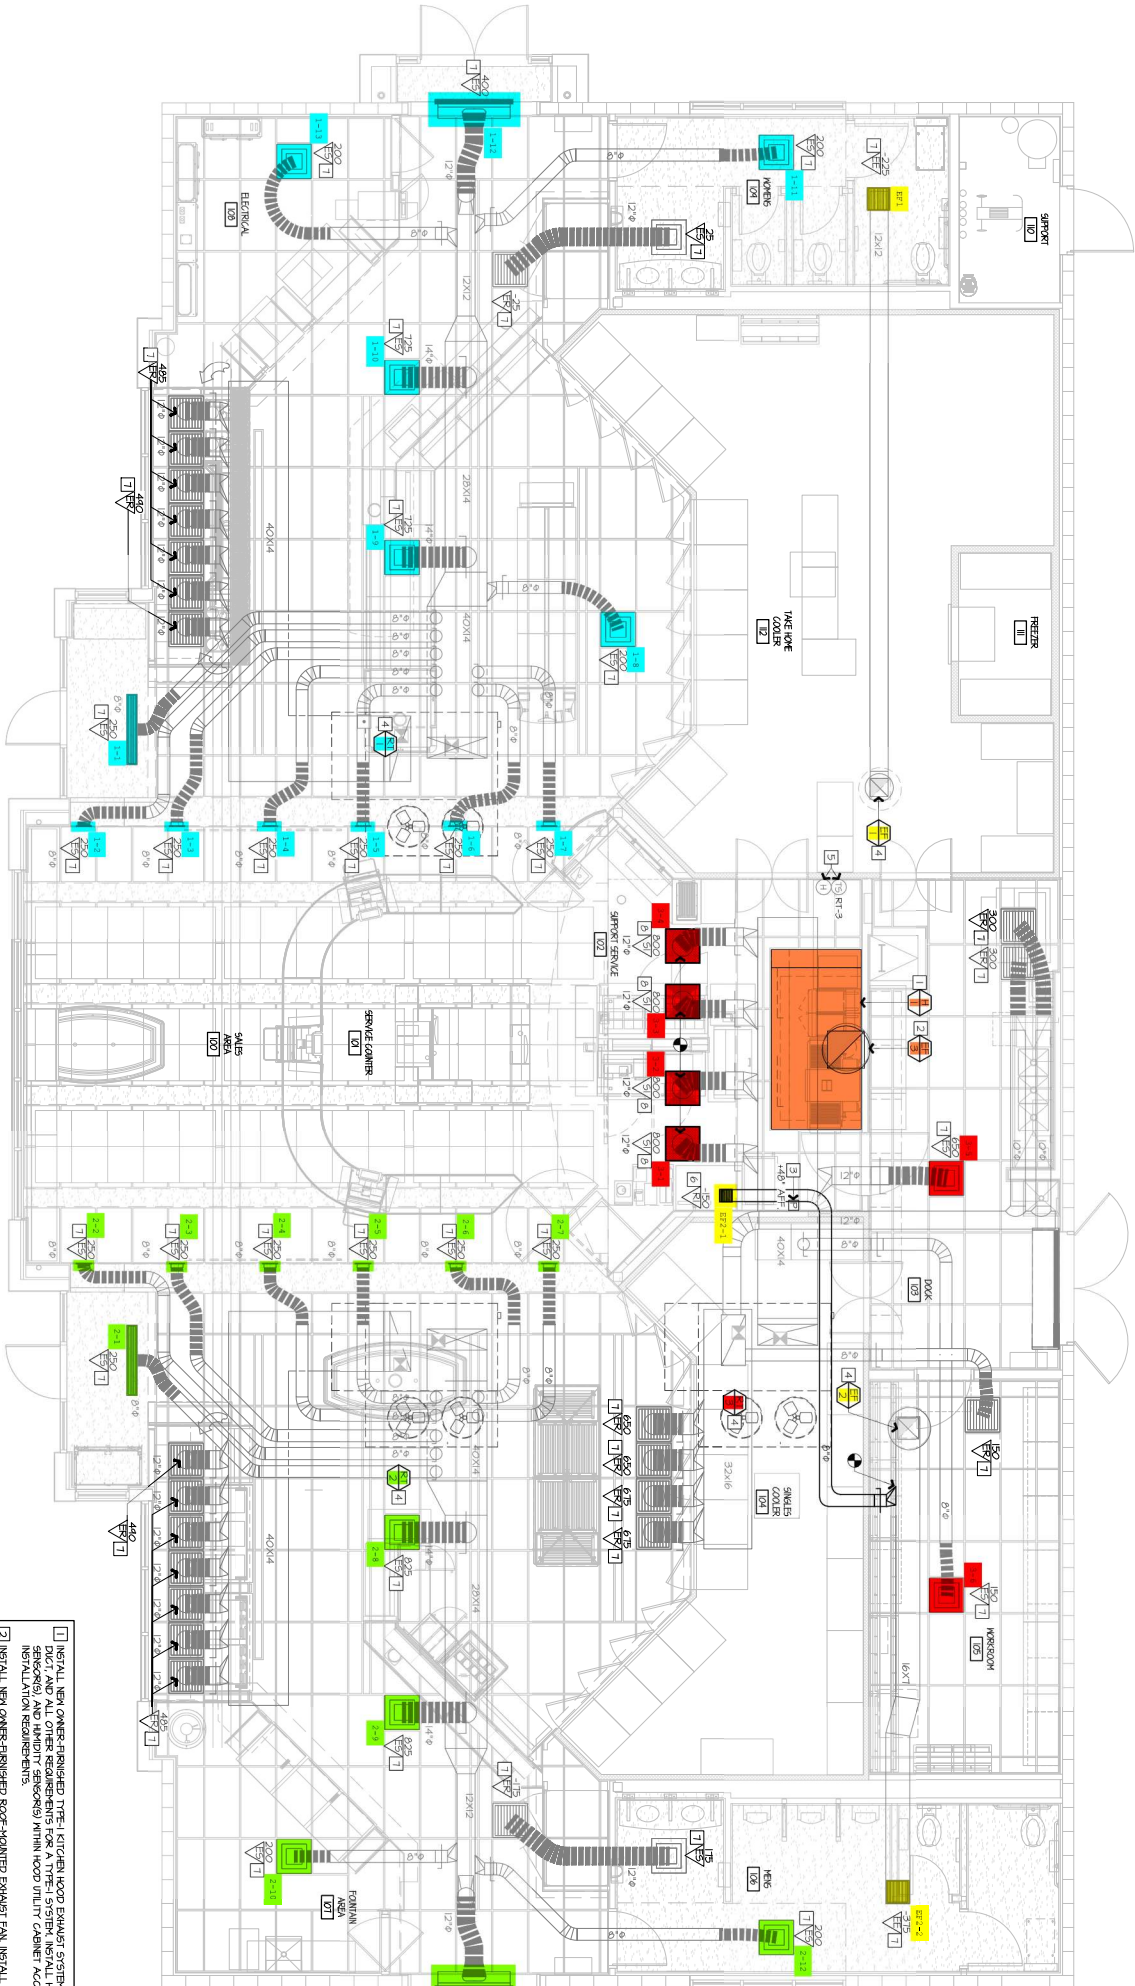
- [1] INSTALL NEW OWNER-FURNISHED TYPE-I KITCHEN HOOD EXHAUST SYSTEM FREE SINK/STOVE SINK DUCT AND ALL OTHER REQUIREMENTS FOR A TYPE-I SYSTEM INSTALL HOOD CAPS, PANELS, METALLIC COVERS, MINIMUM 100% ULTIMATE COORDINATION WITH ALL OTHER MECHANICAL INSTALLATION REQUIREMENTS.
- [2] INSTALL NEW OWNER-FURNISHED ROOF-MOUNTED EXHAUST FAN INSTALL 12" Ø Ø 10'
