National TAB
1329 E Kemper Rd, Ste 4210
Cincinnati, OH 45246

Report: Renew
Date: 12/02/2021

**FREDDY'S - WICHITA, KS (ROCK ROAD) - RENEW 3H
(4)**

Project Summary

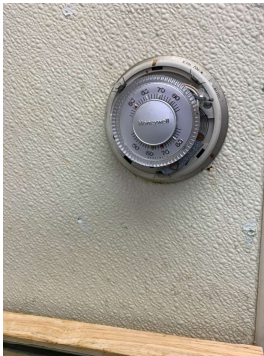
RECOMMENDATION (CLEAN/REPAIR/REPLACE/INFO)	
REPLACE	Office's Furnace thermostat is falling apart. Recommend upgrading the thermostat.

FURNACE THERMOSTAT
OLD RECOMMEND REPLACEMENT

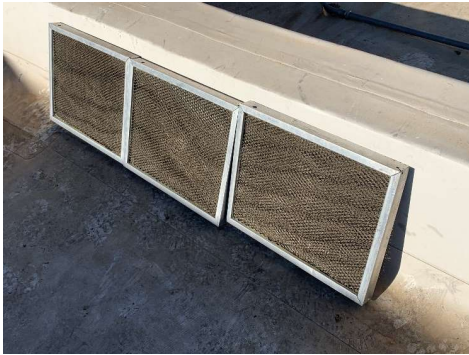
MAU
DIRTY OUTSIDE AIR FILTERS

MAU: The intake filters had slight dirt accumulation. They were washed.

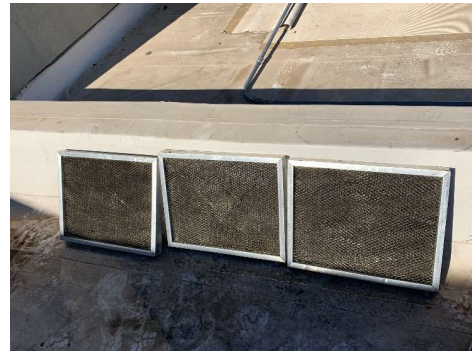
MAU
CLEAN OUTSIDE AIR FILTERS

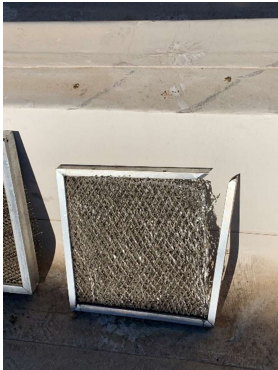
RTU-1 (DINING)
DIRTY OUTSIDE AIR FILTERS

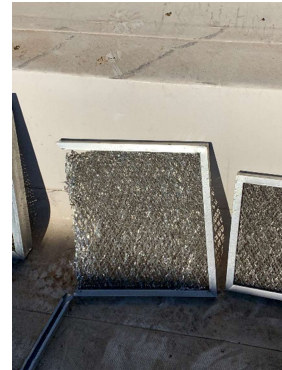
RTU-1 (DINING)
CLEAN OUTSIDE AIR FILTERS

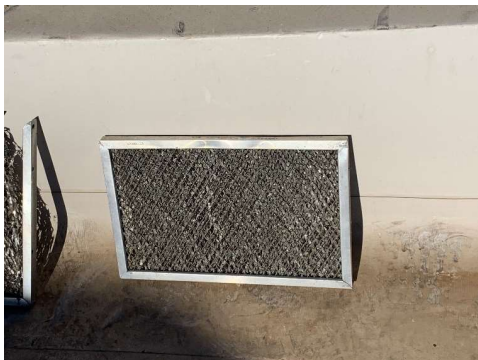
RTU-2 (DINING)
DIRTY OUTSIDE AIR FILTERS

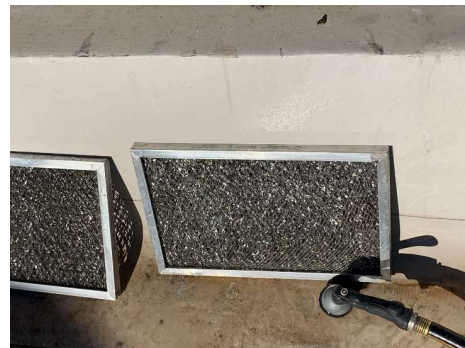
RTU-2 (DINING)
CLEAN OUTSIDE AIR FILTERS

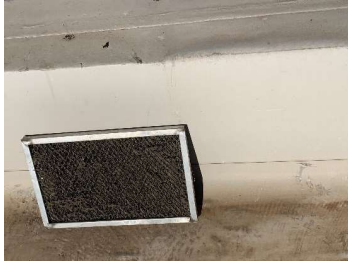
RTU-3 (DINING/ORDERING)
DIRTY OUTSIDE AIR FILTERS

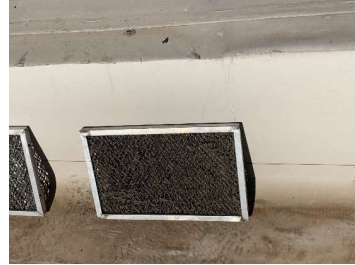
RTU-3 (DINING/ORDERING)
CLEAN OUTSIDE AIR FILTERS

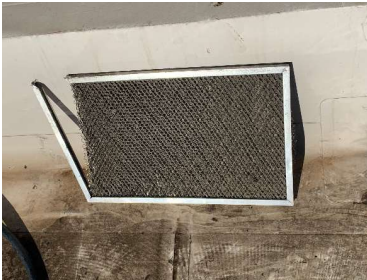
RTU-4 (KITCHEN)
DIRTY OUTSIDE AIR FILTERS

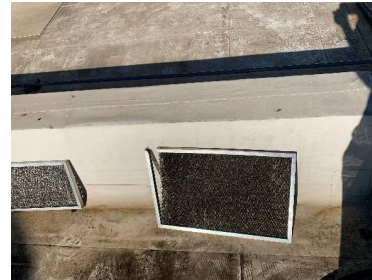
RTU-4 (KITCHEN)
CLEAN OUTSIDE AIR FILTERS

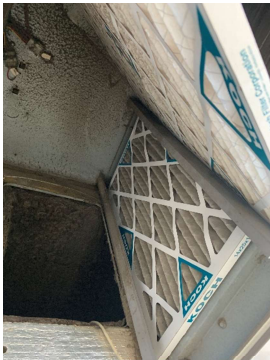
RTU-1 (DINING)
DIRTY EVAPORATOR FILTERS

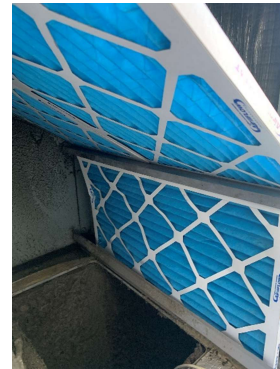
RTU-1 (DINING)
CLEAN EVAPORATOR FILTERS

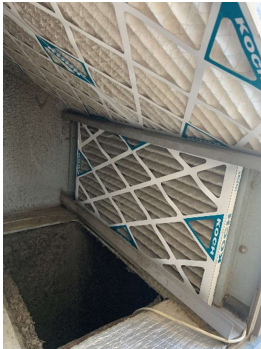
RTU-2 (DINING)
DIRTY EVAPORATOR FILTERS

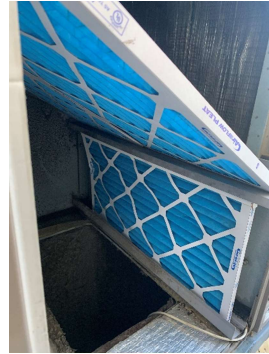
RTU-2 (DINING)
CLEAN EVAPORATOR FILTERS

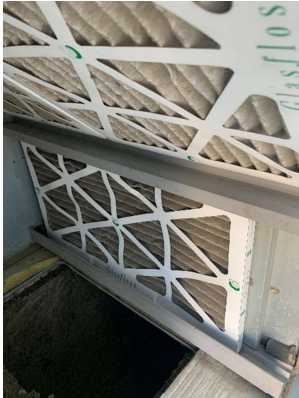
RTU-3 (DINING/ORDERING)
DIRTY EVAPORATOR FILTERS

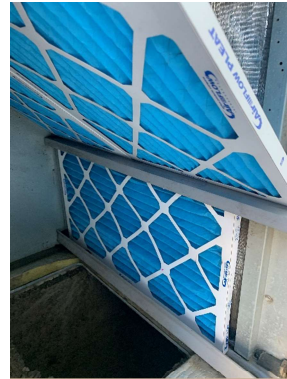
RTU-3 (DINING/ORDERING)
CLEAN EVAPORATOR FILTERS

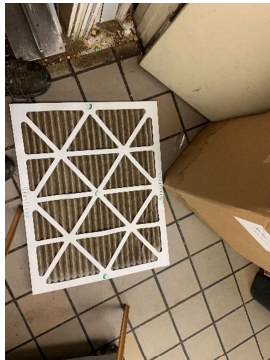
FURNACE
DIRTY EVAPORATOR FILTERS

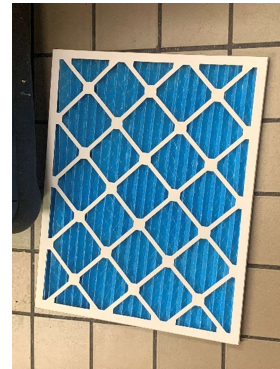
FURNACE
CLEAN EVAPORATOR FILTERS

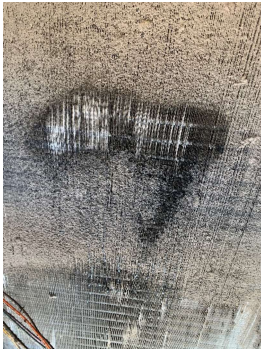
RTU (DINING)
DIRTY EVAPORATOR

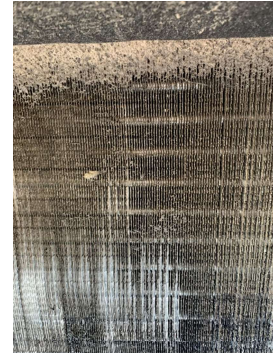
RTU-1 (DINING)
CLEAN EVAPORATOR

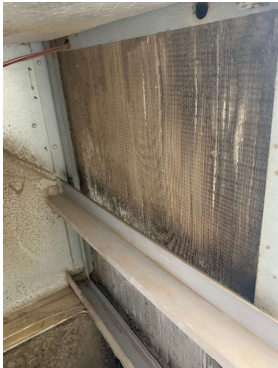
RTU-2 (DINING)
DIRTY EVAPORATOR

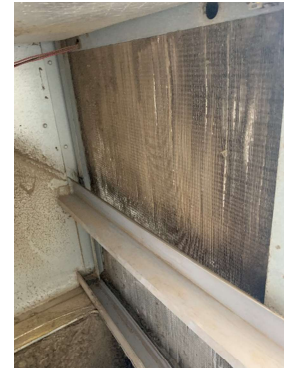
RTU-2 (DINING)
CLEAN EVAPORATOR

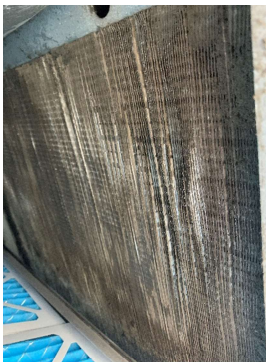
RTU-3 (DINING/ORDERING)
DIRTY EVAPORATOR

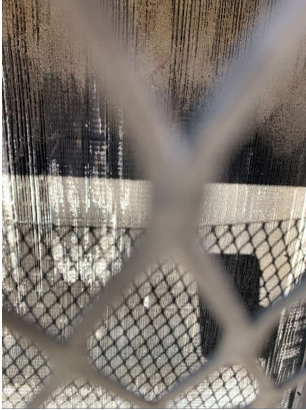
RTU-1 (DINING)
DIRTY CONDENSER

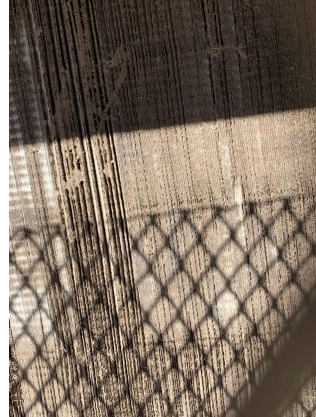
RTU-1 (DINING)
CLEAN CONDENSER

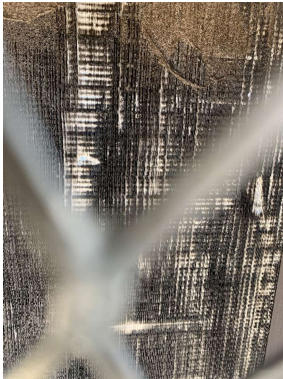
RTU-2 (DINING)
DIRTY CONDENSER

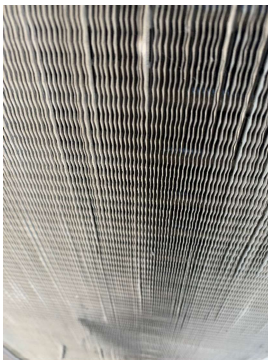
RTU-3 (DINING/ORDERING)
DIRTY CONDENSER

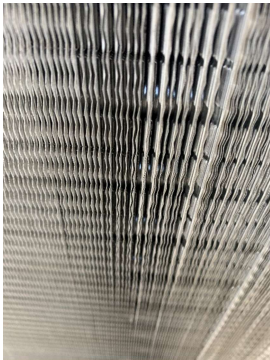
RTU-4 (KITCHEN)
DIRTY CONDENSER

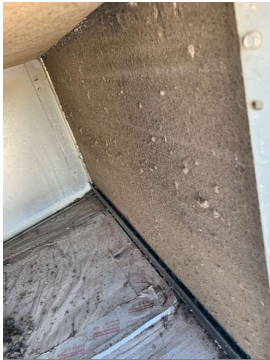
RTU-4 (KITCHEN)
DIRTY EVAPORATOR

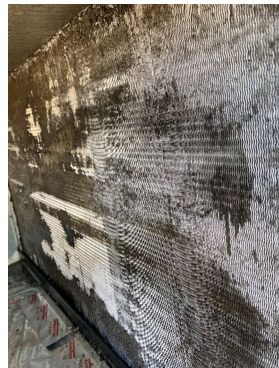
RTU-4 (KITCHEN)
CLEAN EVAPORATOR
