Report: TAB Report
Function: Test, Adjust, & Balance
Date: 02/05/2026
Completed By: National TAB

PROJECT
03-02-26 QT #1730 FORSYTH, GA

240 HAROLD G CLARKE PRKWY

Project: 03-02-26 QT #1730 FORSYTH, GA

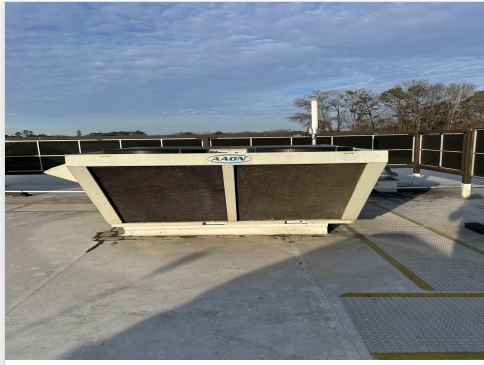
Unit Data - PHOTO LOG

Unit Data	
	Actual
MFG	AAON
Serial Num	202201-ANEK23448
Model Num	RN-013-8-0-EA0A-152
Num OA Filters 1	1
OA Filter Size 1	23X45
Num Final Filter 1	4
Final Filter Size 1	20X25X2

[1] UNIT NOT OPERATING; UNABLE TO TAB, SEE ISSUE

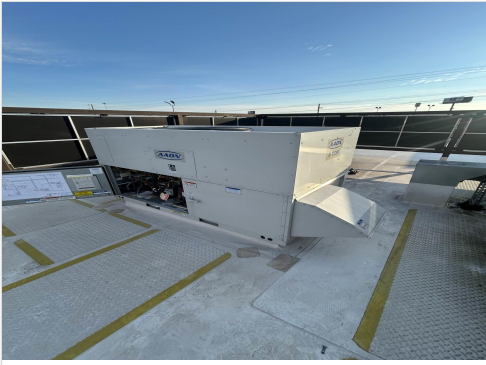
Unit Data - PHOTO LOG

Unit Data	
	Actual
MFG	AAON
Serial Num	202201-AYEF05213
Model Num	RQ-006-8-V-EA09-132
Num OA Filters 1	1
OA Filter Size 1	12X18
Num Final Filter 1	2
Final Filter Size 1	20X25X2

Notes:
Dampers 4-6 and 4-7 are inaccessible.

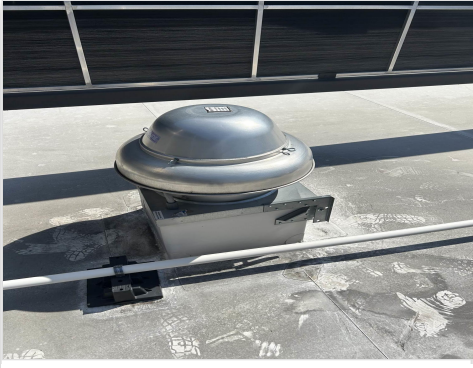
Unit Data - PHOTO LOG

Unit Data		
	Design	Actual
MFG	NA	CAPITIVEAIRE
Model Num	NA	DR33HFA
Serial Num	-	5157507
Type	-	DOWNBLAST
Configuration	-	VERTICAL

Test Data		
	Design	Actual
CFM	650	661
Fan RPM	-	1641
Fan Rotation	-	CCW
Motor RPM	-	1641
System SetPt	-	84 %
RL Voltage	-	115
RL Amperage	-	3.8
Total ESP	-	0.17"
Fan Inlet SP	-	-0.17"
Fan Discharge SP	-	ATM

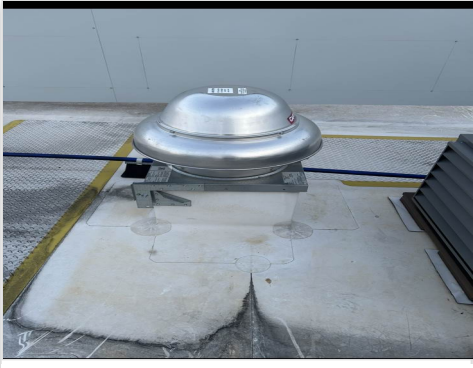
Unit Data - PHOTO LOG

Unit Data		
	Design	Actual
MFG	NA	CAPTIVEAIRE
Model Num	NA	DR12HFA
Serial Num	-	5157507
Type	-	DOWNBLAST
Configuration	-	VERTICAL

Test Data		
	Design	Actual
CFM	350	329
Fan RPM	-	1360
Fan Rotation	-	CCW
Motor RPM	-	1360
System SetPt	-	71 %
RL Voltage	-	115
RL Amperage	-	1.27
Total ESP	-	-0.14"
Fan Inlet SP	-	0.14
Fan Discharge SP	-	ATM

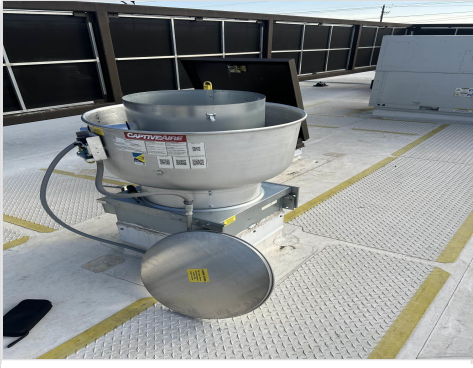
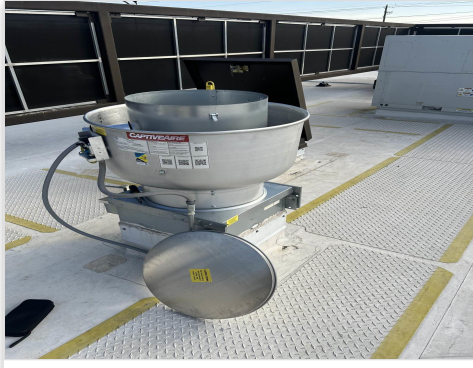
Unit Data - PHOTO LOG

Unit Data		
	Design	Actual
MFG	NA	CAPTIVEAIRE
Model Num	NA	DU50HFA
Serial Num	-	8385043
Type	UPBLAST	UPBLAST
Configuration	VERTICAL	VERTICAL

Test Data		
	Design	Actual
CFM	1350	1460
Fan RPM	-	1177
Fan Rotation	-	CCW
Motor RPM	-	1177
System SetPt	-	53.6 hz
RL Voltage	-	212
RL Amperage	-	1.81
Total ESP	0.75"	0.43"
Fan Inlet SP	-	-0.43"
Fan Discharge SP	-	ATM

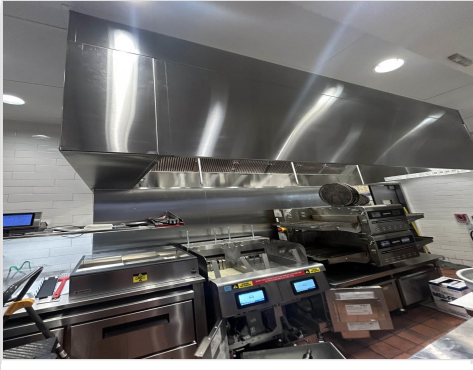
Unit Data - PHOTO LOG

Unit Data		
	Design	Actual
MFG	CAPTIVEAIRE	CAPTIVEAIRE
Model Num	6030ND-2	6030ND-2
Job / Serial Num	-	8385043
Type	TYPE I CANOPY	TYPE I CANOPY
Hood length	108"	108"
Hood Width	60"	60"

Test Data Exhaust		
	Design	Actual
Filter Type	CAPTRATE SOLO FILTER	CAPTRATE SOLO FILTER
Filter Size 1	20X16	20x16
Filter Qty 1	6	6
Filter AK factor size 1	2.08	2.08
Filter Total AK Area	12.48	12.48
Filter1 FPM	-	117
Filter2 FPM	-	116
Filter3 FPM	-	124
Filter4 FPM	-	132
Filter5 FPM	-	112
Filter6 FPM	-	107
Filter Ave FPM(corr)	-	117
CFM	1350	1460
