Report: TAB REPORT
Function: Test, Adjust, & Balance
Date: 07/31/2024

**07-18-24 UCHIKO (LEGACY WEST) PLANO,
TX**

HAI Hospitality

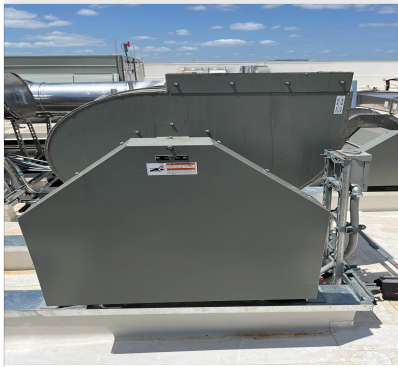
EF-3

Test Data		
	Design	Actual
CFM	1400	981
Fan RPM	1580	1542
Fan Rotation	-	CW
Motor RPM	-	1760
RL Voltage	-	210/213/213
RL Amperage	-	1.9/1.9/1.9
Suction ESP	-	-0.93
Discharge ESP	-	ATM
Total ESP	1.25"	-0.93
