Report: TAB Report
Function: Test, Adjust, & Balance
Date: 03/25/2026
Completed By: National TAB

03-30-26 Chipotle #5532 Belleville, NJ

Project: 03-30-26 Chipotle #5532 Belleville, NJ

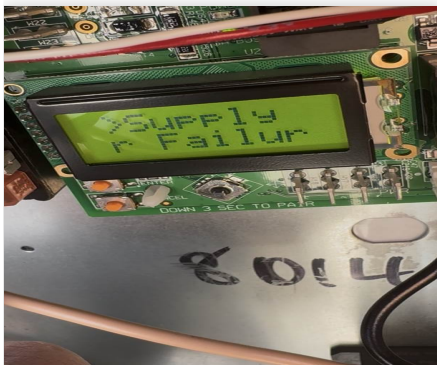
Issue Name : Alarms present on RTU-1
Description : There are two alarms present on RTU-1. They consist of, 1) SUPPLY HUMIDITY SENSOR FAILURE and 2) OUTDOOR AIR QUALITY SENSOR FAILURE. These did not affect TAB, but they need to be serviced.
Created By : National TAB **Assigned To :** National TAB - Will Turnbough
Status : Open
Priority : Low **Asset Tag :**
Originated Date : 03/31/2026 - Ryan Ash - National TAB

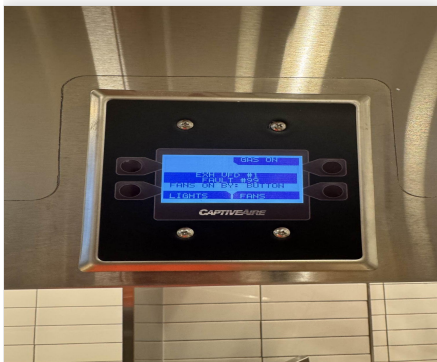
Issue Name : Fault on Hood HMI
Description : There is a Fault #99 displayed on the hood HMI. This is most likely due to a communication error between the HMI and the Exhaust VFD. Captive Air was contacted and a regional tech will need to visit site to reprogram the VFD software. The fan was able to be balanced. The exhaust fan was left turned off manually on the VFD.

There is a FAULT #99 displayed on the HMI. See Remarks section for further detail.

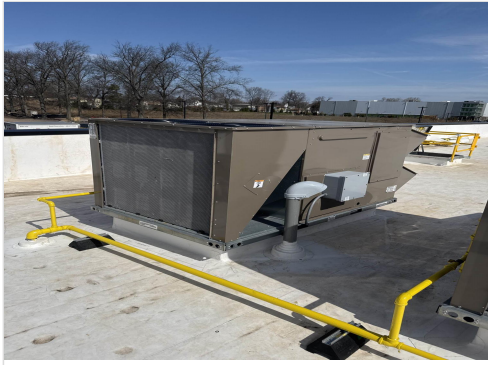
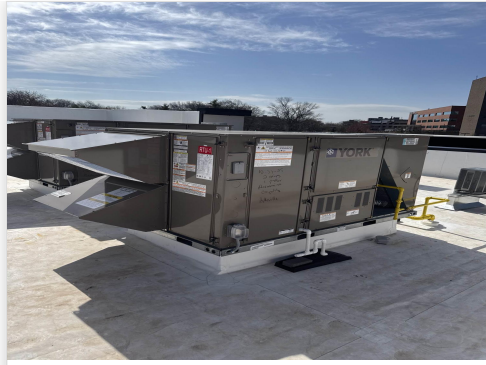
Unit Data - PHOTO LOG

Unit Data		
	Design	Actual
MFG	YORK	YORK
Serial Num	-	N2F5151345
Model Num	ZJ102	ZJ102N18R2BEEAA2A1
Type	RTU	RTU
Configuration	VERTICAL	VERTICAL
Num OA Filters 1	-	1
OA Filter Size 1	-	29X21
Num Final Filter 1	-	4
Final Filter Size 1	-	20X24X2

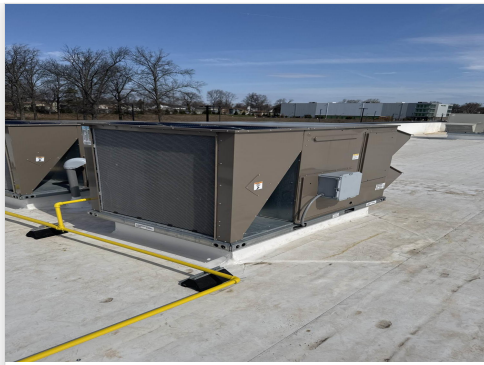
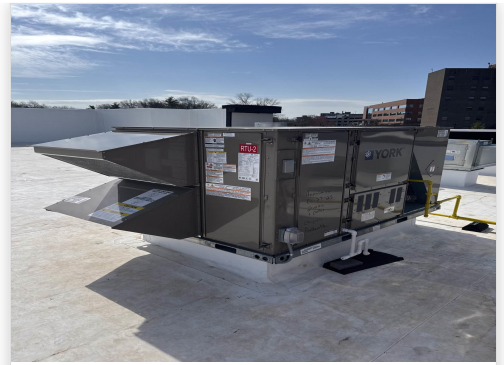
Unit Data - PHOTO LOG

Unit Data		
	Design	Actual
MFG	YORK	YORK
Serial Num	-	N2K5621607
Model Num	ZJ120	ZJ120N24R2BEEAA2A1
Type	RTU	RTU
Configuration	VERTICAL	VERTICAL
Num OA Filters 1	-	1
OA Filter Size 1	-	29X21
Num Final Filter 1	-	4
Final Filter Size 1	-	20X24X2

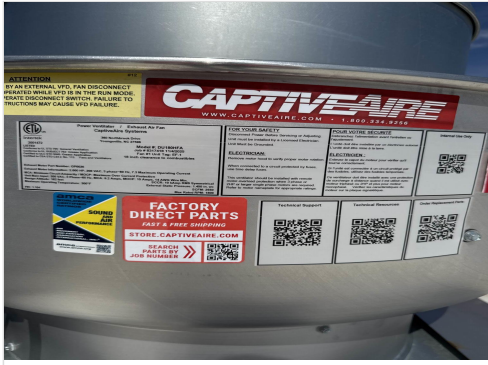
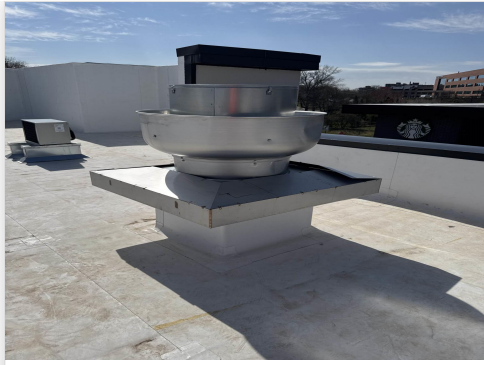
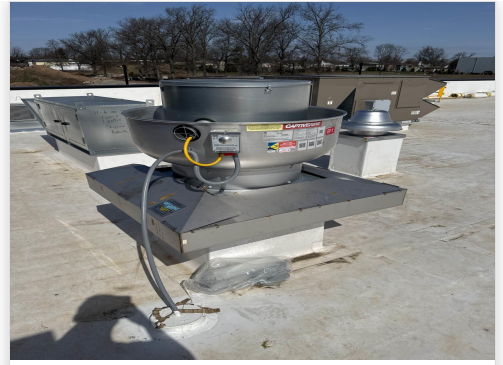
Unit Data - PHOTO LOG

Unit Data		
	Design	Actual
MFG	CAPTIVEAIRE	CAPTIVEAIRE
Model Num	DU180HFA	DU180HFA
Serial Num	-	8317418
Type	UPBLAST	UPBLAST
Configuration	VERTICAL	VERTICAL

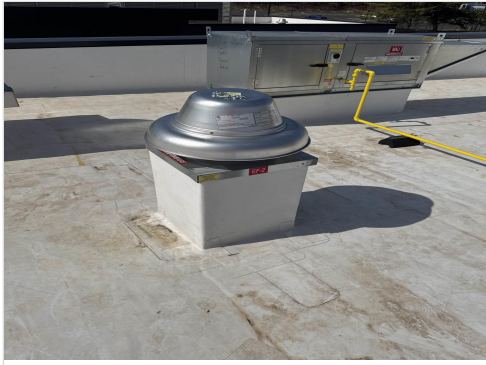
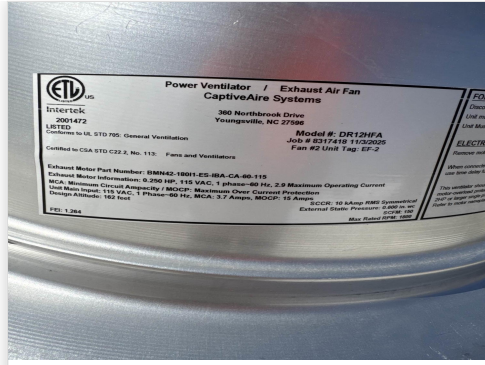
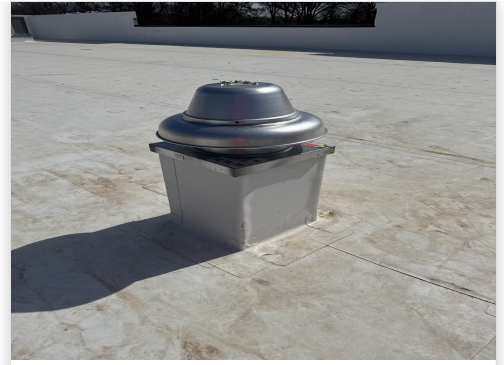
Unit Data - PHOTO LOG

Unit Data		
	Design	Actual
MFG	CAPTIVEAIRE	CAPTIVEAIRE
Model Num	DR12HFA	DR12HFA
Serial Num	-	8317418
Type	DOWNBLAST	DOWNBLAST
Configuration	VERTICAL	VERTICAL

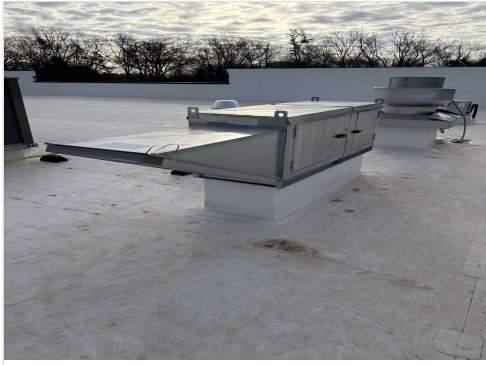
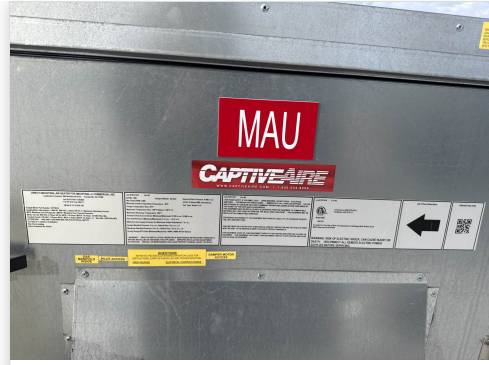
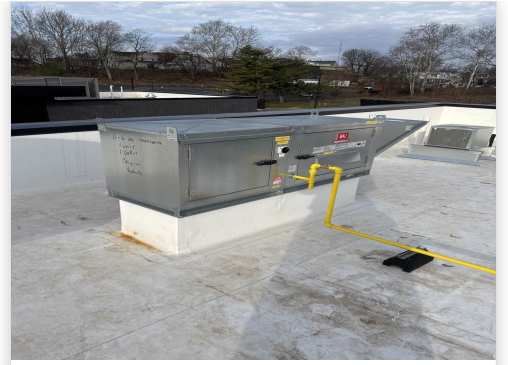
Unit Data - PHOTO LOG

Unit Data		
	Design	Actual
MFG	CAPTIVEAIRE	CAPTIVEAIRE
Model Num	A1-D.250-15D	A1-D.250-15D
Serial Num	-	8317418
Type	MAU	MAU
Configuration	VERTICAL	VERTICAL
