Report: TAB Report
Function: Test, Adjust, & Balance
Date: 03/25/2026
Completed By: National TAB

03-30-26 Chipotle #5532 Belleville, NJ

Project: 03-30-26 Chipotle #5532 Belleville, NJ

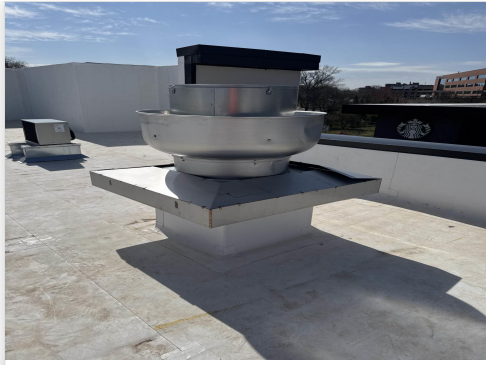
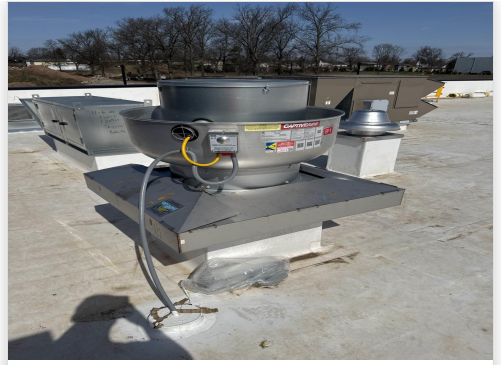
Asset: EF-1

Unit Data		
	Design	Actual
MFG	CAPTIVEAIRE	CAPTIVEAIRE
Model Num	DU180HFA	DU180HFA
Serial Num	-	8317418
Type	UPBLAST	UPBLAST
Configuration	VERTICAL	VERTICAL

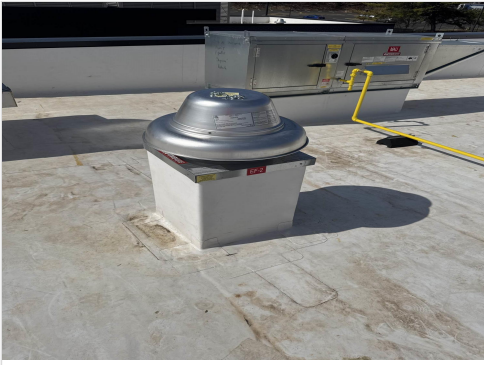
Asset: EF-2

Unit Data		
	Design	Actual
MFG	CAPTIVEAIRE	CAPTIVEAIRE
Model Num	DR12HFA	DR12HFA
Serial Num	-	8317418
Type	DOWNBLAST	DOWNBLAST
Configuration	VERTICAL	VERTICAL
