**Report: TAB REPORT**  
**Function: Test, Adjust, & Balance**  
**Date: 05/31/2023**

## 05-29-23 FAMILY DOLLAR - BOSCOBEL, WI

806 ELM ST

BOSCOBEL, WI 53805

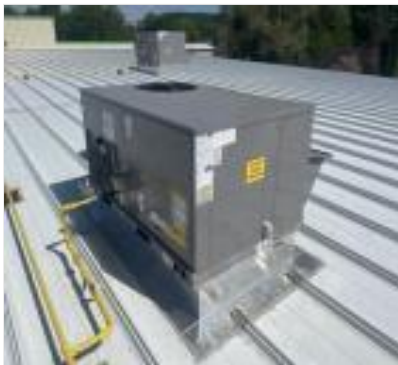
**RTU-1**  
**05/31/2023**

Unit Data		
	Design	Actual
MFG	CARRIER	CARRIER
Serial Num	-	2222C10471
Model Num	48GCE	48GCEM05F2
Type	RTU	RTU
Configuration	VERTICAL	VERTICAL
Num OA Filters 1	-	1
OA Filter Size 1	-	28X14.25
Num Final Filter 1	-	2
Final Filter Size 1	-	16X25X2

Test Data		
	Design	Actual
SF CFM	1750	1686
SF RPM	-	1698
RA CFM	1600	1531
OA CFM	150	155
RL Voltage	-	207
RL Amperage	-	1.9
SF Rotation	-	CORRECT
RA Damper Position	-	HIGH: 91% LOW: 82%
Min OA Damper Position	-	HIGH: 2.8V (9%) LOW: 3.45V (18%)
Min OA Damper Type	-	ECONOMIZER
OA Enthalpy Setpt	-	ES5

Performance Data		
	Design	Actual
MA Plenum SP	-	-0.23"
Fan Suction SP	-	-0.59"
Fan Discharge SP	-	0.42"
Total ESP	1.0"	0.65"
Fan Total SP	-	1.01"

General		
	Design	Actual
Fan Rotation Correct	-	YES
Unit Filters Clean	-	YES, CONSTRUCTION FILTERS INSTALLED
Condensate Drain Installed	-	YES

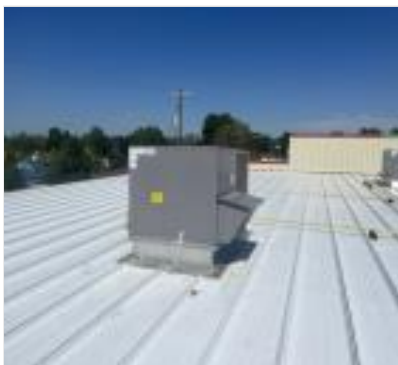
**RTU-2(1)**  
**05/31/2023**

Unit Data		
	Design	Actual
MFG	CARRIER	CARRIER
Serial Num	-	4522P42527
Model Num	48FCE	48HCED08A2
Type	RTU	RTU
Configuration	VERTICAL	VERTICAL
Num OA Filters 1	-	1
OA Filter Size 1	-	35"X19.5"
Num Final Filter 1	-	4
Final Filter Size 1	-	20X20X2

Test Data		
	Design	Actual
SF CFM	2800	2869
SF RPM	-	731
RA CFM	2150	
OA CFM	650	626
RL Voltage	-	
RL Amperage	-	
SF Rotation	-	
RA Damper Position	-	HIGH: 88% LOW: 72%
Min OA Damper Position	-	HIGH: 3.0V (12%) LOW: 4.2V (28%)
Min OA Damper Type	-	
OA Enthalpy Setpt	-

Notes: DCV: H-2.70V L-3.65V

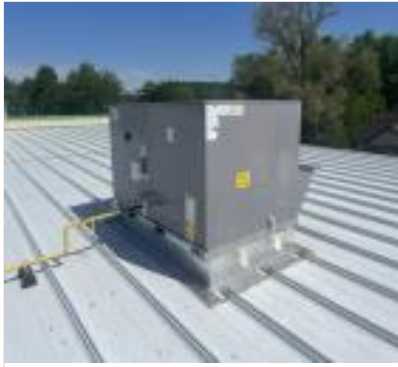
**RTU-3**  
**05/31/2023**

Unit Data		
	Design	Actual
MFG	CARRIER	CARRIER
Serial Num	-	4522P42542
Model Num	48FCE	48HCED08A2
Type	RTU	RTU
Configuration	VERTICAL	VERTICAL
Num OA Filters 1	-	1
OA Filter Size 1	-	35"X16.5"
Num Final Filter 1	-	4
Final Filter Size 1	-	20X20X2

Motor Data		
	Design	Actual
Motor MFG	-	MARATHON
Frame	-	56HZ
Horsepower	2.4	NL
Motor Rpm	-	1670
Phase	3	3
Rated Voltage	208	208-230
Rated Amperage	-	6.7-6.6

Drive Data		
	Design	Actual
Motor Sheave Size	-	MV44
Motor Bore Size	-	5/8"
Motor Sheave SetPt	-	5 TURNS OPEN
Fan Sheave Size	-	AFD74
Fan Sheave Bore	-	1"
Belt CL Distance	-	16.75"
Num of Belts	-	1
Belt Size	-	A48
Belt Alignment	-	VERIFIED

Test Data		
	Design	Actual
SF CFM	2800	2889
SF RPM	-	726
RA CFM	2150	2225
OA CFM	650	664
RL Voltage	-	207/206/206
RL Amperage	-	2.2/2.1/2.6
SF Rotation	-	CORRECT
RA Damper Position	-	HIGH: 86% LOW: 75%
Min OA Damper Position	-	HIGH: 3.15V (14%) LOW: 4.05 (25%)
Min OA Damper Type	-	ECONOMIZER
OA Enthalpy Setpt	-	ES5

Performance Data		
	Design	Actual
MA Plenum SP	-	-0.43"
Fan Suction SP	-	-0.64"
Fan Discharge SP	-	0.51"
Total ESP	1.00"	0.94"
Fan Total SP	-	1.15"

General		
	Design	Actual
Fan Rotation Correct	-	YES
Unit Filters Clean	-	YES, CONSTRUCTION FILTERS INSTALLED
Condensate Drain Installed	-	YES

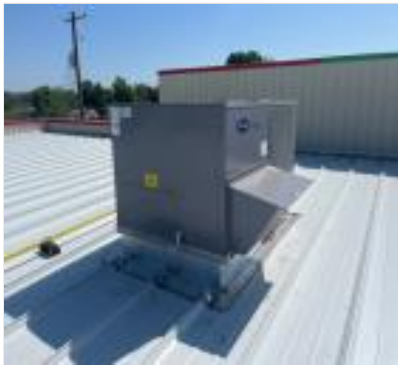
**RTU-4**  
**05/30/2023**

Unit Data		
	Design	Actual
MFG	CARRIER	CARRIER
Serial Num	-	0123P70609
Model Num	48FCE	48FCEM12F2
Type	RTU	RTU
Configuration	VERTICAL	VERTICAL
Num OA Filters 1	-	1
OA Filter Size 1	-	35"X19.5"
Num Final Filter 1	-	4
Final Filter Size 1	-	20X20X2

Test Data		
	Design	Actual
SF CFM	3500	3584
SF RPM	-	1665
RA CFM	2725	2826
OA CFM	775	758
RL Voltage	-	206/207/206
RL Amperage	-	3.2/3.3/3.4
SF Rotation	-	CORRECT
RA Damper Position	-	HIGH: 85% LOW: 78%
Min OA Damper Position	-	HIGH: 3.2V (15%) LOW: 3.8V (22%)
Min OA Damper Type	-	ECONOMIZER
OA Enthalpy Setpt	-	ES5

Performance Data		
	Design	Actual
MA Plenum SP	-	-0.64"
Fan Suction SP	-	-0.93"
Fan Discharge SP	-	0.62"
Total ESP	1.00"	1.26"
Fan Total SP	-	1.55"

General		
	Design	Actual
Fan Rotation Correct	-	YES
Unit Filters Clean	-	YES, CONSTRUCTION FILTERS INSTALLED
Condensate Drain Installed	-	YES

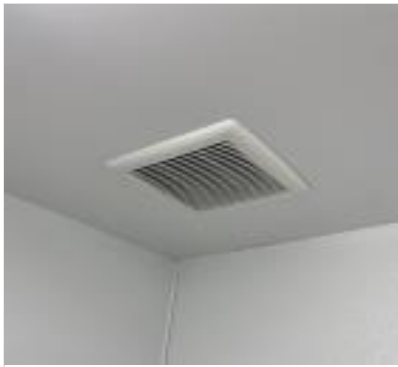
**EF-1**  
**05/31/2023**

Unit Data		
	Design	Actual
MFG	GREENHECK	BROAN
Model Num	SP-B110	AE80B-B
Serial Num	-	32B10H3
Type	CEILING	CEILING
Configuration	VERTICAL	VERTICAL

Test Data		
	Design	Actual
CFM	75	70

Motor Data		
	Design	Actual
Horsepower	80W	80W
Phase	1	1
Voltage (rated)	120	120
Amperage (rated)	-	0.3
