**Report: FINAL TAB REPORT**  
**Function: Test, Adjust, & Balance**  
**Date: 09/23/2022**

## 09-05 FREDDY'S - TOMBALL, TX

27645 TOMBALL PLWY

Client

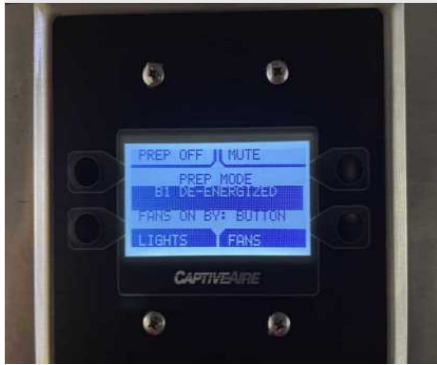
**hmi.png**

**Description :** "B1 De-energized" alarm on the hood. (Canopy lights are not turning on).

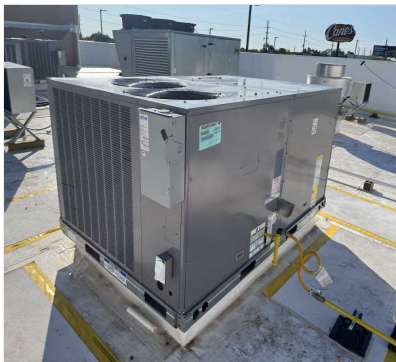
#### RTU-1

**Description :** ALL RTUs MISSING ECONOMIZERS.

- **09/26/2022 National TAB - Will Turnbough**
  - BUILDING WILL BE HIGHLY NEGATIVE AS A RESULT. RETURN TRIP RECOMMENDED ONCE THEY ARE INSTALLED.

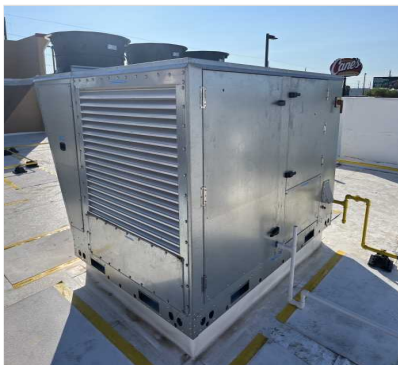
DOAS-1

**Description :** DOAS SET TO 60 Hz AND MEASURED AT 84% (2257/2688) OF DESIGN AIR FLOW. SUPPLY DUCT MEASURES 22x18 PER DESIGN. LEFT CALL BACK NUMBER WITH CAS TECHNICAL SUPPORT TO SEE HOW HIGH UNIT CAN BE SET.

DESIGN CHANGED FROM MUA TO DOAS. DOAS AT MAX SPEED PER CAS TECHNICAL SUPPORT. SUPPLY DUCT SIZE MATCHES DESIGN. UNIT MEASURED AT 85% OF DESIGN AIR FLOW.

Notes: VFD SPEED SET TO MAX (60HZ). LEFT VM FOR CAPTIVE AIRE TECH SUPPORT TO GET APPROVAL TO INCREASE VFD ABOVE 60HZ.

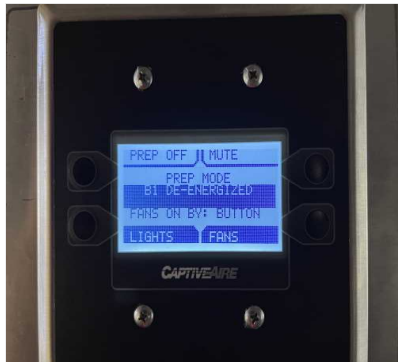
Image\_2022\_09\_07T2108...

All diffusers and grilles are installed and match design?	YES
All hood filters installed and accounted for?	YES
Hoods are wired and have power?	YES
Hood is free of alarms?	"B1 DE-ENERGIZED" ALARM ON HOOD. (CANOPY LIGHTS NOT TURNING ON)

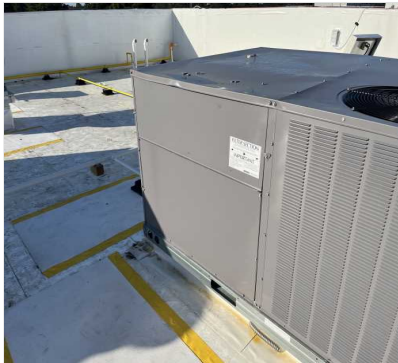
Image\_2022\_09\_07T2108...

Economizers are assembled and functional?

ECONOMIZERS ARE NOT INSTALLED ON RTUs. PER GC ECONOMIZERS ARE 2-3 WEEKS OUT FROM TIME OF BALANCE (9/7).

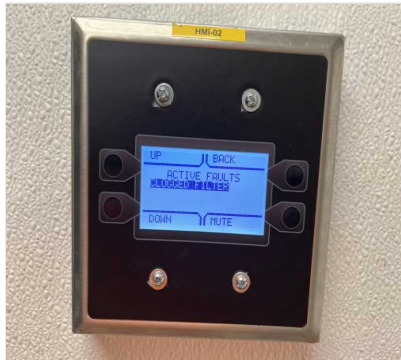
Is gas piping installed and valves turned on?	YES
Unit free of noticeable noise and vibration	YES
<b>EF's</b>	
Rotation is correct?	YES
Belts are tight?	N/A
Grease cup installed on hood fan?	YES
Hinge kit installed installed on hood fan?	YES
Lean fan back. Is grease duct installation adequate and is duct ran all the way to the base of the fan?	YES
Flex conduit is long enough so that fan can be completely tilted back?	YES
There is no major leakage around base of fan?	YES
Is the motor operating below the motor FLA rating?	YES
For restroom fan(s) is the back draft damper installed and can it fully open?	RESTROOM FANS ARE CEILING MOUNTED.
Unit free of noticeable noise and vibration?	YES
<b>MUA (DOAS)</b>	
DOAS is free of alarms?	CLOGGED FILTER ALARM ON DOAS.

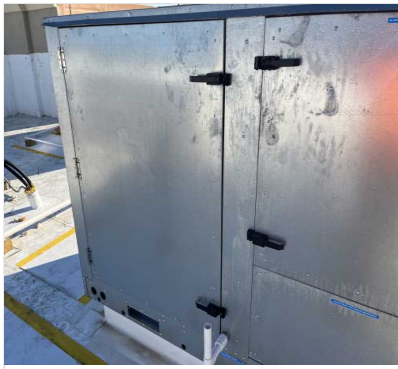
Image\_2022\_09\_07T2108...

<p>Image_2022_09_07T2108...</p>	
DOAS is free of damage?	DAMAGED DOOR LATCHES ON SUCTION DOOR.
