Report: FINAL TAB REPORT
Function: Test, Adjust, & Balance
Date: 09/23/2022

09-05 FREDDY'S - TOMBALL, TX

Houston Custard, LLC

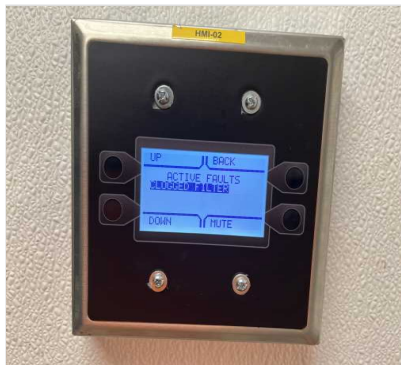
Is gas piping installed and valves turned on?	YES
Unit free of noticeable noise and vibration	YES
EF's	
Rotation is correct?	YES
Belts are tight?	N/A
Grease cup installed on hood fan?	YES
Hinge kit installed installed on hood fan?	YES
Lean fan back. Is grease duct installation adequate and is duct ran all the way to the base of the fan?	YES
Flex conduit is long enough so that fan can be completely tilted back?	YES
There is no major leakage around base of fan?	YES
Is the motor operating below the motor FLA rating?	YES
For restroom fan(s) is the back draft damper installed and can it fully open?	RESTROOM FANS ARE CEILING MOUNTED.
Unit free of noticeable noise and vibration?	YES
MUA (DOAS)	
DOAS is free of alarms?	CLOGGED FILTER ALARM ON DOAS.
