**Report: FINAL TAB REPORT**  
**Function: Test, Adjust, & Balance**  
**Date: 09/23/2022**

## 09-05 FREDDY'S - TOMBALL, TX

Project: 09-05 FREDDY'S - TOMBALL, TX

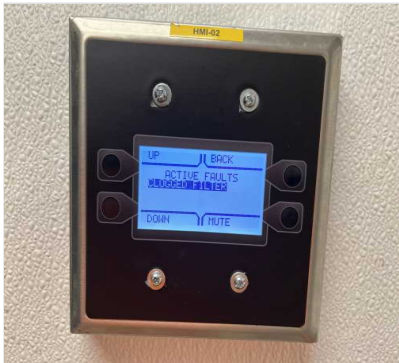
Is gas piping installed and valves turned on?	YES
Unit free of noticeable noise and vibration	YES
<b>EF's</b>	
Rotation is correct?	YES
Belts are tight?	N/A
Grease cup installed on hood fan?	YES
Hinge kit installed installed on hood fan?	YES
Lean fan back. Is grease duct installation adequate and is duct ran all the way to the base of the fan?	YES
Flex conduit is long enough so that fan can be completely tilted back?	YES
There is no major leakage around base of fan?	YES
Is the motor operating below the motor FLA rating?	YES
For restroom fan(s) is the back draft damper installed and can it fully open?	RESTROOM FANS ARE CEILING MOUNTED.
Unit free of noticeable noise and vibration?	YES
<b>MUA (DOAS)</b>	
DOAS is free of alarms?	CLOGGED FILTER ALARM ON DOAS.
