Report By:

Report: FINAL TAB REPORT
Function: Test, Adjust, & Balance
Date: 09/23/2022

09-05 FREDDY'S - TOMBALL, TX

Houston Custard, LLC

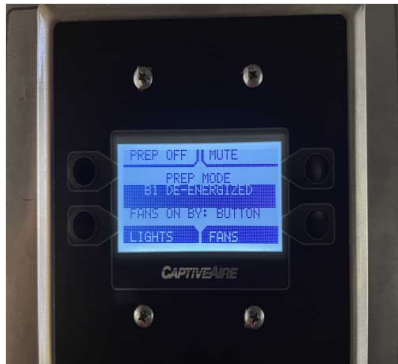
Image_2022_09_07T2108...

All diffusers and grilles are installed and match design?	YES
All hood filters installed and accounted for?	YES
Hoods are wired and have power?	YES
Hood is free of alarms?	"B1 DE-ENERGIZED" ALARM ON HOOD. (CANOPY LIGHTS NOT TURNING ON)
