**Report: Issues Report**

**Function: Test, Adjust, & Balance**

**Date: 04/11/2025**

**03-31-25 CHIPOTLE #5592 ASHLAND, OR**

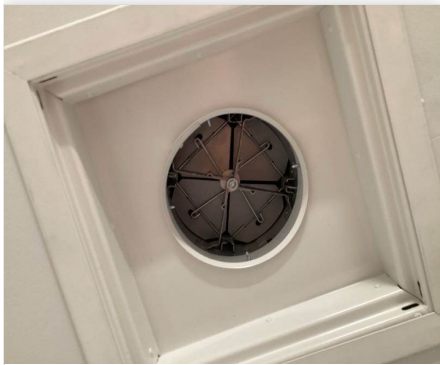
**Issue Name :** Butterfly Dampers  
**Description :** Outlets S-06 and S-05 are fully closed and operating at 82 and 88 CFM for a design of 50. Rooms are neutral.  
**Created By :** United Test & Balance, Inc.      **Assigned To :** United Test & Balance, Inc. - William Clayton  
**Status :** Open  
**Priority :** Urgent      **Asset Tag :** RTU1-SGRD5  
**Originated Date :** 04/11/2025 - William Clayton - United Test & Balance, Inc.

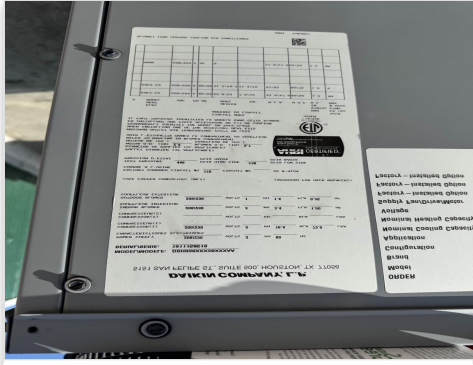
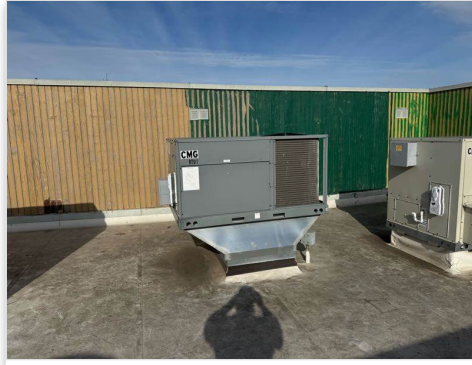
# Unit Data - PHOTO LOG

Unit Data		
	Design	Actual
MFG	DAIKIN	DAIKIN
Serial Num	-	1911158519
Model Num	DSH036	DSH036
Type	RTU	RTU
Configuration	VERTICAL	Vertical
Num Final Filter 1	-	4
Final Filter Size 1	-	14x20x2

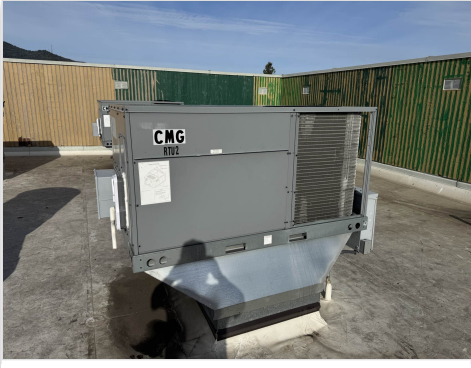
# Unit Data - PHOTO LOG

Unit Data		
	Design	Actual
MFG	DAIKIN	DAIKIN
Serial Num	-	1907063709
Model Num	DSH048	DSH048
Type	RTU	RTU
Configuration	VERTICAL	Vertical
Num OA Filters 1	-	-
OA Filter Size 1	-	-
Num Final Filter 1	-	4
Final Filter Size 1	-	14x20x2
Num Final Filter 2	-	-
Final Filter Size 2	-	-

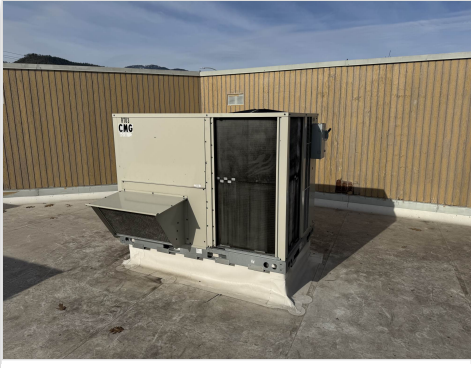
# Unit Data - PHOTO LOG

Unit Data		
	Design	Actual
MFG	DAIKIN	DAIKIN
Serial Num	-	2204006877
Model Num	DRG072	DRG072
Type	RTU	RTU
Configuration	VERTICAL	Vertical
Num OA Filters 1	-	-
OA Filter Size 1	-	-
Num Final Filter 1	-	4
Final Filter Size 1	-	20x20x2
Num Final Filter 2	-	-
Final Filter Size 2	-	-

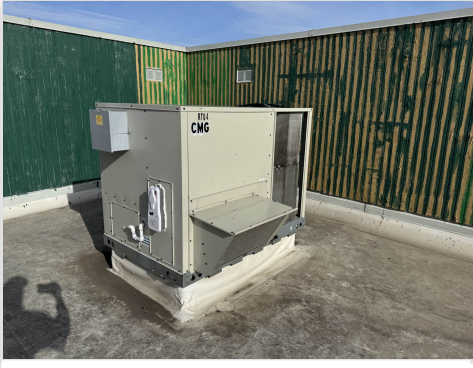
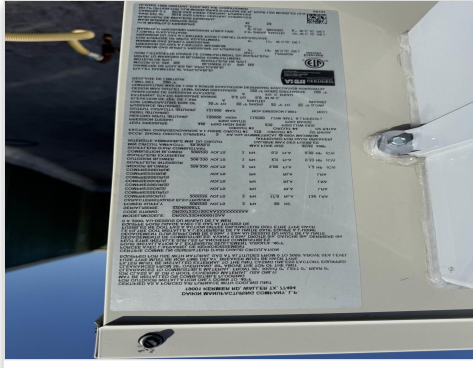
# Unit Data - PHOTO LOG

Unit Data		
	Design	Actual
MFG	DAIKIN	DAIKIN
Serial Num	-	2203286667
Model Num	DRG072	DRG072
Type	-	RTU
Configuration	-	Vertical
Num OA Filters 1	-	-
OA Filter Size 1	-	-
Num Final Filter 1	-	4
Final Filter Size 1	-	20x20x2
Num Final Filter 2	-	-
Final Filter Size 2	-	-
