Report: TAB Report
Function: Test, Adjust, & Balance
Date: 04/02/2026
Completed By: National TAB

PROJECT
03-16-26 QT #1728 ATHENS, GA

3270 LEXINGTON RD

Project: 03-16-26 QT #1728 ATHENS, GA

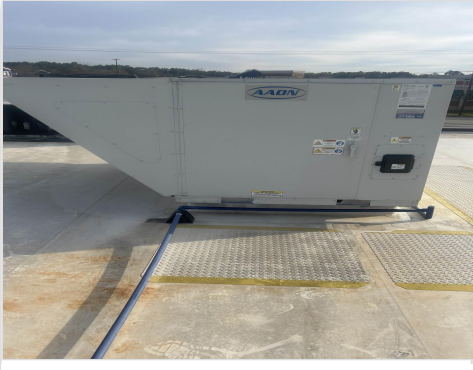
Unit Data - PHOTO LOG

Unit Data	
	Actual
MFG	AAON
Serial Num	202210-ANEK25533
Model Num	RN-013-8-0-EA0A-152
Num OA Filters 1	1
OA Filter Size 1	23X45
Num Final Filter 1	4
Final Filter Size 1	20X25X2

Test Data		
	Design	Actual
SF CFM	4200	4190
SF RPM	-	1760
OA CFM (Hoods On)	800	814
OA CFM (Hoods Off)	350	355
RL Voltage	-	151V
RL Amperage	-	7.4A
VFD Max SetPt	-	45 hz
VFD Min SetPt	-	24 hz
OA Damper Position (Hoods On)	-	46% - MANUAL ADJUSTMENT
OA Damper Position (Hoods Off)	-	26%

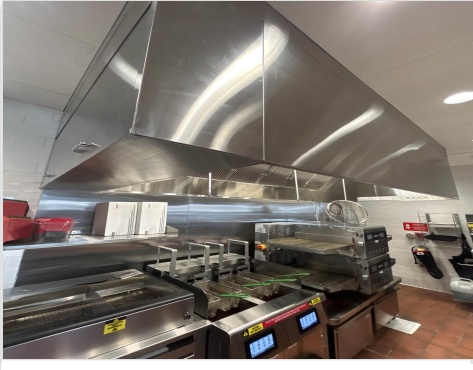
Unit Data - PHOTO LOG

Unit Data		
	Design	Actual
MFG	CAPTIVEAIRE	CAPTIVEAIRE
Model Num	6030ND-2-F	6030ND-2-F
Job / Serial Num	-	8366431
Type	TYPE I CANOPY	TYPE I CANOPY
Hood length	108"	108"
Hood Width	60"	60"

Test Data Exhaust		
	Design	Actual
Filter Type	CAPTRATE SOLO FILTER	CAPTRATE SOLO FILTER
Filter Size 1	20X16	20X16
Filter Qty 1	6	6
Filter AK factor size 1	2.08	2.08
Filter Total AK Area	12.48	12.48
Filter1 FPM	-	111
Filter2 FPM	-	118
Filter3 FPM	-	117
Filter4 FPM	-	124
Filter5 FPM	-	107
Filter6 FPM	-	108
Filter Ave FPM(corr)	-	114
CFM	1350	1422
