Report: TAB Report
Function: Test, Adjust, & Balance
Date: 02/18/2026
Completed By: National TAB

PROJECT
03-16-26 QT #1728 ATHENS, GA

Project: 03-16-26 QT #1728 ATHENS, GA

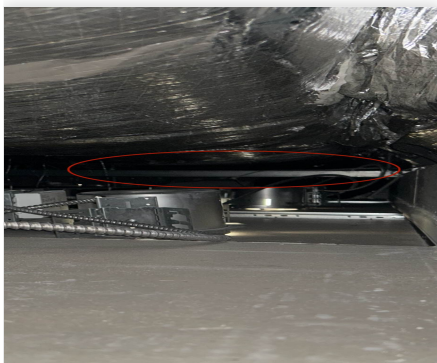
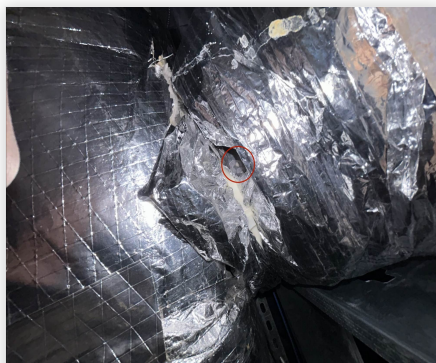
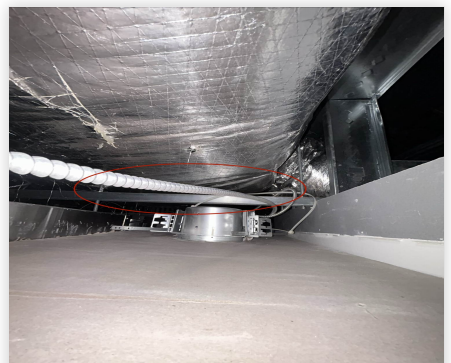
Issue Name : RTU-3 Inaccessible Dampers
Description : While balancing RTU-3 the kitchen diffusers were inaccessible. Light conduit within the ceiling tiles and a bar platform supporting the main duct restricted tile removal near the diffuser dampers and the damper handles are located on top of the duct. As a result individual diffuser balancing could not be performed but was able to reach total design
Created By : National TAB **Assigned To :** National TAB - Dan Hertenstein
Status : Open
Priority : Urgent **Asset Tag :**
Originated Date : 03/19/2026 - Anthony Taylor - National TAB

Notes:
Unable to balance due to kitchen diffusers being inaccessible. Please review Punch List for more details.

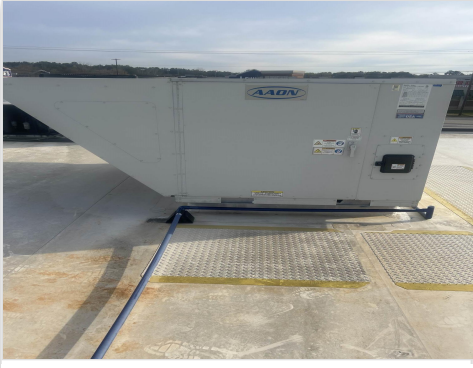
Unit Data - PHOTO LOG

Unit Data	
	Actual
MFG	AAON
Serial Num	202210-ANEK25533
Model Num	RN-013-8-0-EA0A-152
Num OA Filters 1	1
OA Filter Size 1	23X45
Num Final Filter 1	4
Final Filter Size 1	20X25X2

Test Data		
	Design	Actual
SF CFM	4200	4190
SF RPM	-	1760
OA CFM (Hoods On)	800	814
OA CFM (Hoods Off)	350	355
RL Voltage	-	151V
RL Amperage	-	7.4A
VFD Max SetPt	-	45 hz
VFD Min SetPt	-	24 hz
OA Damper Position (Hoods On)	-	46% - MANUAL ADJUSTMENT
OA Damper Position (Hoods Off)	-	26%

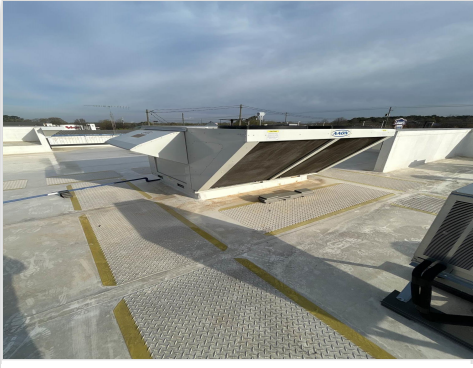
Unit Data - PHOTO LOG

Unit Data	
	Actual
MFG	AAON
Serial Num	202210-ANEK25534
Model Num	RN-013-8-0-EA0A-152
Num OA Filters 1	1
OA Filter Size 1	23X45
Num Final Filter 1	4
Final Filter Size 1	20X25X2

Test Data		
	Design	Actual
SF CFM	4200	4214
SF RPM	-	1760
OA CFM (Hoods On)	800	799
OA CFM (Hoods Off)	350	348
RL Voltage	-	151V
RL Amperage	-	7.6A
VFD Max SetPt	-	45 hz
VFD Min SetPt	-	24 hz
OA Damper Position (Hoods On)	-	46% - MANUAL ADJUSTMEN
OA Damper Position (Hoods Off)	-	25%

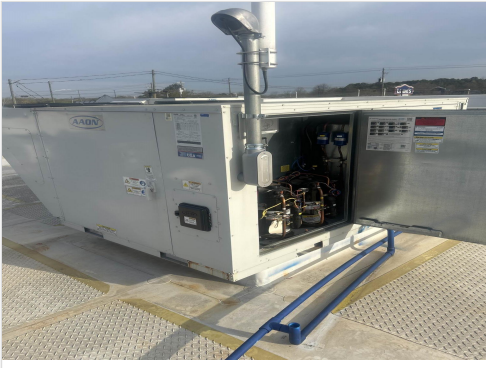
Unit Data - PHOTO LOG

Unit Data	
	Actual
MFG	AAON
Serial Num	202210-ANEK25532
Model Num	RN-013-8-0-EA0A-152
Num OA Filters 1	1
OA Filter Size 1	23X45
Num Final Filter 1	4
Final Filter Size 1	20X25X2

Test Data		
	Design	Actual
SF CFM	4200	4209
SF RPM	-	1760
OA CFM (Hoods On)	800	863
OA CFM (Hoods Off)	350	339
RL Voltage	-	171V
RL Amperage	-	8.4A
VFD Max SetPt	-	48 hz
VFD Min SetPt	-	24 hz
OA Damper Position (Hoods On)	-	46 - MANUAL ADJUSTMENT
OA Damper Position (Hoods Off)	-	25%

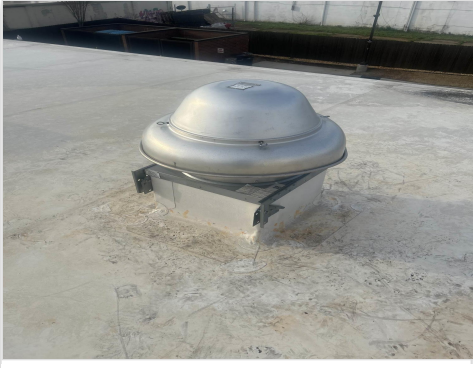
Unit Data - PHOTO LOG

Unit Data		
	Design	Actual
MFG	NA	CAPTIVEAIRE
Model Num	NA	DR50HFA
Serial Num	-	5608965
Type	-	DOWNBLAST
Configuration	-	ATM

Test Data		
	Design	Actual
CFM	750	698
Fan RPM	-	2000
Fan Rotation	-	CCW
Motor RPM	-	2000
System SetPt	-	HIGH - DIAL
RL Voltage	-	115v
RL Amperage	-	4.6A
Total ESP	-	0.33"
Fan Inlet SP	-	-0.33"
Fan Discharge SP	-	ATM

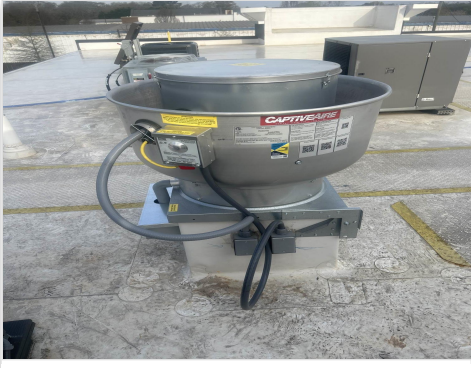
Unit Data - PHOTO LOG

Unit Data		
	Design	Actual
MFG	NA	CAPTIVEAIRE
Model Num	NA	DU50HFA
Serial Num	-	8366431
Type	UPBLAST	UPBLAST
Configuration	VERTICAL	VERTICAL

Test Data		
	Design	Actual
CFM	1350	1422
Fan RPM	-	1195
Fan Rotation	-	CCW
Motor RPM	-	1195
System SetPt	-	52.8 hz
RL Voltage	-	212V
RL Amperage	-	1.9A
Total ESP	0.75"	0.38"
Fan Inlet SP	-	-0.38"
Fan Discharge SP	-	ATM

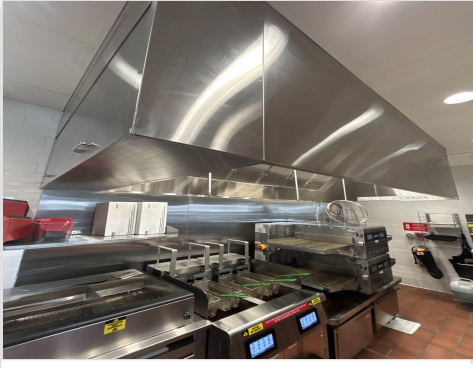
Unit Data - PHOTO LOG

Unit Data		
	Design	Actual
MFG	CAPTIVEAIRE	CAPTIVEAIRE
Model Num	6030ND-2-F	6030ND-2-F
Job / Serial Num	-	8366431
Type	TYPE I CANOPY	TYPE I CANOPY
Hood length	108"	108"
Hood Width	60"	60"

Test Data Exhaust		
	Design	Actual
Filter Type	CAPTRATE SOLO FILTER	CAPTRATE SOLO FILTER
Filter Size 1	20X16	20X16
Filter Qty 1	6	6
Filter AK factor size 1	2.08	2.08
Filter Total AK Area	12.48	12.48
Filter1 FPM	-	111
Filter2 FPM	-	118
Filter3 FPM	-	117
Filter4 FPM	-	124
Filter5 FPM	-	107
Filter6 FPM	-	108
Filter Ave FPM(corr)	-	114
CFM	1350	1422
