**Report: TAB REPORT**  
**Function: Test, Adjust, & Balance**  
**Date: 12/11/2024**  
**Completed By: National TAB**

**PROJECT**  
**12-09-24 CULVERS ALBERTVILLE, AL**

500 Mathis Mill RD.

Albertville, AL 35951

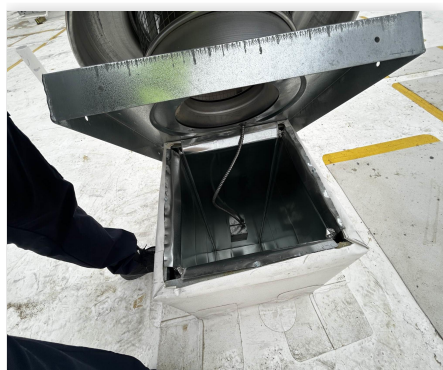
**Issue Name :** PRV-1 BACKDRAFT DAMPER  
**Description :** Gravity damper is not installed in fan duct drop as per plan. Recommend having mechanical install damper as per plan. See M204> “PRV-1 RESTROOM: SELECTED OPTIONS AND ACCESSORIES”.  
**Created By :** National TAB                      **Assigned To :** National TAB - Kristopher Passley  
**Status :** Open  
**Priority :** Urgent                                      **Asset Tag :**  
**Originated Date :** 12/10/2024 - Kristopher Passley - National TAB

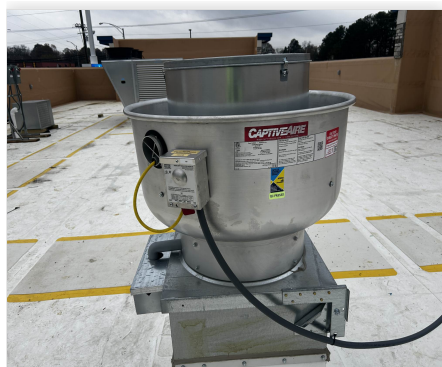
**Issue Name :** PRV-2  
**Description :** Fan motor is modulating continuously and over amping. Troubleshooting with Captive-Aire tech support was unsuccessful. Recommend electrician or Captive-Aire Tech. check fan wiring and motor for issues.  
**Created By :** National TAB                      **Assigned To :** National TAB - Kristopher Passley  
**Status :** Open  
**Priority :** Urgent                      **Asset Tag :**  
**Originated Date :** 12/10/2024 - Kristopher Passley - National TAB

PRV2 MOTOR IS MODULATING (ABOVE MOTOR FLA).
