Report: TAB REPORT
Function: Test, Adjust, & Balance
Date: 12/11/2024
Completed By: National TAB

PROJECT
12-09-24 CULVERS ALBERTVILLE, AL

Project: 12-09-24 CULVERS ALBERTVILLE, AL

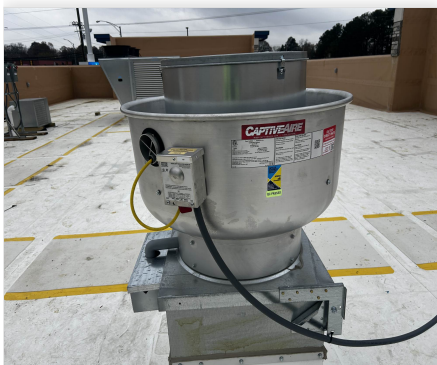
Issue Name : PRV-2
Description : Fan motor is modulating continuously and over amping. Troubleshooting with Captive-Aire tech support was unsuccessful. Recommend electrician or Captive-Aire Tech. check fan wiring and motor for issues.
Created By : National TAB **Assigned To :** National TAB - Kristopher Passley
Status : Open
Priority : Urgent **Asset Tag :**
Originated Date : 12/10/2024 - Kristopher Passley - National TAB

PRV2 MOTOR IS MODULATING (ABOVE MOTOR FLA).

Measurements may not be accurate due to motor modulating at the time of Test & Balance. (See Issues)

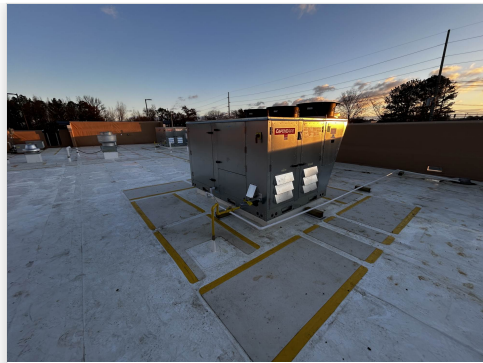
Unit Data - PHOTO LOG

Unit Data		
	Design	Actual
MFG	CAPTIVEAIRE	CAPTIVEAIRE
Serial Num	-	6844161
Model Num	CAS-HVAC3-1.300-24-20T	CAS-HVAC3-1.300-24-20T
Type	RTU	DOAS
Configuration	VERTICAL	VERTICAL
Num OA Filters 1	-	4
OA Filter Size 1	-	16"X25"X2"
Num Final Filter 1	-	8
Final Filter Size 1	-	20"X25"X2"

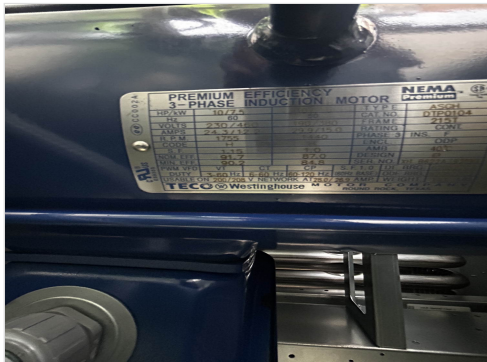
Motor Data - PHOTO LOG

Motor Data		
	Design	Actual
Motor MFG	-	TECO WESTINGHOUSE
Frame	-	215T
Horsepower	-	10
Motor Rpm	-	1755
Phase	3	3
Rated Voltage	208	200/208
Rated Amperage	-	28/26.9

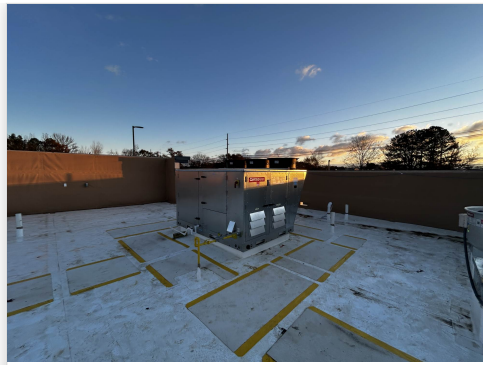
Unit Data - PHOTO LOG

Unit Data		
	Design	Actual
MFG	CAPTIVEAIRE	CAPTIVEAIRE
Serial Num	-	6844161
Model Num	CAS-HVAC3-1.300-24-20T	CAS-HVAC3-1.300-24-20T
Type	RTU	DOAS
Configuration	VERTICAL	VERTICAL
Num OA Filters 1	-	4
OA Filter Size 1	-	16"X25"X2"
Num Final Filter 1	-	8
Final Filter Size 1	-	20"X25"X2"

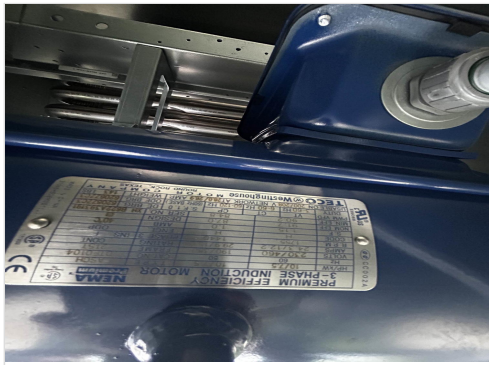
Motor Data - PHOTO LOG

Motor Data		
	Design	Actual
Motor MFG	-	TECO WESTINGHOUSE
Frame	-	215T
Horsepower	-	10
Motor Rpm	-	1755
Phase	3	3
Rated Voltage	208	200/208
Rated Amperage	-	28/26.9

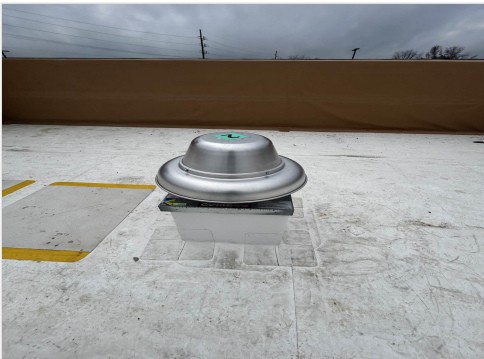
Unit Data - PHOTO LOG

Unit Data		
	Design	Actual
MFG	CAPTIVEAIRE	CAPTIVEAIRE
Model Num	DR12HFA	DR12HFA
Serial Num	-	6844161
Type	DOWNBLAST	DOWNBLAST
Configuration	VERTICAL	VERTICAL

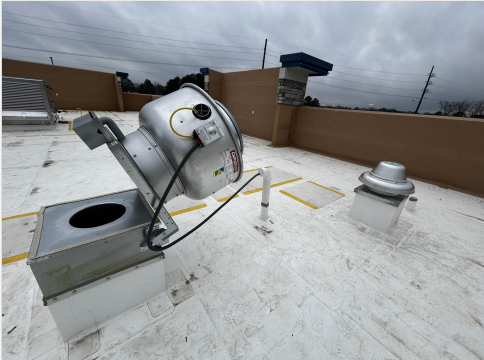
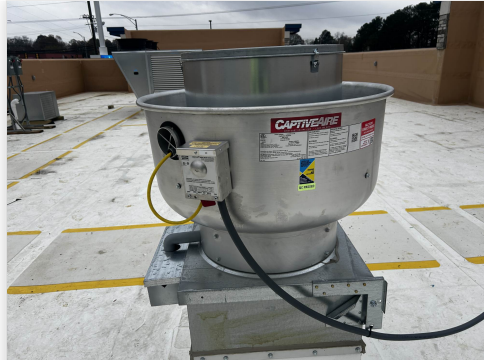
Unit Data - PHOTO LOG

Unit Data		
	Design	Actual
MFG	CAPTIVEAIRE	CAPTIVEAIRE
Model Num	DU85HFA	DU85HFA
Serial Num	-	6844161
Type	UPBLAST	UPBLAST
Configuration	VERTICAL	VERTICAL

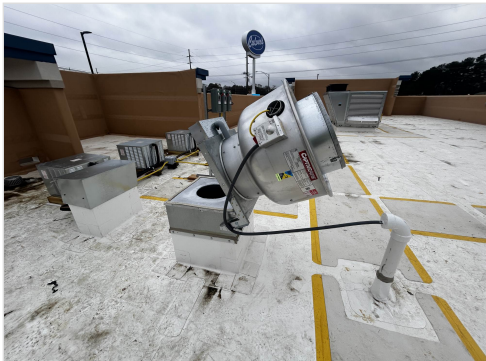
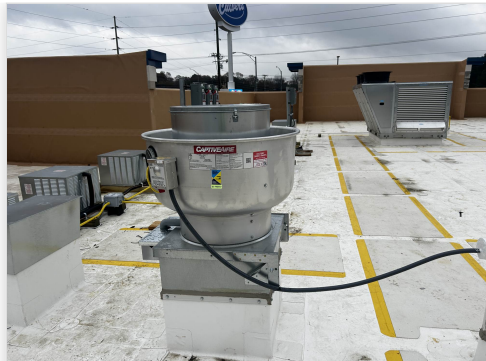
Unit Data - PHOTO LOG

Unit Data		
	Design	Actual
MFG	CAPTIVEAIRE	CAPTIVEAIRE
Model Num	DU85HFA	DU85HFA
Serial Num	-	6844161
Type	DOWNBLAST	UPBLAST
Configuration	VERTICAL	VERTICAL

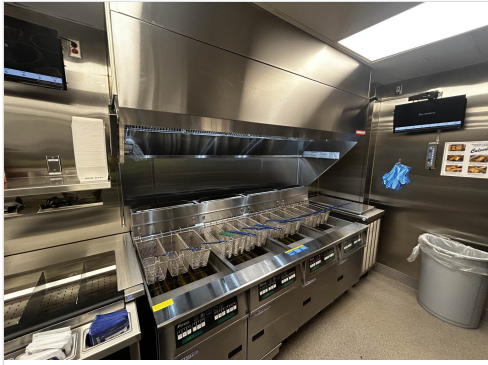
Unit Data - PHOTO LOG

Unit Data		
	Design	Actual
MFG	CAPTIVEAIRE	CAPTIVEAIRE
Model Num	3347BD-2	3347BD-2
Job / Serial Num	-	6844161
Type	TYPE I	TYPE 1 CANOPY
Hood length	84"	84"
Hood Width	33"	33"

Notes:
Measurements may not be accurate due to motor modulating at the time of Test & Balance. (See Issues)

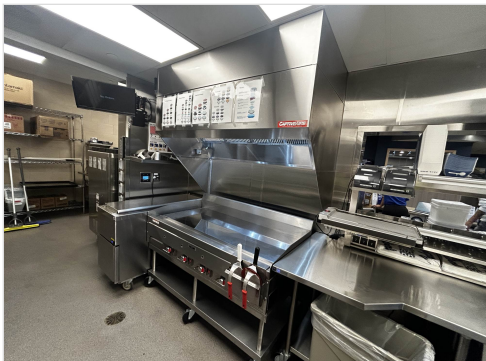
Unit Data - PHOTO LOG

Unit Data		
	Design	Actual
MFG	CAPTIVEAIRE	CAPTIVEAIRE
Model Num	3347BD-2	3347BD-2
Job / Serial Num	-	6844161
Type	TYPE I	TYPE I CANOPY
Hood length	66"	66"
Hood Width	33"	33"
