**Report: TAB REPORT**  
**Function: Test, Adjust, & Balance**  
**Date: 12/11/2024**  
**Completed By: National TAB**

**PROJECT**  
**12-09-24 CULVERS ALBERTVILLE, AL**

500 Mathis Mill RD.

Albertville, AL 35951

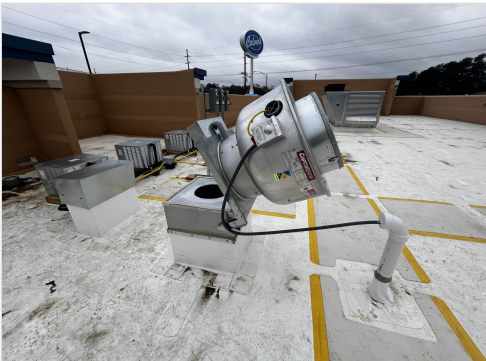
## Unit Data - PHOTO LOG

Asset: PRV3

Unit Data		
	Design	Actual
MFG	CAPTIVEAIRE	CAPTIVEAIRE
Model Num	DU85HFA	DU85HFA
Serial Num	-	6844161
Type	DOWNBLAST	UPBLAST
Configuration	VERTICAL	VERTICAL

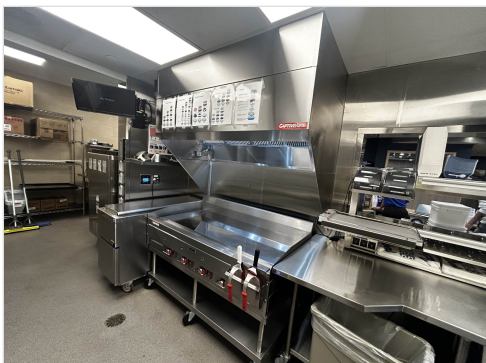
### Unit Data - PHOTO LOG

Asset: HD2

Unit Data		
	Design	Actual
MFG	CAPTIVEAIRE	CAPTIVEAIRE
Model Num	3347BD-2	3347BD-2
Job / Serial Num	-	6844161
Type	TYPE I	TYPE I CANOPY
Hood length	66"	66"
Hood Width	33"	33"
