**Report: TAB REPORT**  
**Function: Test, Adjust, & Balance**  
**Date: 12/11/2024**  
**Completed By: National TAB**

**PROJECT**  
**12-09-24 CULVERS ALBERTVILLE, AL**

500 Mathis Mill RD.

Albertville, AL 35951

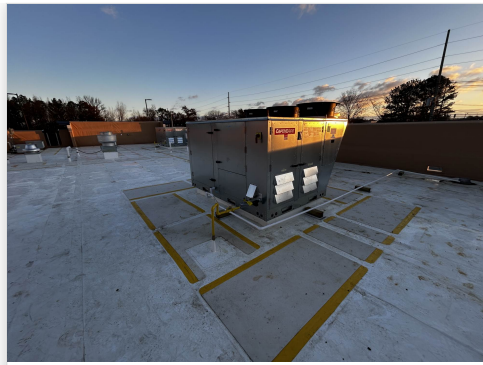
### Unit Data - PHOTO LOG

Asset: RTU1

| Unit Data | | |
|---|---|---|
| MFG | CAPTIVEAIRE | CAPTIVEAIRE |
| Serial Num | - | 6844161 |
| Model Num | CAS-HVAC3-1.300-24-20T | CAS-HVAC3-1.300-24-20T |

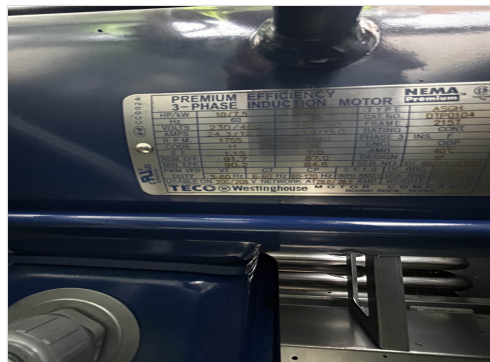
## Motor Data - PHOTO LOG

| Motor Data | | |
|---|---|---|
| Motor MFG | - | TECO<br>WESTINGHOUSE |
| Frame | - | 215T |
| Horsepower | - | 10 |

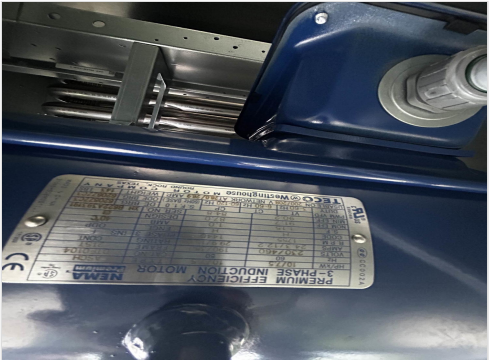
Motor Data - PHOTO LOG

| Motor Data | | |
|---|---|---|
| Motor MFG | - | TECO<br>WESTINGHOUSE |
| Frame | - | 215T |
| Horsepower | - | 10 |
