Report: TAB REPORT
Function: Test, Adjust, & Balance
Date: 12/11/2024
Completed By: National TAB

PROJECT
12-09-24 CULVERS ALBERTVILLE, AL

Project: 12-09-24 CULVERS ALBERTVILLE, AL

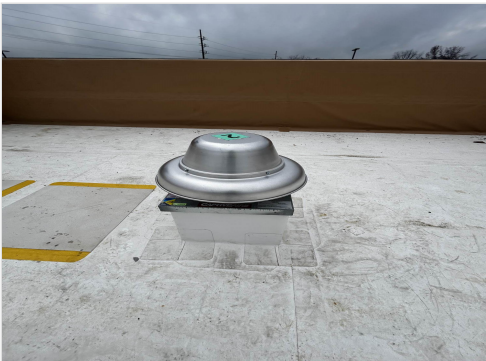
Unit Data - PHOTO LOG

Unit Data		
	Design	Actual
MFG	CAPTIVEAIRE	CAPTIVEAIRE
Model Num	DR12HFA	DR12HFA
Serial Num	-	6844161
Type	DOWNBLAST	DOWNBLAST
Configuration	VERTICAL	VERTICAL
