Report: TAB REPORT
Function: Test, Adjust, & Balance
Date: 12/11/2024
Completed By: National TAB

PROJECT
12-09-24 CULVERS ALBERTVILLE, AL

Project: 12-09-24 CULVERS ALBERTVILLE, AL

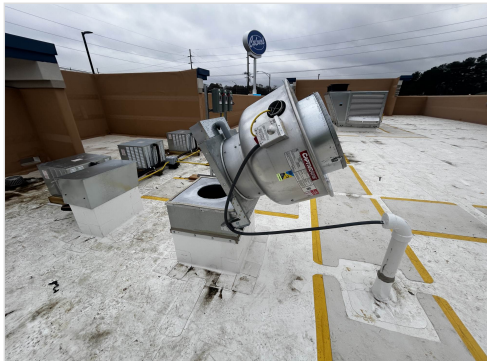
Unit Data - PHOTO LOG

Unit Data		
	Design	Actual
MFG	CAPTIVEAIRE	CAPTIVEAIRE
Model Num	DU85HFA	DU85HFA
Serial Num	-	6844161
Type	DOWNBLAST	UPBLAST
Configuration	VERTICAL	VERTICAL
