Report: TAB REPORT
Function: Test, Adjust, & Balance
Date: 12/11/2024
Completed By: National TAB

PROJECT
12-09-24 CULVERS ALBERTVILLE, AL

Project: 12-09-24 CULVERS ALBERTVILLE, AL

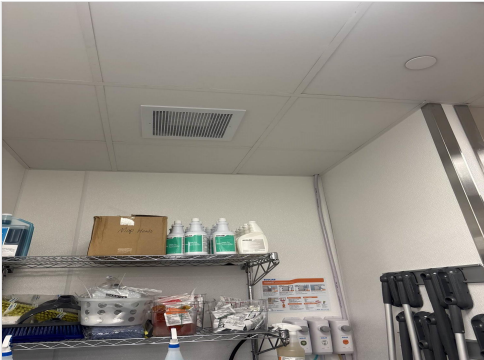
Unit Data - PHOTO LOG

Unit Data		
	Design	Actual
MFG	CAPTIVEAIRE	BROAN
Model Num	CFA100CA	L100
Serial Num	-	NL
Type	CEILING	CEILING
Configuration	VERTICAL	HORIZONTAL
