**Report: TAB Report**  
**Function: Test, Adjust, & Balance**  
**Date: 02/17/2026**  
**Completed By: National TAB**

**03-30-26 QT #1468 TUCSON, AZ**

2670 W RUTHRAUFF RD

QUIKTRIP  
4705 SOUTH 129TH EAST AVENUE  
TULSA, OK 74134

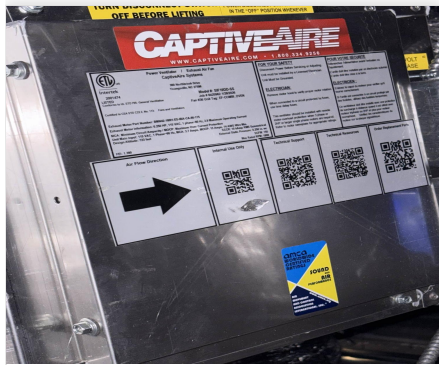
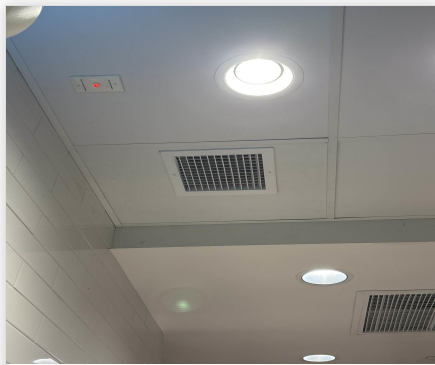
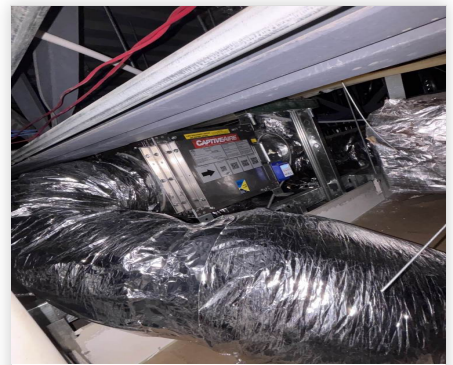
**Issue Name :** EF-1 SGRD 1-4 separate EF  
**Description :** Diffuser 1-4 for EF-1 has a separate EF (EF-4) and is not connected to EF-1. EF-4 Not on GRD.  
**Created By :** National TAB                      **Assigned To :** National TAB - Brianna Biggs  
**Status :** Open  
**Priority :** InfoOnly                                      **Asset Tag :** EF4  
**Originated Date :** 03/29/2026 - Ethan Van Orden - National TAB
