**Report: TAB REPORT**  
**Function: Test, Adjust, & Balance**  
**Date: 10/14/2025**  
**Completed By: National TAB**

**PROJECT**  
**10-06-25 QT #1423 TOLLESON, AZ**

1201 N. 91ST AVE

QUIKTRIP  
4705 SOUTH 129TH EAST AVENUE  
TULSA, OK 74134

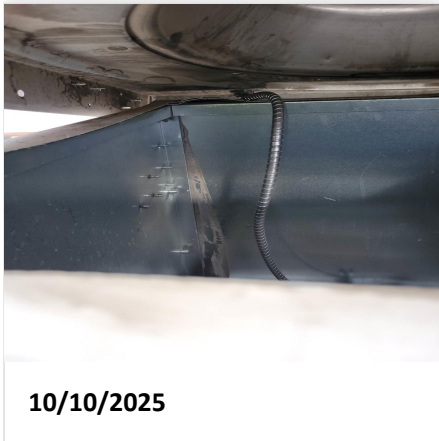
Project Issue File Details

**Issue Name :** EF1 IMPROPER INSTALL - CAUSED MALFUNCTION  
**Description :** The electrical conduit/hinge was improperly installed, so that when the unit was tilted by the hinge, the conduit was bent, there was a pop, and the motor stopped. UPDATE : Wire which was pulled loose fixed, conduit repaired and lengthened.  
**Created By :** National TAB                      **Assigned To :** National TAB - Dan Hertenstein  
**Status :** Closed  
**Priority :** Urgent                                      **Asset Tag :** EF1  
**Originated Date :** 10/10/2025 - Christine Weale - National TAB

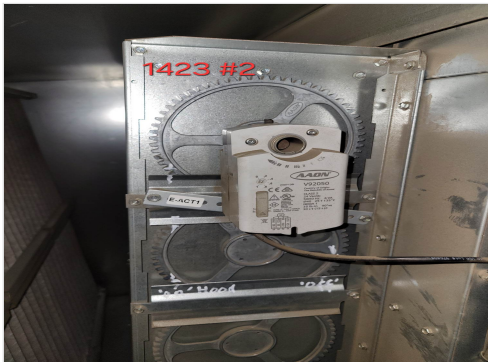
## Test Data - PHOTO LOG

RTU2 GRD5 was installed in incorrect location, picture shows inaccessible. Air flow was diverted from it for testing, then the damper reopened after balancing.
