Report: TAB Report
Function: Test, Adjust, & Balance
Date: 6/27/2022

PROJECT
**06-20 CAVA - BOSTON, MA (PRUDENTIAL
CENTER)**

Project: 06-20 CAVA - BOSTON, MA (PRUDENTIAL CENTER)

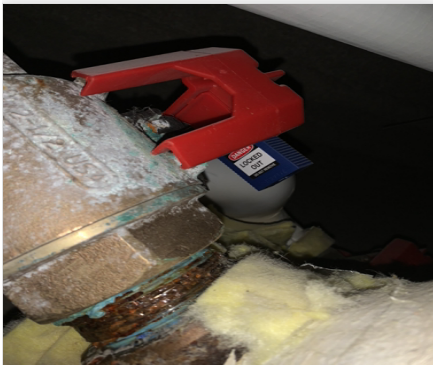
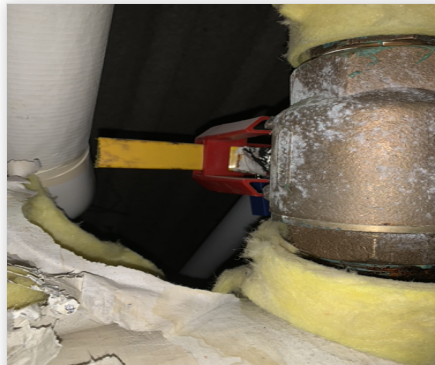
Issue Name : Main chilled water valves closed
Description : At building service piping are two valves on The CHW lines that serve the space. Both are closed and have lockout tags on them
Created By : National TAB **Assigned To :** National TAB - Tyler Youells
Status : Pending
Originated Date : 06/20/2022 - Tyler Youells - National TAB

- **06/23/2022** **National TAB - Tyler Youells**
 - GC Found that building is requiring the lines be coated prior to opening the valves so water balance could not be completed

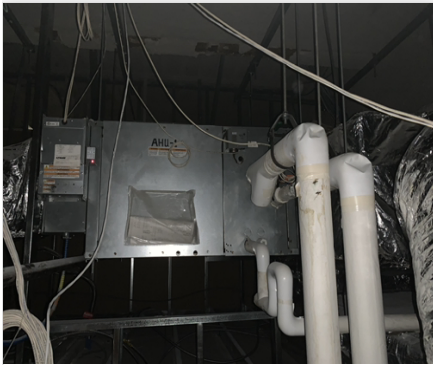
Issue Name : AHUs are not piped for hotwater.
Description : AHU's are existing and not piped for hot water as plans show.
Created By : National TAB **Assigned To :** National TAB - Tyler Youells
Status : Closed
Originated Date : 06/20/2022 - Tyler Youells - National TAB

- **06/27/2022 National TAB - Will Turnbough**
 - BOTH EXISTING AHU'S ARE EQUIPPED WITH DUCT HEATERS. AHU-1: TUTCO, MN:DB21385-15.00-3P (15KW). AHU-2 IS : TUTCO MN:DB21385-16.00-3P (16KW). ENGINEER OF RECORD WAS NOTIFIED AND APPROVED THE DEVIATION.

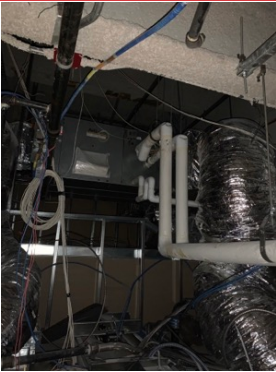
AHU-1

Serves the serve line and acpsp

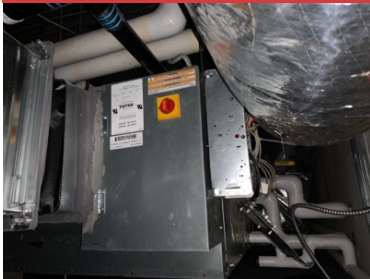
AHU-2

Serves the BOH

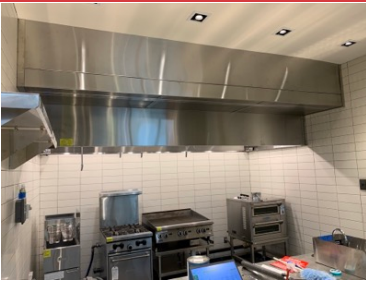
HOOD-1

List equipment turned on for testing	BURNER STOVE AND GRILL
List smoke candle type used	45 SEC SMOKE
Smoke test capture - Perimeter of hood	100%
Smoke test capture - Top of cooking surface	100%

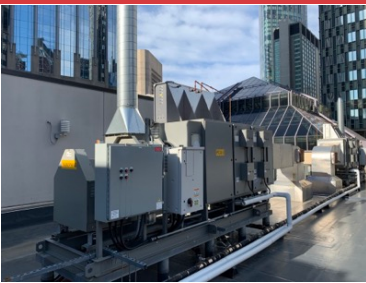
Issue Name : PCU-1 Belts are loose

Description : Belts are loose. They squeal on startup but at full speed there is no slippage. Motor mount plate does not have enough adjustment to tighten them. Belts are old and worn. Replacing may adequately tighten them. If not recommend one size smaller belt (A50 - Qty 2)

Rotation is correct?	YES ROTATION IS CORRECT
Belts are tight?	EXHUAUST FAN BELTS ARE FAIRLY LOOSE, THERE IS SQUEAL ON STARTUP BUT NO SLIPPING WHEN RUNNING.
Grease cup installed on hood fan?	HOOD FAN IS CONNECTED TO A PCU ON THE ROOF
Hinge kit installed installed on hood fan?	N/A

Notes:[1] FAN IS SET TO BYPASS THE VFD SO IT IS RUNNING AT 60HZ, VFD LOOKS TO BE IN WORKING ORDER SO IF WANTING TO USE VFD MAKE SURE IT IS SET TO 60HZ FOR DESIGN FLOW [2] BELTS ARE FAIRLY LOOSE RECOMMEND REPLACING

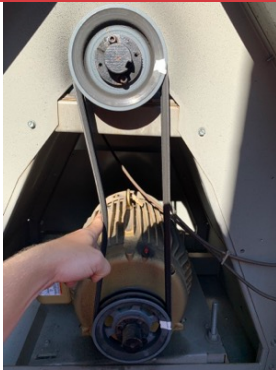
PCU-1

BELTS ARE LOOSE. They squeal on startup but there is no slipping when at full speed

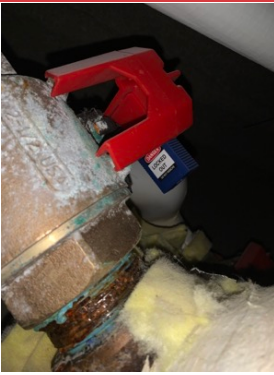
CHILLED WATER VALVES LOCKED OUT
