Report: TAB Report
Function: Test, Adjust, & Balance
Date: 10/22/2025
Completed By: National TAB

PROJECT
01-12-26 QT #1426 AVONDALE, AZ

Project: 01-12-26 QT #1426 AVONDALE, AZ

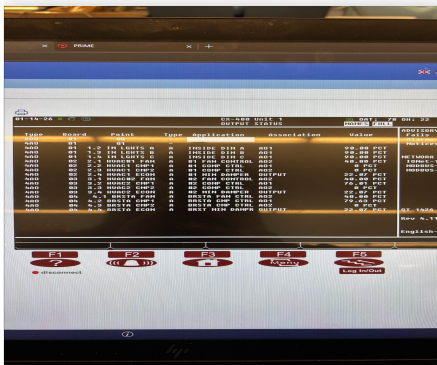
Issue Name : EXHAUST FAN ON EMERSON
Description : Exhaust fan for the hood don't show up on Emerson on the store computer
Created By : National TAB **Assigned To :** National TAB - Dan Hertenstein
Status : Open
Priority : Low **Asset Tag :**
Originated Date : 01/15/2026 - Ethan Van Orden - National TAB

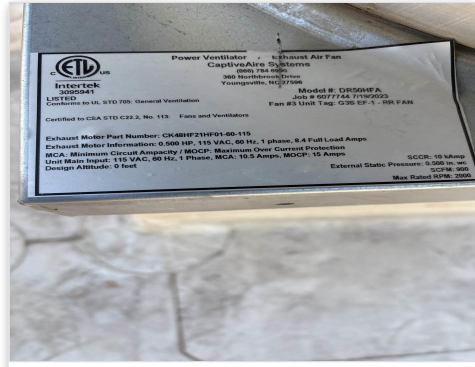
Unit Data - PHOTO LOG

Unit Data	
	Actual
MFG	CAPTIVEAIRE
Model Num	DR50HFA
Serial Num	6077744
Type	DOWNBLAST
Configuration	VERTICAL

Test Data		
	Design	Actual
CFM	750	773
Fan Rotation	-	CCW
System SetPt	-	LOW
RL Amperage	-	4.1
Total ESP	-	0.82
Fan Inlet SP	-	-0.82
Fan Discharge SP	-	ATMS

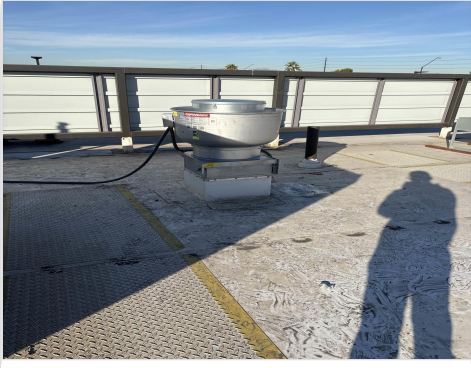
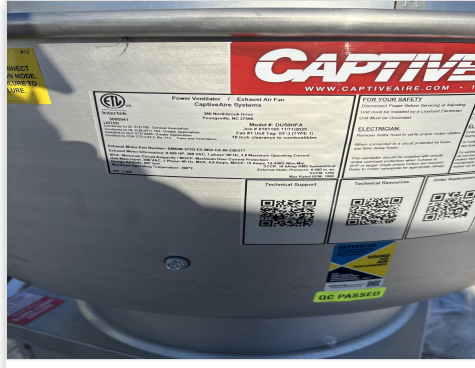
Unit Data - PHOTO LOG

Unit Data	
	Actual
MFG	CAPTIVEAIRE
Model Num	DU50HFA
Serial Num	8181165
Type	UPBLAST
Configuration	VERTICAL

Test Data		
	Design	Actual
CFM	1350	1372
Fan RPM	-	1184
Fan Rotation	-	CCW
Motor RPM	-	1184
System SetPt	-	50.6HZ
RL Voltage	-	219
RL Amperage	-	1.66
Total ESP	-	0.35
Fan Inlet SP	-	-0.35
Fan Discharge SP	-	ATMS

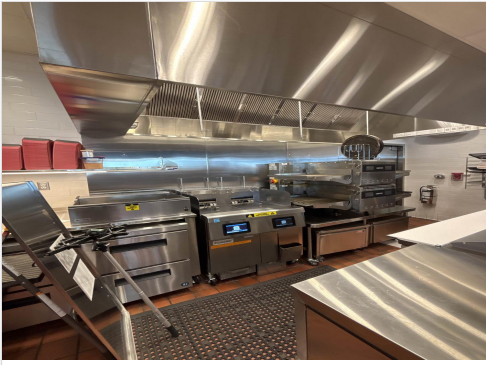
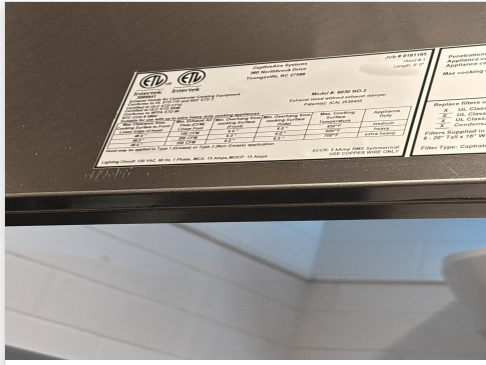
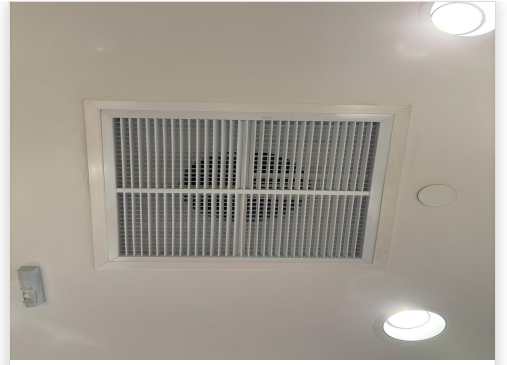
Unit Data - PHOTO LOG

Unit Data		
	Design	Actual
MFG	CAPTIVEAIRE	CAPTIVEAIRE
Model Num	6030ND-2-F	6030ND-2
Job / Serial Num	-	8181165
Type	-	TYPE I CANOPY
Hood length	-	120"
Hood Width	-	60"

Test Data Exhaust		
	Design	Actual
Filter Type	-	BAFFLE
Filter Size 1	-	16X20
Filter Qty 1	-	6
Filter AK factor size 1	-	2.08
Filter Total AK Area	-	12.48
Filter1 FPM	-	111
Filter2 FPM	-	113
Filter3 FPM	-	123
Filter4 FPM	-	108
Filter5 FPM	-	111
Filter6 FPM	-	96
Filter Ave FPM(corr)	-	110
CFM	1350	1372
