Report: TAB Report
Function: Test, Adjust, & Balance
Date: 10/22/2025
Completed By: National TAB

PROJECT
01-12-26 QT #1426 AVONDALE, AZ

Project: 01-12-26 QT #1426 AVONDALE, AZ

Project Summary

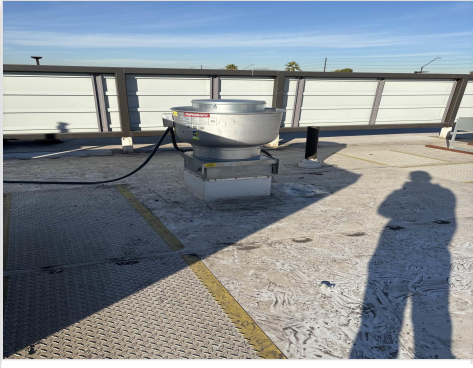
Unit Data - PHOTO LOG

Unit Data	
	Actual
MFG	CAPTIVEAIRE
Model Num	DU50HFA
Serial Num	8181165
Type	UPBLAST
Configuration	VERTICAL

Test Data		
	Design	Actual
CFM	1350	1372
Fan RPM	-	1184
Fan Rotation	-	CCW
Motor RPM	-	1184
System SetPt	-	50.6HZ
RL Voltage	-	219
RL Amperage	-	1.66
Total ESP	-	0.35
Fan Inlet SP	-	-0.35
Fan Discharge SP	-	ATMS
