## Test Results Summary

## Executive Summary

A building enclosure test was performed at the 1813 Locust Development Building. The building consists of Cosmo as well as an empty tenant on the north side. Per the architect, these spaces form their own air barrier separate from the rest of the building. North of the empty tenant space is another empty tenant space that appears to be in disrepair. The test was performed per the 2021 International Energy Code using the ASTM E1827 methodology and NEBB Procedural Standard.

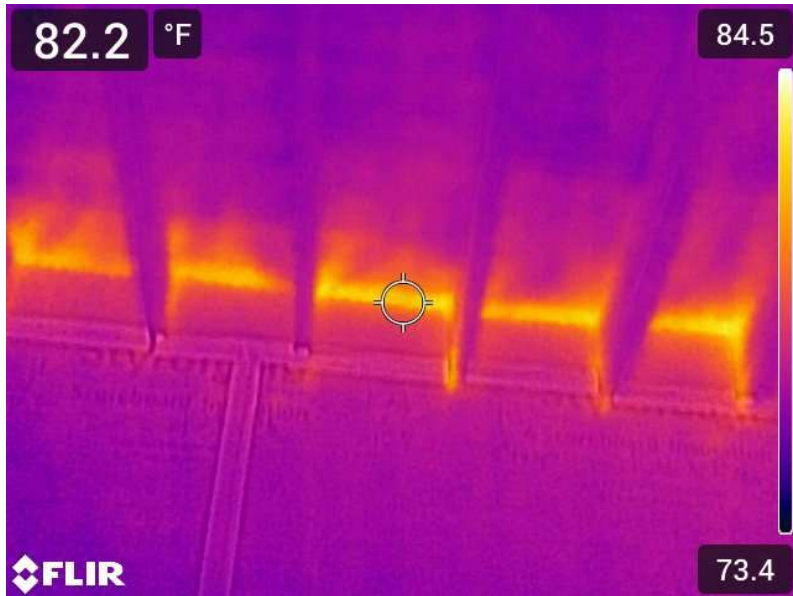
Figure 1. North side of the empty tenant space

Infrared images are provided below for reference of areas with noticeable leakage. Since the depressurization results passed, no action is required.
