Report: TAB Report
Function: Test, Adjust, & Balance
Date: 01/07/2025
Completed By: National TAB

PROJECT
12-02-24 CULVERS ORMOND BEACH, FL

Project: 12-02-24 CULVERS ORMOND BEACH, FL

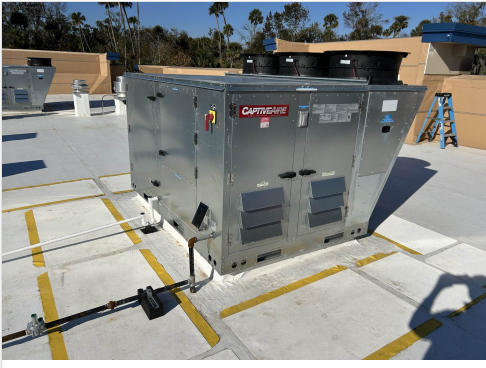
Asset: RTU1

AREA:DINING

Test Data		
	Design	Actual
SF CFM	5000	5071
SF RPM	-	1316
RA CFM	3000	3045
OA CFM	2000	2026
RL Voltage	-	137 VFD
RL Amperage	-	16.5 VFD
SF Rotation	-	CCW
SF System SetPt	-	45 HZ
RA Damper Position	-	6.1 V
Min OA Damper Position	-	3.9 V
Min OA Damper Type	-	ECONOMIZER

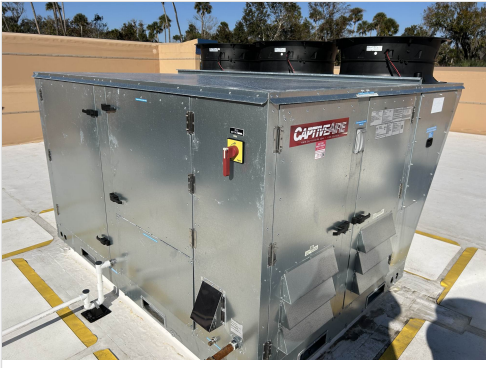
Asset: RTU2

AREA:KITCHEN

Test Data		
	Design	Actual
SF CFM	5000	5060
SF RPM	-	1404
RA CFM	3000	3067
OA CFM	2000	1993
RL Voltage	-	159 VFD
RL Amperage	-	17.8 VFD
SF Rotation	-	CCW
SF System SetPt	-	48 HZ
RA Damper Position	-	6.2 V
Min OA Damper Position	-	3.8 V
Min OA Damper Type	-	ECONOMIZER

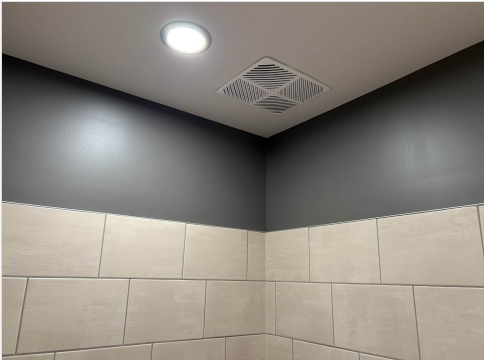
Asset: EF1

AREA: MEN'S RESTROOM

Test Data		
	Design	Actual
CFM	220	192
Fan RPM	829	900
Fan Rotation	-	CCW
Motor RPM	-	900
System SetPt	-	SINGLE SPEED
RL Voltage	-	123
RL Amperage	-	0.46

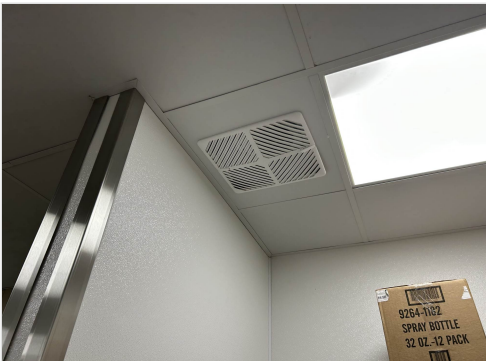
Asset: EF2

AREA:MOP ROOM

Test Data		
	Design	Actual
CFM	50	63
Fan RPM	519	LOW
Fan Rotation	-	CCW
Motor RPM	-	LOW
System SetPt	-	SPEED CONTROLLER (MINIMUM SETTING)
RL Voltage	-	122
RL Amperage	-	0.1

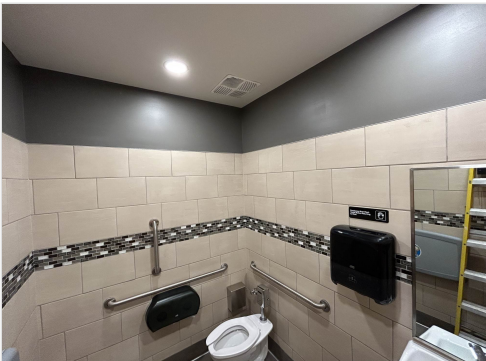
Asset: EFA3

AREA:WOMEN'S RR (LARGE STALL)

Test Data		
	Design	Actual
CFM	70	69
Fan RPM	642	675
Fan Rotation	-	CCW
Motor RPM	-	675
System SetPt	-	MAX
RL Voltage	-	123
RL Amperage	-	0.15

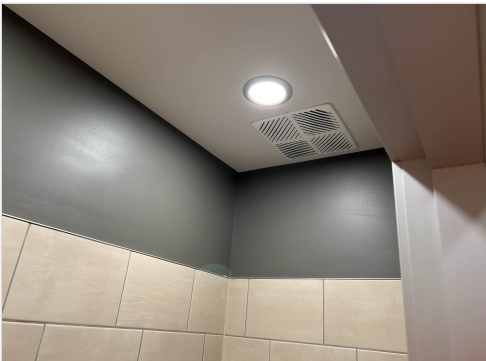
Asset: EFB3

AREA:WOMEN'S RR (NARROW STALL)

Test Data		
	Design	Actual
CFM	70	64
Fan RPM	642	675
Fan Rotation	-	CCW
Motor RPM	-	675
System SetPt	-	MAX
RL Voltage	-	123
RL Amperage	-	0.15

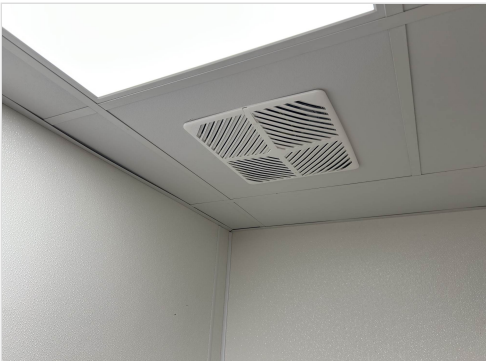
Asset: EFC3

AREA:EMPLOYEE RESTROOM

Test Data		
	Design	Actual
CFM	70	72
Fan RPM	642	675
Fan Rotation	-	CCW
Motor RPM	-	675
System SetPt	-	MAX
RL Voltage	-	122
RL Amperage	-	0.15

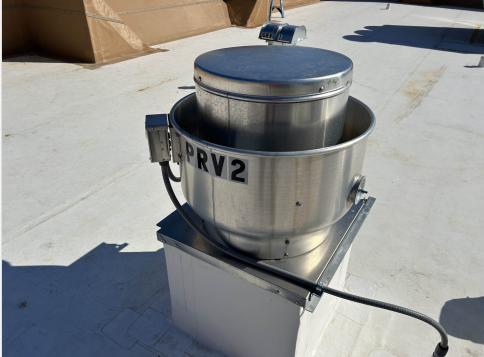
Asset: PRV2

AREA:HOOD 1

Test Data		
	Design	Actual
CFM	1500	1524
Fan RPM	1703	1155
Fan Rotation	-	CW
Motor RPM	-	1155
System SetPt	-	6.6 V
RL Voltage	-	122
RL Amperage	-	3.9
Total ESP	1.80"	0.57"
Fan Inlet SP	-	-0.57"
Fan Discharge SP	-	ATM

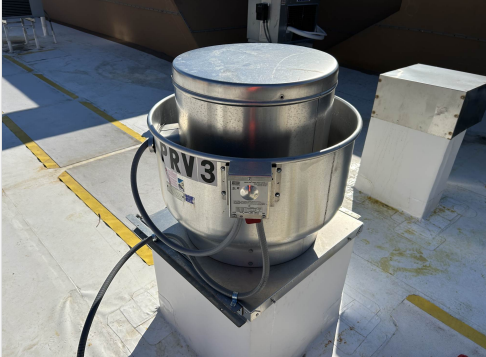
Asset: PRV3

AREA:HOOD 2

Test Data		
	Design	Actual
CFM	1500	1522
Fan RPM	1350	1155
Fan Rotation	-	CW
Motor RPM	-	1155
System SetPt	-	6.5 V
RL Voltage	-	124
RL Amperage	-	3.7
Total ESP	1.00"	0.48"
Fan Inlet SP	-	-0.48"
Fan Discharge SP	-	ATM

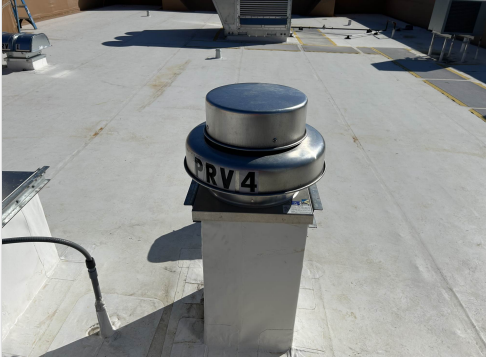
Asset: PRV4

AREA:HOOD 3

Test Data		
	Design	Actual
CFM	350	377
Fan RPM	1467	1050
Fan Rotation	-	CW
Motor RPM	-	1050
System SetPt	-	LOW SPEED WIRE
RL Voltage	-	124
RL Amperage	-	1.3
Total ESP	0.60"	0.48"
Fan Inlet SP	-	-0.48"
Fan Discharge SP	-	ATM

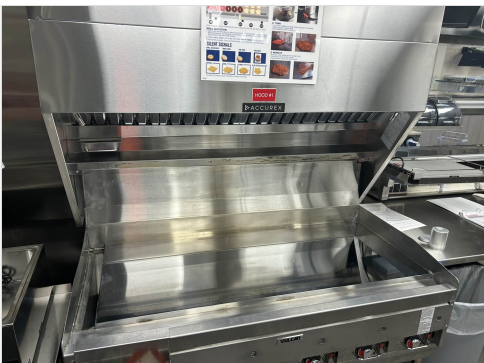
Asset: HD1

AREA:GRIDDLE

Unit Data		
	Design	Actual
MFG	ACCUREX	ACCUREX
Model Num	XGEP-64S	XXEP-83.00-S
Job / Serial Num	-	25144485
Type	TYPE I	TYPE I LOW PROXIMITY
Hood length	64"	64"
Hood Width	23"	23"

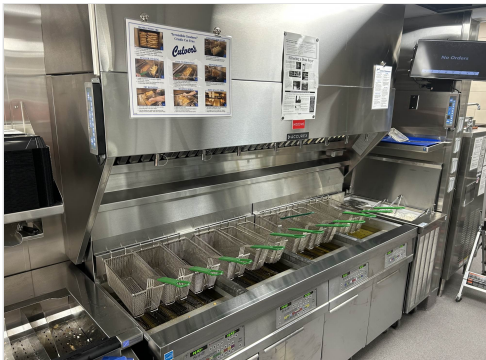
Asset: HD2

AREA:FRYERS
