Report: TAB REPORT
Function: Test, Adjust, & Balance
Date: 09/30/2024
Completed By: National TAB

09-30-24 DOLLAR TREE - UNION GROVE, WI

Project Summary

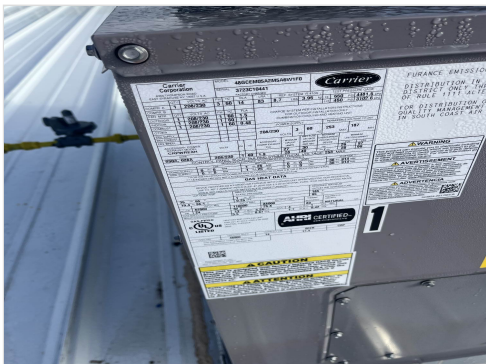
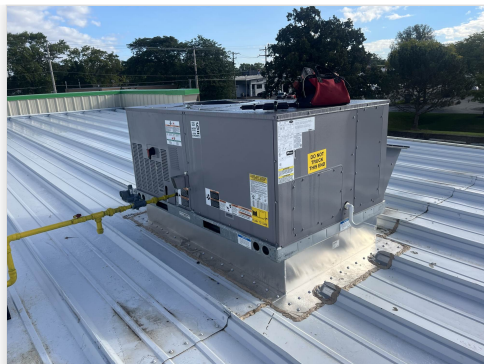
Unit Data - PHOTO LOG

Asset: RTU 1

AREA:STORAGE

Unit Data			Test Data																										
	Design	Actual		Design	Actual																								
MFG	CARRIER	CARRIER	SF CFM	1750	1801																								
Serial Num	-	3723C10441	SF RPM	-	2051																								
Model Num	48FCEM12A2M5A6F1J0	48GCEM05F2M5A6F1C0	RA CFM	1600	1661																								
Type	RTU	RTU	OA CFM	150	140																								
Configuration	VERTICAL	VERTICAL	RL Voltage	-	211																								
Num OA Filters 1	-	1	RL Amperage	-	3.6																								
OA Filter Size 1	-	28X14	SF Rotation	-	CORRECT																								
Num Final Filter 1	-	2	SF System SetPt	-	9.0 VDC (CAV)																								
Final Filter Size 1	-	18X24X2	RA Damper Position	-	MECHANICALLY LINKED

General	
	Actual
Fan Rotation Correct	YES
Unit Filters Clean	YES
Condensate Drain Installed	YES

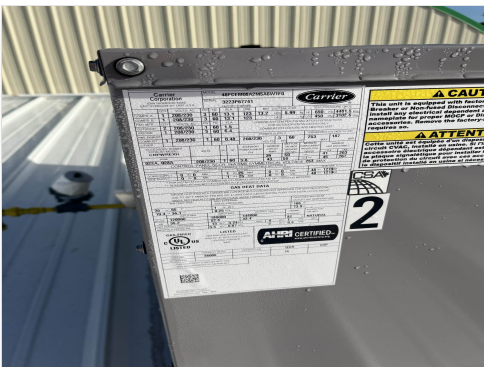
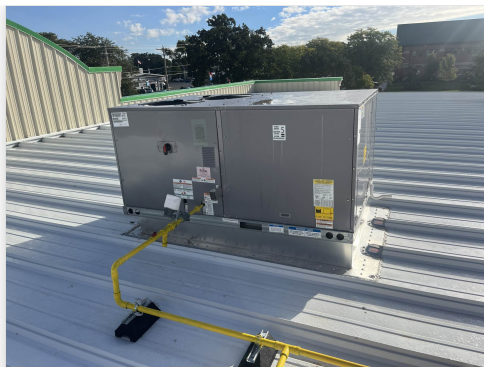
Unit Data - PHOTO LOG

Asset: RTU 2

AREA:WEST SALES

Unit Data		
	Design	Actual
MFG	CARRIER	CARRIER
Serial Num	-	3223P67741
Model Num	48FCEM12A2M5A6F1J0	48HCED08F2M5A6F1J0
Type	RTU	RTU
Configuration	VERTICAL	VERTICAL
Num OA Filters 1	-	1
OA Filter Size 1	-	35X19.5
Num Final Filter 1	-	4
Final Filter Size 1	-	16X20X2

General	
	Actual
Fan Rotation Correct	YES
Unit Filters Clean	YES
Condensate Drain Installed	YES

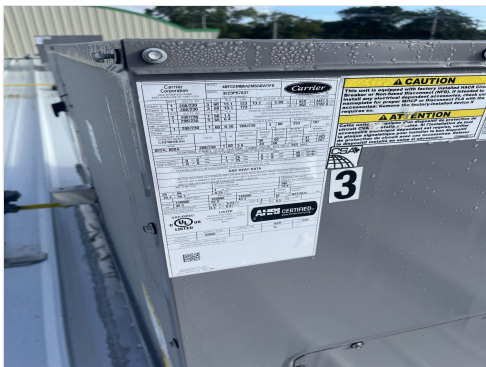
Unit Data - PHOTO LOG

Asset: RTU 3

AREA: EAST SALES

Unit Data		
	Design	Actual
MFG	CARRIER	CARRIER
Serial Num	-	3223P67837
Model Num	48FCEM12A2M5A6F1J0	48HCED08F2M5A6F1J0
Type	RTU	RTU
Configuration	VERTICAL	VERTICAL
Num OA Filters 1	-	1
OA Filter Size 1	-	35X19.5
Num Final Filter 1	-	4
Final Filter Size 1	-	16X20X2

General	
	Actual
Fan Rotation Correct	YES
Unit Filters Clean	YES
Condensate Drain Installed	YES
