Report: TAB REPORT
Function: Test, Adjust, & Balance
Date: 09/30/2024
Completed By: National TAB

09-30-24 DOLLAR TREE - UNION GROVE, WI

Project: 09-30-24 DOLLAR TREE - UNION GROVE, WI

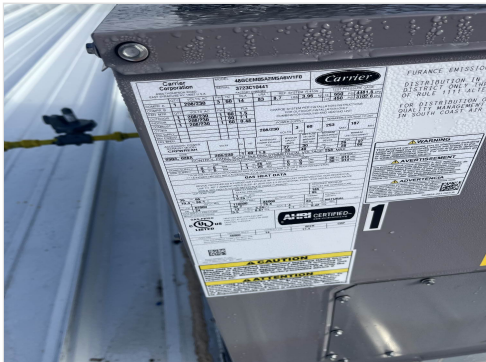
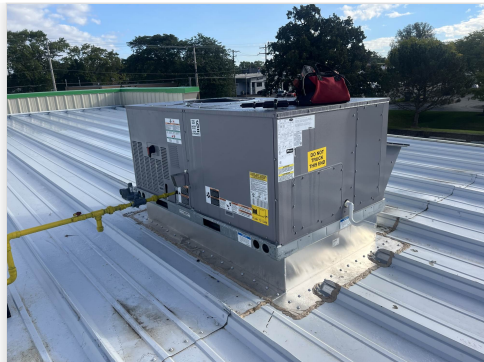
Unit Data - PHOTO LOG

Asset: RTU 1

Unit Data			Test Data																																	
	Design	Actual		Design	Actual																															
MFG	CARRIER	CARRIER	SF CFM	1750	1801																															
Serial Num	-	3723C10441	SF RPM	-	2051																															
Model Num	48FCEM12A2M5A6F1J0	48GCEM05F2M5A6F1C0	RA CFM	1600	1661																															
Type	RTU	RTU	OA CFM	150	140																															
Configuration	VERTICAL	VERTICAL	RL Voltage	-	211																															
Num OA Filters 1	-	1	RL Amperage	-	3.6																															
OA Filter Size 1	-	28X14	SF Rotation	-	CORRECT																															
Num Final Filter 1	-	2	SF System SetPt	-	9.0 VDC (CAV)																															
Final Filter Size 1	-	18X24X2	RA Damper Position	-	MECHANICALLY LINKED																															
<table border="1"> <thead> <tr> <th colspan="3">Motor Data</th> </tr> <tr> <th></th> <th>Design</th> <th>Actual</th> </tr> </thead> <tbody> <tr> <td>Motor MFG</td> <td>-</td> <td>NL</td> </tr> <tr> <td>Horsepower</td> <td>1.4</td> <td>NL</td> </tr> <tr> <td>Motor Rpm</td> <td>-</td> <td>NL</td> </tr> <tr> <td>Phase</td> <td>1</td> <td>1</td> </tr> <tr> <td>Rated Voltage</td> <td>208</td> <td>208</td> </tr> <tr> <td>Rated Amperage</td> <td>-</td> <td>7.1</td> </tr> </tbody> </table>			Motor Data				Design	Actual	Motor MFG	-	NL	Horsepower	1.4	NL	Motor Rpm	-	NL	Phase	1	1	Rated Voltage	208	208	Rated Amperage	-	7.1	Min OA Damper Position	-	3.75V (22%)

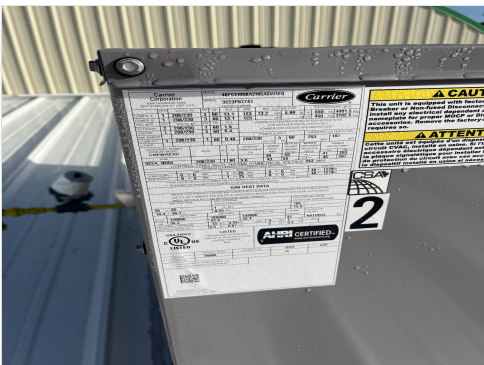
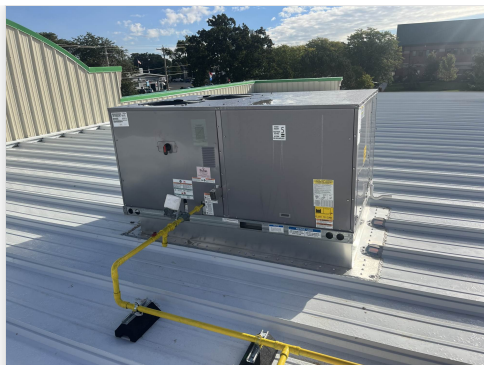
Unit Data - PHOTO LOG

Asset: RTU 2

Test Data		
	Design	Actual
SF CFM	2800	2827
SF RPM	-	1446
RA CFM	2150	2168
OA CFM	650	659
RL Voltage	-	211/212/211
RL Amperage	-	2.2/2.3/2.1
SF Rotation	-	CORRECT
SF System SetPt	-	6.8VDC (MSAV)
RA Damper Position	-	MECHANICALLY LINKED
Min OA Damper Position	-	HIGH: 3.8V (22%) LOW: 5.05V (38%)
Min OA Damper Type	-	ECONOMIZER
OA Enthalpy Setpt	-	ES5

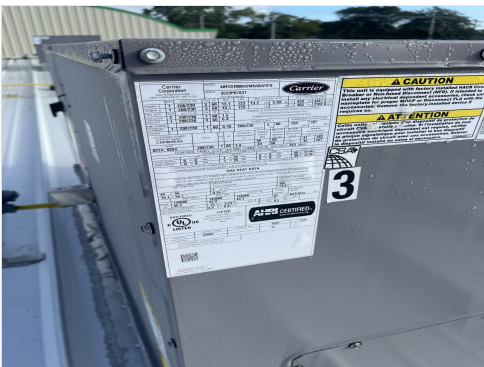
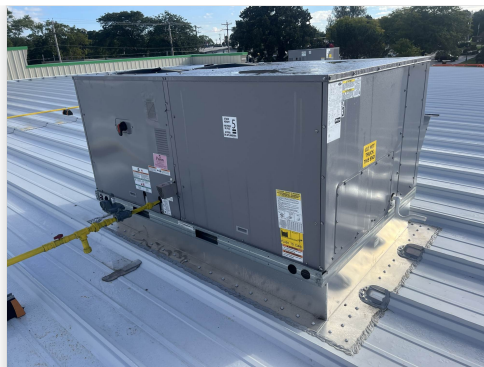
Unit Data - PHOTO LOG

Asset: RTU 3

Test Data		
	Design	Actual
SF CFM	2800	2837
SF RPM	-	1448
RA CFM	2150	2164
OA CFM	650	673
RL Voltage	-	212/212/212
RL Amperage	-	2.2/2.4/2.2
SF Rotation	-	CORRECT
SF System SetPt	-	6.8VDC (MSAV)
RA Damper Position	-	MECHANICALLY LINKED
Min OA Damper Position	-	HIGH: 3.85V (23%) LOW: 5.15 (39%)
Min OA Damper Type	-	ECONOMIZER
OA Enthalpy Setpt	-	ES5

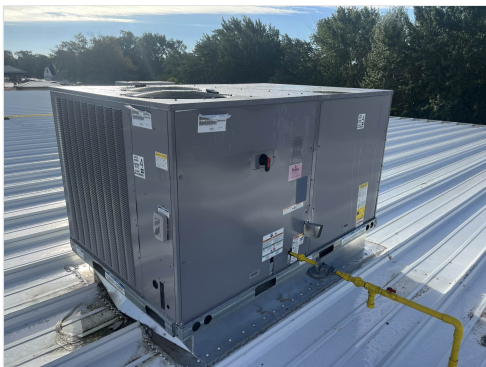
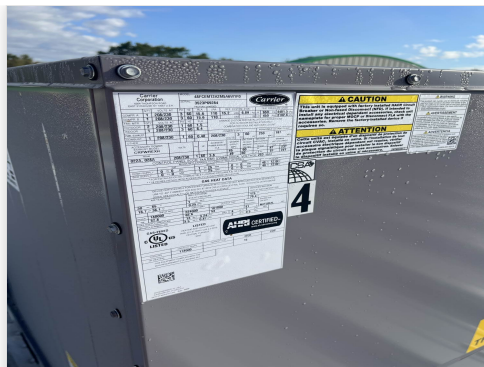
Unit Data - PHOTO LOG

Asset: RTU 4

Unit Data			Test Data		
	Design	Actual		Design	Actual
MFG	CARRIER	CARRIER	SF CFM	3500	3497
Serial Num	-	3523P69284	SF RPM	-	DD
Model Num	48FCEM12A2M5A6F1J0	48FCEM12A2M5A6F1J0	RA CFM	2725	2729
Type	RTU	RTU	OA CFM	775	768
Configuration	VERTICAL	VERTICAL	RL Voltage	-	212/212/212
Num OA Filters 1	-	1	RL Amperage	-	3.6/3.6/3.4
OA Filter Size 1	-	35X19.5	SF Rotation	-	CORRECT
Num Final Filter 1	-	4	SF System SetPt	-	7.8VDC (MSAV)
Final Filter Size 1	-	20X20X2	RA Damper Position	-	MECHANICALLY LINKED

[1] RTU-4 Disconnect not operational at time of TAB. Scheduled to be replaced.

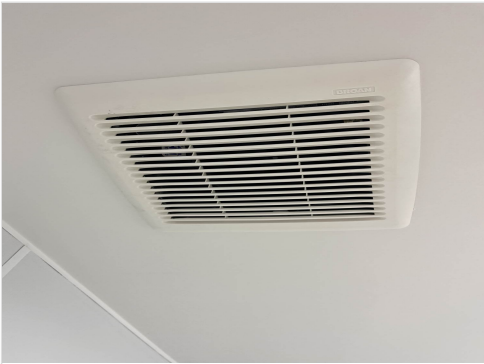
Unit Data - PHOTO LOG

Asset: EF1

Test Data		
	Design	Actual
CFM	75	70
Fan RPM	-	DD
Fan Rotation	-	CCW, CORRECT
Motor RPM	-	DD
System SetPt	-	SINGLE SPEED
RL Voltage	-	119
RL Amperage	-	NA

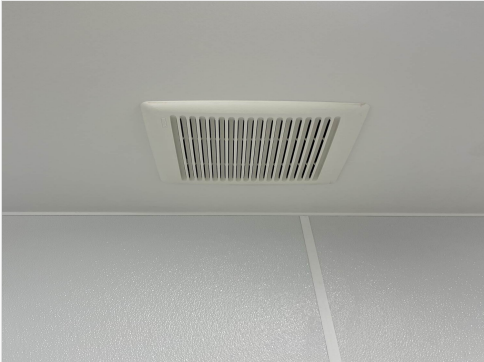
Unit Data - PHOTO LOG

Asset: EF2

Test Data		
	Design	Actual
CFM	75	72
Fan RPM	-	DD
Fan Rotation	-	CCW CORRECT
Motor RPM	-	DD
System SetPt	-	SINGLE SPEED
RL Voltage	-	120
RL Amperage	-	NA

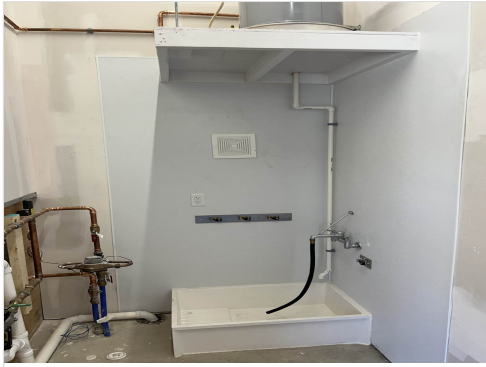
Unit Data - PHOTO LOG

Asset: EF3

Test Data		
	Design	Actual
CFM	50	55

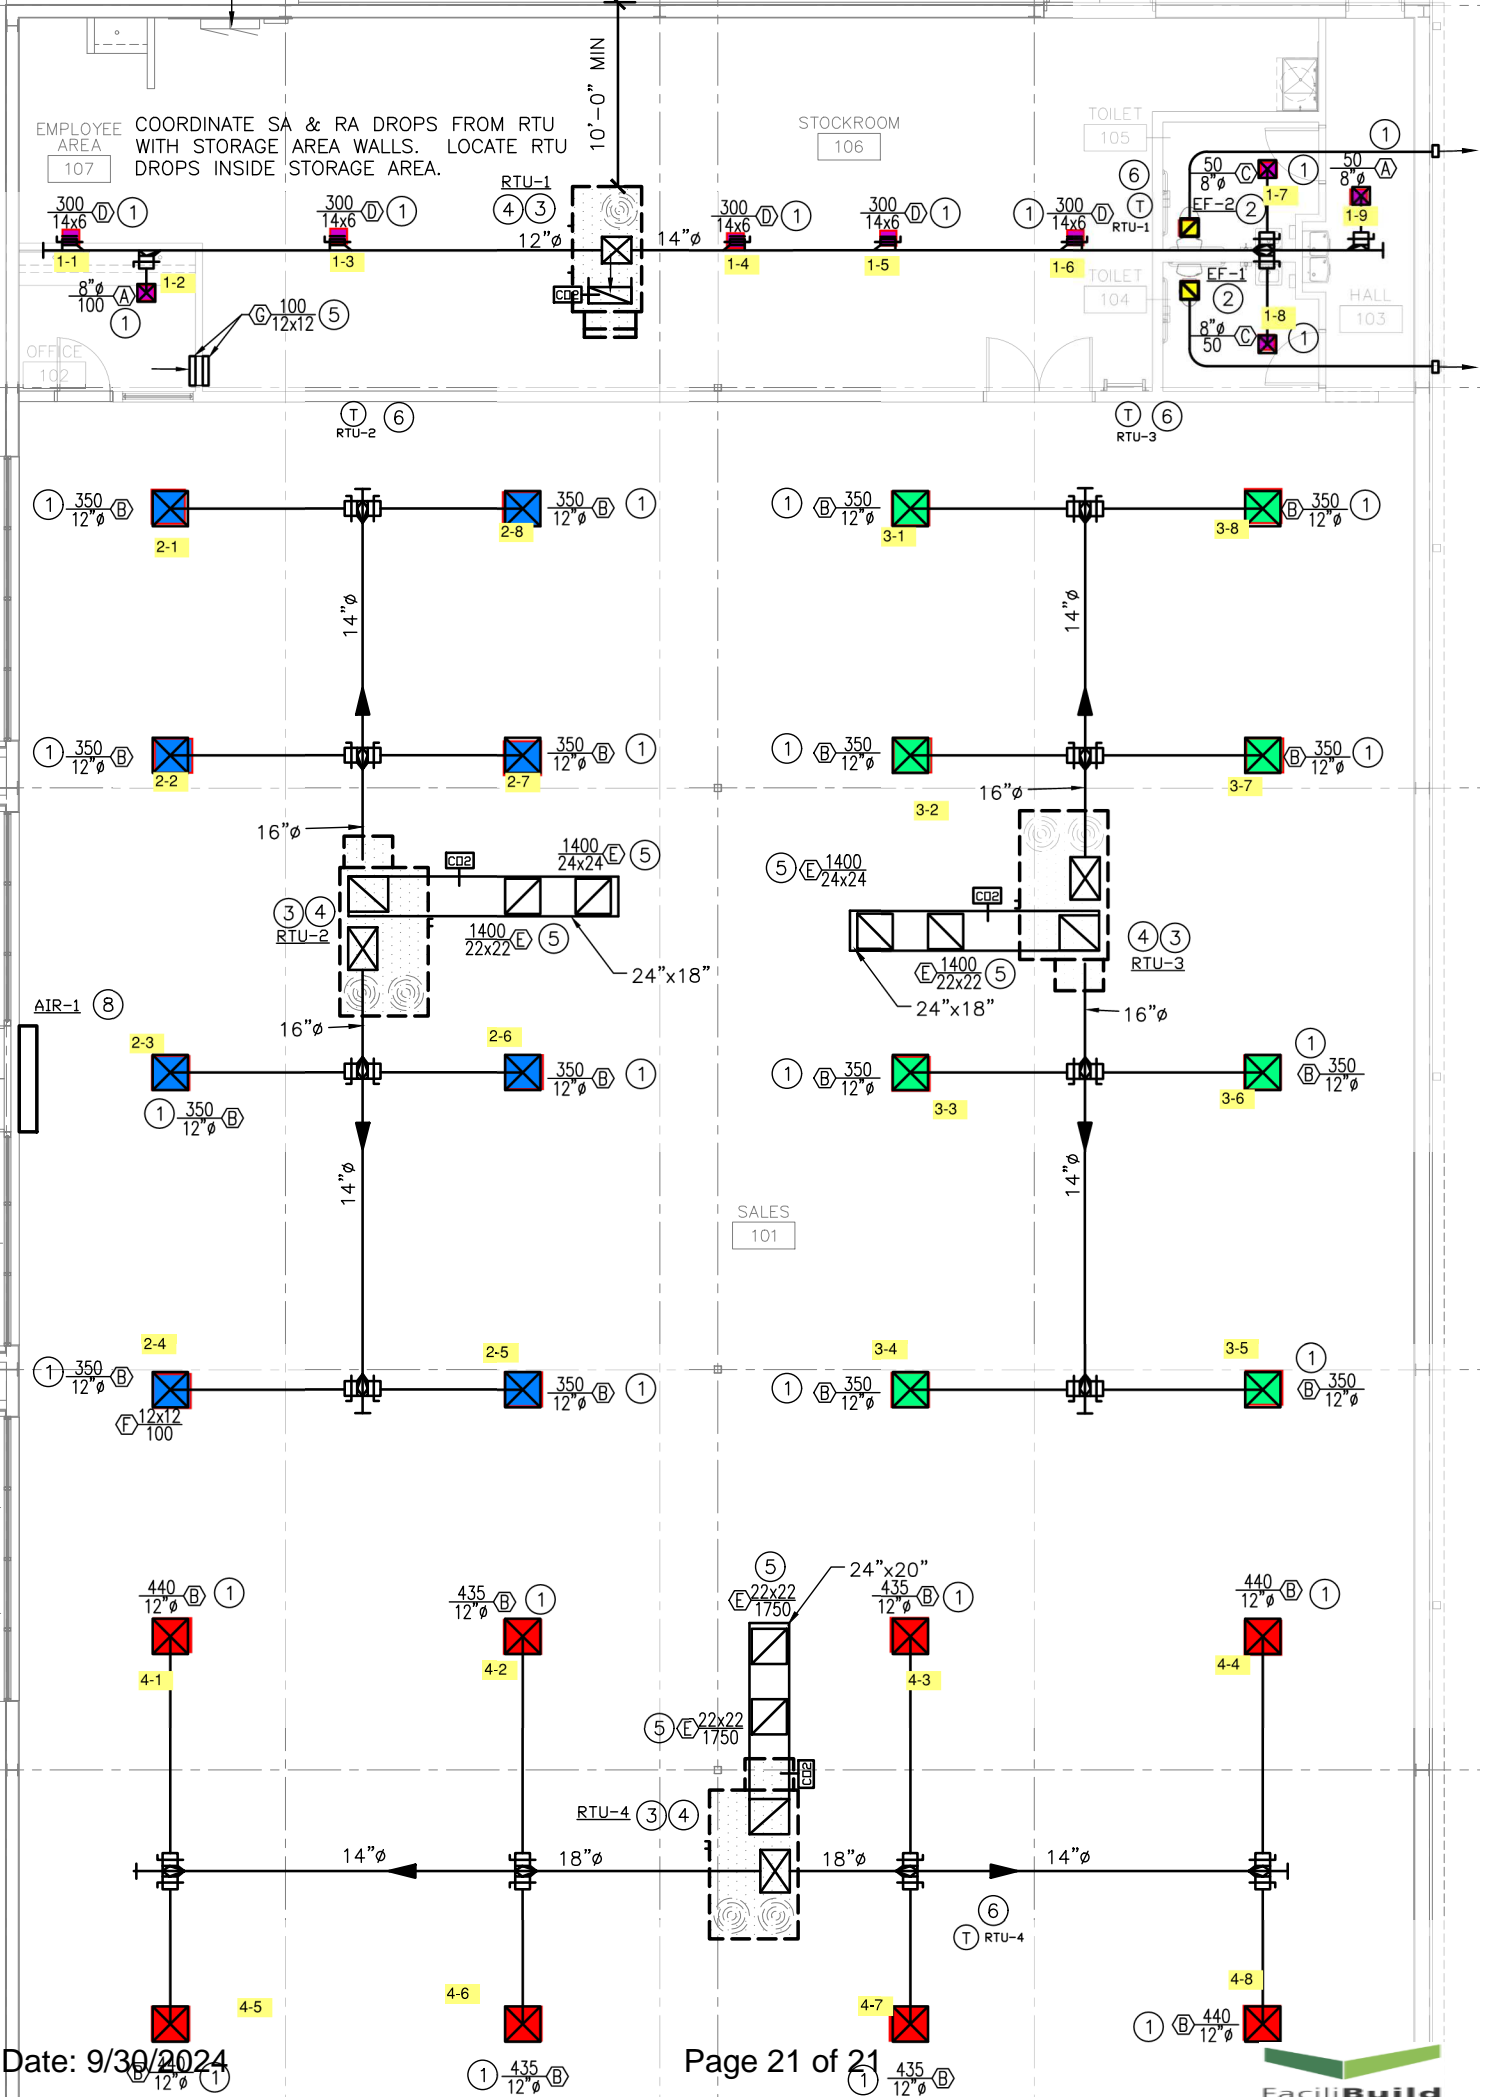
EMPLOYEE AREA 107
 COORDINATE SA & RA DROPS FROM RTU WITH STORAGE AREA WALLS. LOCATE RTU DROPS INSIDE STORAGE AREA.
