**Report: TAB Report  
Function: Test, Adjust, & Balance  
Date: 10/28/2025  
Completed By: National TAB**

**PROJECT  
10-13-25 QT #1409 GLENDALE, AZ**

Project: 10-13-25 QT #1409 GLENDALE, AZ

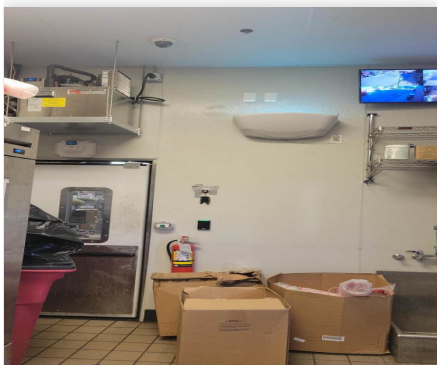
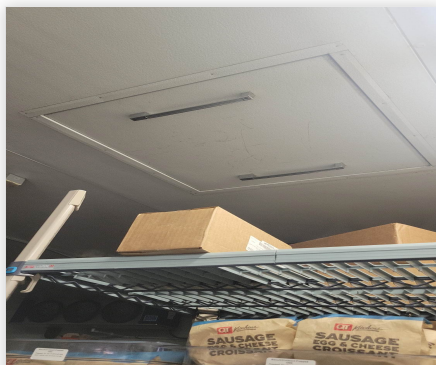
**Issue Name :** EF-1: Combi-oven Grille Exhaust Low  
**Description :** EF1-GRD4 (combi-oven) damper is over the freezer and cannot be accessed easily or safely (hatch door is very heavy, and only accessed on an 8' ladder. No way to access the freezer from the back room. Recommend making sure damper is always completely open on install. Grille exhaust low.  
**Created By :** National TAB                      **Assigned To :** National TAB - Dan Hertenstein  
**Status :** Open  
**Priority :** Low                                      **Asset Tag :** EGRD4  
**Originated Date :** 10/16/2025 - Christine Weale - National TAB

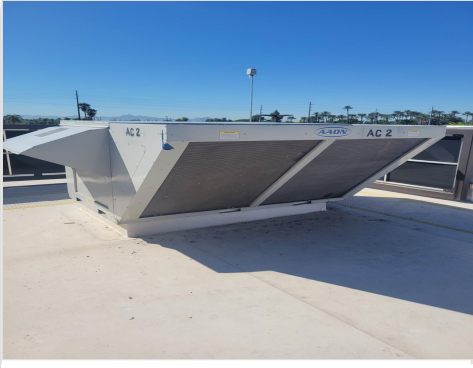
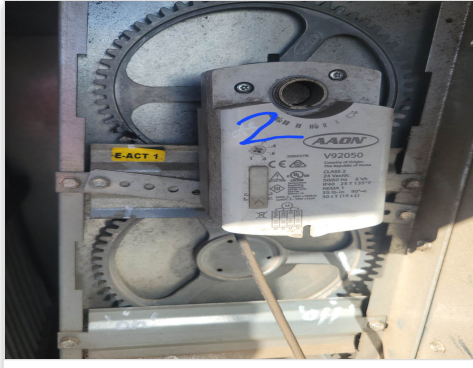
RTU2-GRD5 is installed in the incorrect place and is completely inaccessible - requiring damper closure during measure. Damper was reopened to former position after measurement, halfway. Picture attached to show.

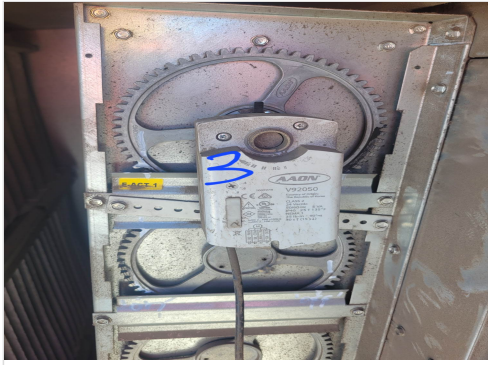
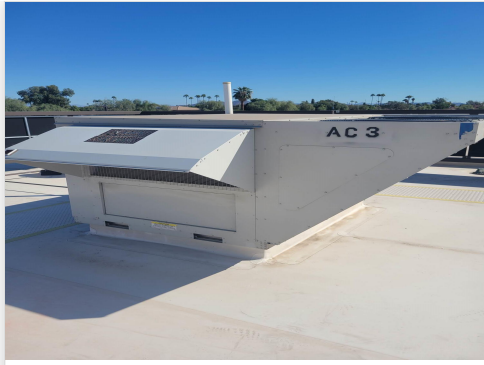
Notes:  
RTU3-GRD6 almost inaccessible. Picture shows bent hood to measure diffuser which may have led to inaccurate measurement.
