**Report: Test and Balance
Date: 2/26/2019**

**PROJECT
FREDDY'S - EDWARDSVILLE, IL**

Project: FREDDY'S - EDWARDSVILLE, IL

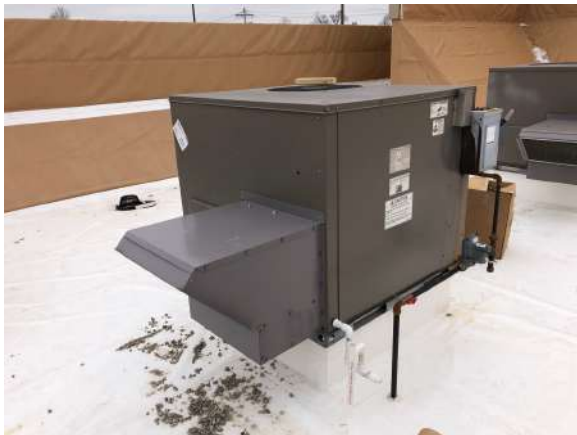
XRTU3

PRIORITY (HIGH/LOW/INFO ONLY)	
HIGH	Existing RTU 3 and 4 are low on airflow. There is a dirt build up on the fan wheels and filters. The coil is blow through style and was not accessible for inspection. The filters are mesh style and should be replaced with disposable filters. Did not find spec that the cleanliness of existing equipment was in mechanical contractors scope so this issue will be evaluated during the Renew program.
LOW	New RTU-1 and 2 low voltage wiring not completed from OCP terminal at RTU's to thermostat to enable economizer while restaurant is occupied. A jumper wire was temporarily installed so balancing could be completed. But wiring needs to be completed.
LOW	Grease trough is not installed on KEF 1 or KEF 2.
INFO ONLY	Existing RTU 3 and 4 Outside air damper motors do not work, Removed from linkage and opened up to maximum allowable point. Dampers were manually set to this position. No further action required at this time.

- Notes:
- [1] Motor sticker is not accessible, motor data taken from unit sticker
 - [2] Internal Filters are metal mesh
 - [3] Unit has no way to increase speed, Diffusers are proportionally balanced
 - [4] OA damper motor does not work, removed from linkage and opened to max allowable point
 - [5] There is dirty buildup on fan wheel and filters, this means the coil is dirty and needs to be cleaned. Also the metal filters need to be replaced with typ fiber internal filters.

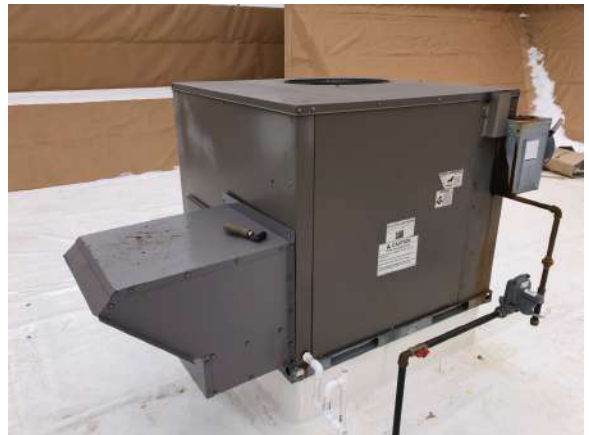
XRTU4

- Notes:
- [1] Motor sticker is not accessible, motor data taken from unit sticker
 - [2] Internal Filters are metal mesh
 - [3] Unit has no way to increase speed, Diffusers are proportionally balanced
 - [4] OA damper motor does not work, removed from linkage and opened to max allowable point
 - [5] There is dirty buildup on fan wheel and filters, this means the coil is dirty and needs to be cleaned. Also the metal filters need to be replaced with typ fiber internal filters.

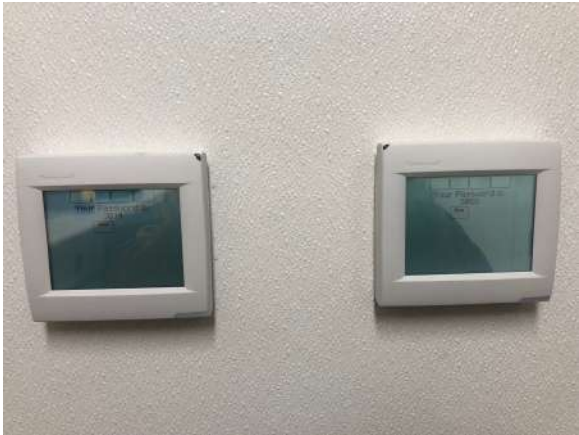
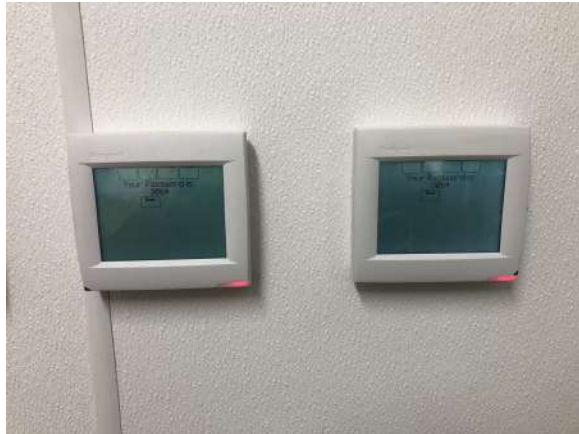
Left Thermostats

- [1] For the existing units, RTU1 and 2 have prodegy board.
- [2] This shows the outside bounds when in operation. The dish hood is currently wired to only run while the dishwasher is running.
- [3] Password for thermostats is are 3074 3058 3064 3064 starting at the left most thermostat and going right. See pictures.

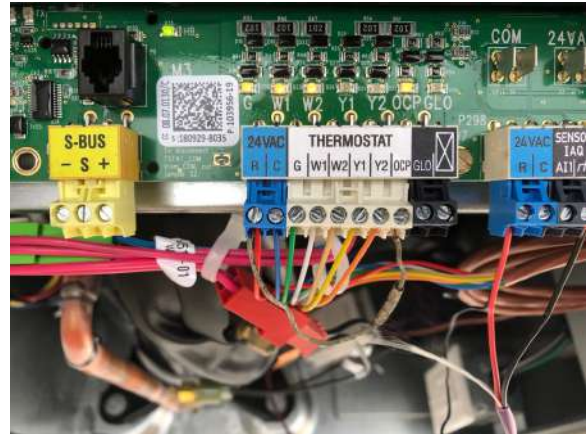
Jump B/t R and OCP

- Notes: [1] Motor sticker not accessible, motor data taken from unit sticker
 [2] OCP not hooked up, Unit was jumped to set OA
 [3] Speed set to 61%

Notes: [1] OCP not hooked up, OCP jumped to set OA

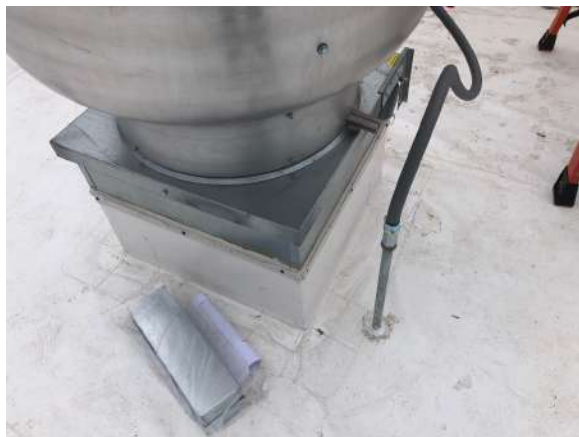
Typ Grease Trough

Notes: [1] Grease trough not installed

Notes: [1] Grease trough is not installed
