**Report: TAB REPORT**  
**Function: Test, Adjust, & Balance**  
**Date: 05/07/2025**  
**Completed By: National TAB**

**05-05-25 WHATABURGER #1561 HICKORY,  
NC**

Project: 05-05-25 WHATABURGER #1561 HICKORY, NC

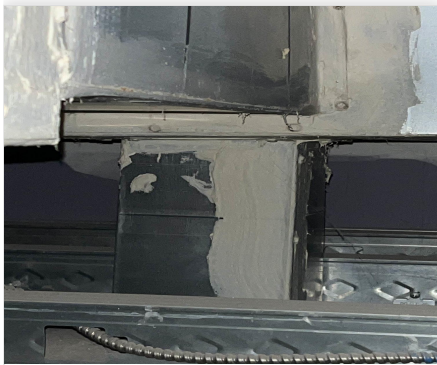
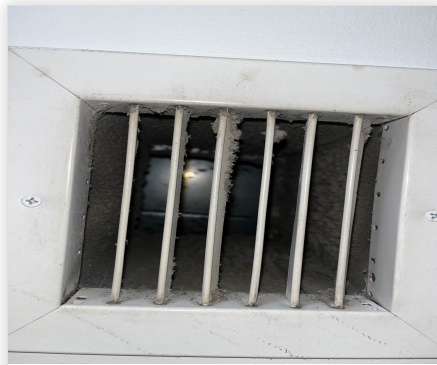
**Issue Name :** EF1 / MISSING DAMPERS  
**Description :** EF1 DAMPERS ARE NOT INSTALLED. UNABLE TO BALANCE EACH INDIVIDUAL GRILL TO DESIGN CFM. FAN TOTAL HAD TO BE SET DUE TO THIS ISSUE.  
**Created By :** National TAB                      **Assigned To :** National TAB - Brianna Biggs  
**Status :** Open  
**Priority :** Medium                                      **Asset Tag :**  
**Originated Date :** 05/07/2025 - Dale Wheeler - National TAB

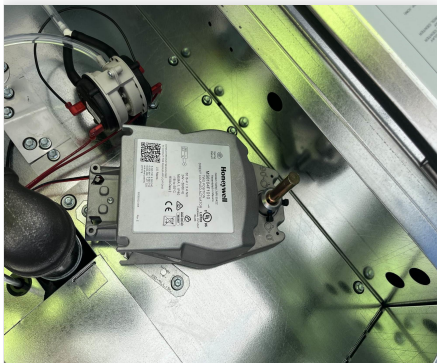
**Issue Name :** MAU / CONTROL BOARD  
**Description :** MAU CONTROL BOARD IS NOT WIRED / OPERATIONAL. MECHANICAL WAS UNABLE TO RESOLVE ISSUE WHILE ON SITE. HEATER WAS UNABLE TO BE TESTED DUE TO THIS ISSUE & MAU DAMPER HAD TO BE MANUALLY OPENED FOR BALANCE. MAU VFD WAS OPERATIONAL AND SUPPLY FAN WAS ABLE TO BE BALANCED TO DESIGN.

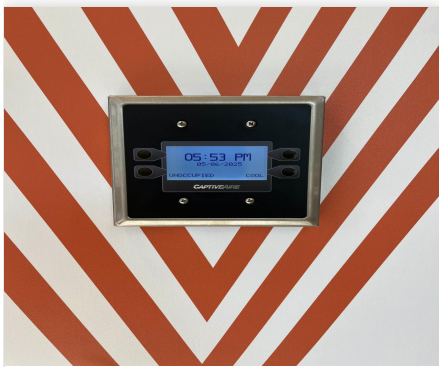
**Issue Name :** RTU1 / CAPTIVE AIRE CONTROLLER  
**Description :** RTU1 CONTROLLER NEEDS TO BE PROGRAMMED BY CAS. UNIT IS RUNNING IN HEATING MODE THROUGHOUT THE DAY CAUSING THE DINING AREA TO BECOME VERY WARM.  
**Created By :** National TAB                      **Assigned To :** National TAB - Brianna Biggs  
**Status :** Open  
**Priority :** Medium                                      **Asset Tag :**  
**Originated Date :** 05/07/2025 - Dale Wheeler - National TAB

DINING ROOM IS HOT DUE TO RTU1 RUNING IN HEAT MODE. CAS WILL PROGRAM RTU1 ONCE BALANCE IS COMPLETED PER G.C.

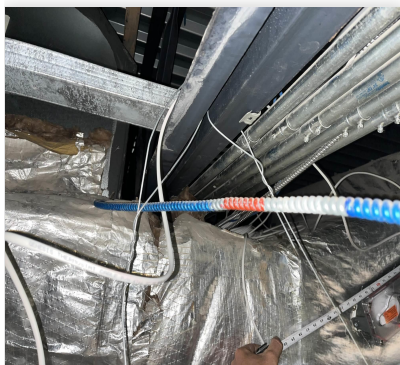
**Screenshot of the GRD marked up with supply and return traverse locations for RTU-1 (Add picture here)**

RTU1 - SUPPLY TRUNK LINE CANNOT BE TRAVERSED DUE TO NOT HAVING THE MINIMUM AMOUNT OF 4FT. OF STRAIGHT DUCT. RETURN DUCT CANNOT BE ACCESSED DUE TO BEING ABOVE HARD CEILING.

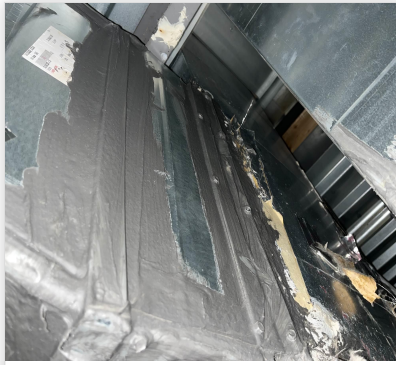
**Screenshot of the GRD marked up with supply and return traverse locations for RTU-2 (Add picture here)**

RTU2 - SUPPLY & RETURN TRUNK LINES CANNOT BE TRAVERSED DUE TO NOT HAVING THE MINIMUM AMOUNT OF 4FT. OF STRAIGHT DUCT.

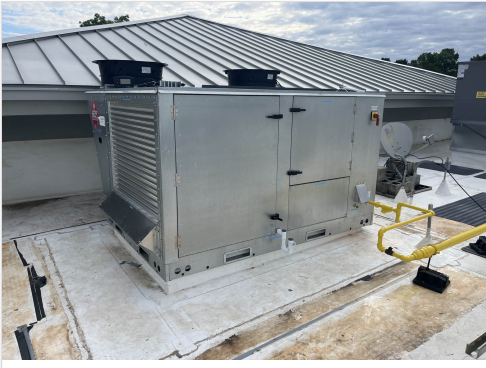
## Unit Data - PHOTO LOG

Unit Data		
	Design	Actual
MFG	CARRIER	CAPTIVEAIRE
Serial Num	-	7280977
Model Num	48FCTN16	CAS-HVAC3-1.300-24-15T
Num OA Filters 1	-	4
OA Filter Size 1	-	16x25x2
Num Final Filter 1	-	4
Final Filter Size 1	-	20x25x2

Test Data		
	Design	Actual
SF CFM (Traverse)	-	[1]
SF CFM	5000	5368
SF RPM	-	DD / 1755
MOTOR RPM	-	DD / 1755
RA CFM (Traverse)	-	[1]
RA CFM	3750	4046
OA CFM	1250	1322
RL Voltage	-	153 AVG.
RL Amperage	-	16.4 AVG.
SF System SetPt	-	48 HZ.
RA Damper Position	-	4.5V
Min OA Damper Position	-	5.5V
Min OA Damper Type	-	ECON

[1] SUPPLY TRUNK LINE CANNOT BE TRAVERSED DUE TO NOT HAVING THE MINIMUM AMOUNT OF 4FT. OF STRAIGHT DUCT.

RETURN DUCT CANNOT BE ACCESSED DUE TO BEING ABOVE HARD CEILING.

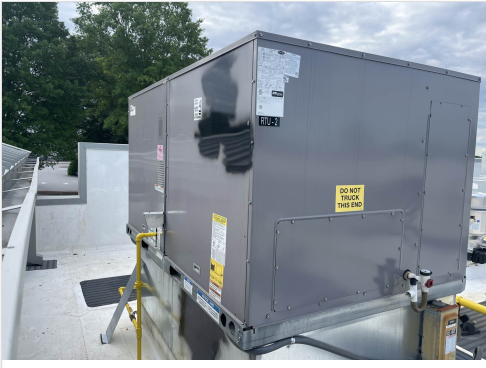
## Unit Data - PHOTO LOG

Unit Data		
	Design	Actual
MFG	CARRIER	CARRIER
Serial Num	-	3123P35095
Model Num	48FCEM09	48FCEM09A2A5A0A0A0
Num Final Filter 1	-	4
Final Filter Size 1	-	20x20x4

Test Data		
	Design	Actual
SF CFM (Traverse)	-	[1]
SF CFM	3200	3237
SF RPM	-	DD
MOTOR RPM	-	DD
RA CFM (Traverse)	-	[1]
RA CFM	3200	3237
OA CFM	0	0
RL Voltage	-	206/207/207
RL Amperage	-	6.3/6.2/6.0
SF System SetPt	-	HIGH SPEED
RA Damper Position	-	NO DAMPER INSTALLED
Min OA Damper Position	-	NO OA
Min OA Damper Type	-	NO OA

[1] SUPPLY & RETURN TRUNK LINES CANNOT BE TRAVERSED DUE TO NOT HAVING THE MINIMUM AMOUNT OF 4FT. OF STRAIGHT DUCT.

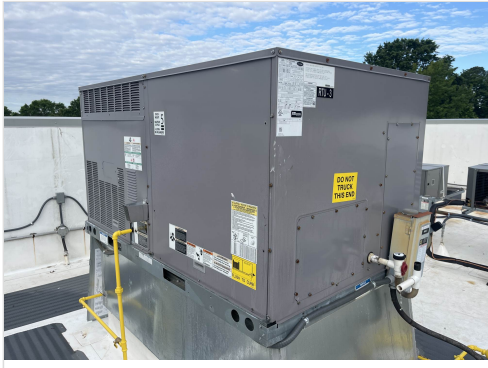
## Unit Data - PHOTO LOG

Unit Data		
	Design	Actual
MFG	CARRIER	CARRIER
Serial Num	-	1723C08764
Model Num	48FCEM07	48FCEM07A2A5A0A0A0
Num OA Filters 1	-	1
OA Filter Size 1	-	23.5"x7"
Num Final Filter 1	-	4
Final Filter Size 1	-	16x16x2

Test Data		
	Design	Actual
SF CFM (Traverse)	-	[2]
SF CFM	2100	1711
SF RPM	-	DD
MOTOR RPM	-	DD
RA CFM (Traverse)	-	[2]
RA CFM	1690	1270
OA CFM	410	441
RL Voltage	-	207 / 208/ 208
RL Amperage	-	2.2/2.1/2.2
SF System SetPt	-	HIGH
RA Damper Position	-	NO DAMPER
Min OA Damper Position	-	2.0"
Min OA Damper Type	-	MANUAL

[1] RTU3 IS A 4 TON UNIT. UNIT IS NOT CAPIABLE OF REACHING 2100. UNIT IS RUNNING AT MAX SPEED WITH UNIT TOTAL SET TO ALLOW MAX AIR TO SPACE.

[2] SUPPLY & RETURN TRUNK LINES CANNOT BE TRAVERSED DUE TO NOT HAVING THE MINIMUM AMOUNT OF 4FT. OF STRAIGHT DUCT.

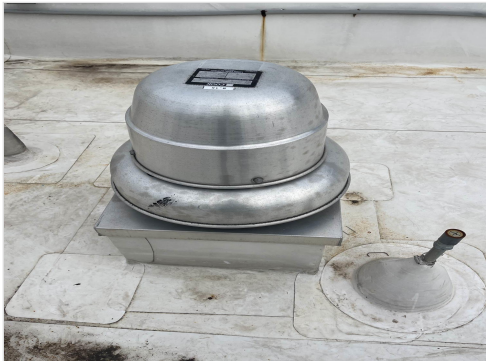
### Unit Data - PHOTO LOG

Unit Data		
	Design	Actual
MFG	COOK	COOK
Model Num	90C15DH	90C15DH
Serial Num	-	410SE89102-00
Type	DOWNBLAST	DOWNBLAST
Configuration	VERTICAL	VERTICAL

Test Data		
	Design	Actual
CFM	300	290
Fan RPM	-	DD / 1600
Fan Rotation	-	CCW
Motor RPM	-	DD / 1600
System SetPt	-	MED - LOW
RL Voltage	-	[1]
RL Amperage	-	[1]
Total ESP	0.50"	0.215"
Fan Inlet SP	-	-0.215"
Fan Discharge SP	-	ATM

[1] LIGHT SWITCH STYLE DISCONNECT NO SAFE WAY TO TAKE AMP DRAW.

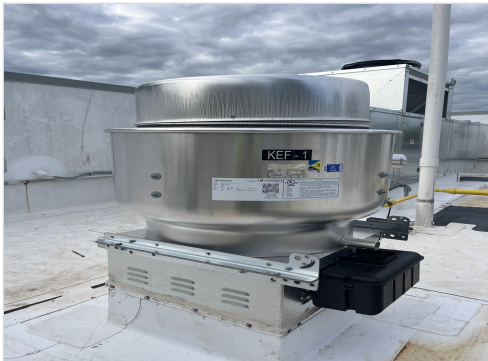
## Unit Data - PHOTO LOG

Unit Data		
	Design	Actual
MFG	GREENHECK	GREENHECK
Model Num	CUE-140-VG	CUE-140-10-VG
Serial Num	-	25951835 25A
Type	UPBLAST	UPBLAST
Configuration	VERTICAL	VERTICAL

Test Data		
	Design	Actual
CFM	1994	1897
Fan RPM	-	DD/ 1750
Fan Rotation	-	CW
Motor RPM	-	DD / 1750
System SetPt	-	SP=6
RL Voltage	-	209
RL Amperage	-	1.7
Total ESP	1"	0.237"
Fan Inlet SP	-	-0.237"
Fan Discharge SP	-	ATM

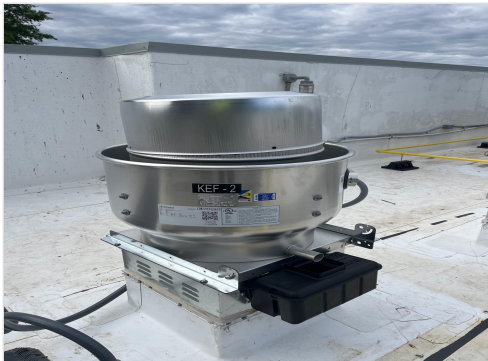
## Unit Data - PHOTO LOG

Unit Data		
	Design	Actual
MFG	GREENHECK	GREENHECK
Model Num	CUE-120-VG	CUE-120-5-VG
Serial Num	-	25951836 25A
Type	UPBLAST	UPBLAST
Configuration	VERTICAL	VERTICAL

Test Data		
	Design	Actual
CFM	1216	1288
Fan RPM	-	DD / 1750
Fan Rotation	-	CW
Motor RPM	-	DD / 1750
System SetPt	-	SP=7
RL Voltage	-	210
RL Amperage	-	1.6
Total ESP	1"	0.483"
Fan Inlet SP	-	-0.483"
Fan Discharge SP	-	ATM

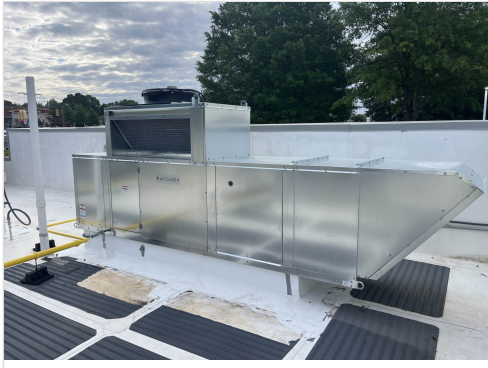
## Unit Data - PHOTO LOG

Unit Data		
	Design	Actual
MFG	GREENHECK	ACCUREX
Model Num	DGX-P112-H12-MF	XDGX-P116-H12-D1-8
Serial Num	-	26271614
Type	MAU	MAU
Configuration	HORIZONTAL	VERTICAL

Gas Heat		
	Design	Actual
Heater Operates (y/n)	-	[1]
Flame Status (pass/fail)	-	[1]
Inlet Air Temp SetPt	55	[1]
Discharge Air Temp SetPt	60	[1]
Air Flow Switch SP Actual	-	0.705"

Test Data		
	Design	Actual
CFM	2000	1888
SF RPM	-	DD / 1755
Motor RPM	-	DD / 1755
SF System SetPt	-	49.6 HZ.
RL Voltage	-	159/159/158
RL Amperage	-	2.9/3.0/2.9
Total ESP	-	N/R
Fan Discharge SP	-	N/R
