Report: TAB Report
Function: Test, Adjust, & Balance
Date: 11/21/2025
Completed By: National TAB

11-24-25 CHIPOTLE #5545 HAMMONTON, NJ

Project: 11-24-25 CHIPOTLE #5545 HAMMONTON, NJ

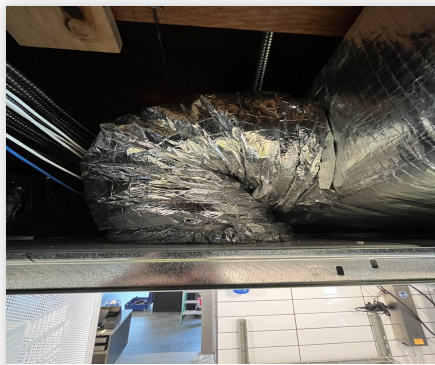
Issue Name : Diffuser 1-6 Flow
Description : Diffuser 1-6 is not reaching design flow, flex connection is choked. Diffuser is unable to be relocated and ductwork routing cannot be improved due to space limitation. Flow is 324/425CFM
Created By : National TAB **Assigned To :** National TAB - Tyler Youells
Status : Open
Priority : Medium **Asset Tag :**
Originated Date : 11/21/2025 - Tyler Youells - National TAB

Asset	Notes	Date	Written By
SGRD5	[1] FLEX DUCT IS KINKED, UNABLE TO GET DIFFUSER TO WITHIN DESIGN.	11/21/2025	Tyler Youells

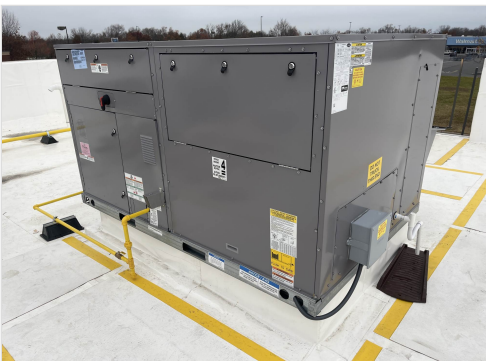
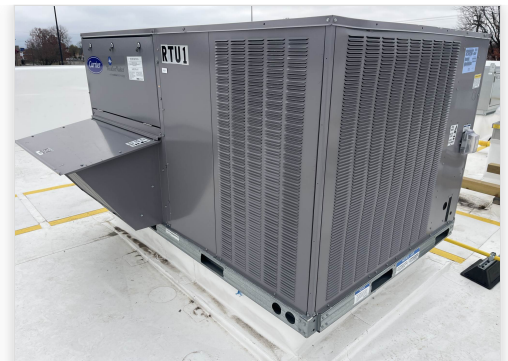
Unit Data - PHOTO LOG

Asset: RTU1

Unit Data		
	Design	Actual
MFG	CARRIER	CARRIER
Serial Num	-	0524P63209
Model Num	48FCN09	48FCN09D3M5A6W4F0
Type	RTU	RTU
Configuration	VERTICAL	VERTICAL
Num OA Filters 1	-	1
OA Filter Size 1	-	36X20
Num Final Filter 1	-	4
Final Filter Size 1	-	20X20X2

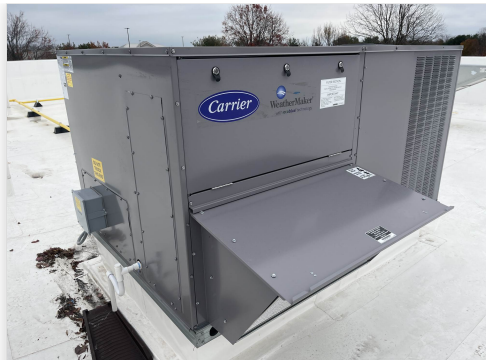
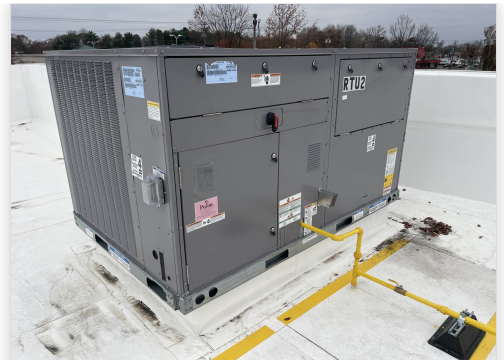
Unit Data - PHOTO LOG

Asset: RTU2

Unit Data		
	Design	Actual
MFG	CARRIER	CARRIER
Serial Num	-	0524P63208
Model Num	48FCN09	48FCN09D3M5A6W4F0
Type	RTU	RTU
Configuration	VERTICAL	VERTICAL
Num OA Filters 1	-	1
OA Filter Size 1	-	36X20
Num Final Filter 1	-	4
Final Filter Size 1	-	20X20X2

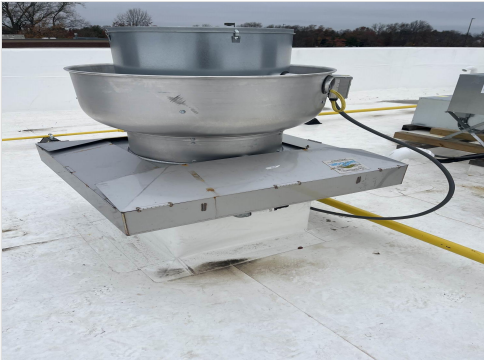
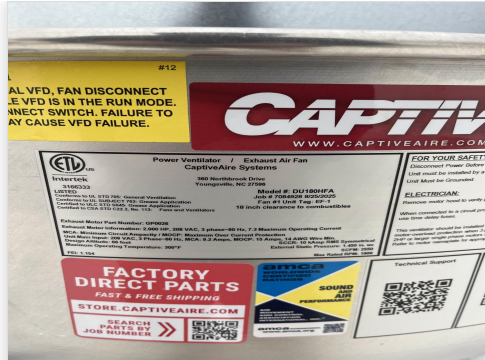
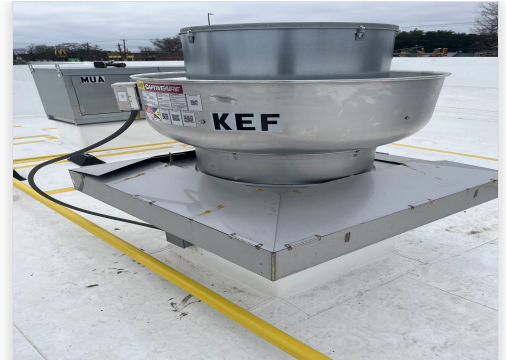
Unit Data - PHOTO LOG

Asset: EF1

Unit Data		
	Design	Actual
MFG	CAPTIVE-AIRE	CAPTIVE-AIRE
Model Num	DU180HFA	DU180HFA
Serial Num	-	7084928
Type	UPBLAST	UPBLAST
Configuration	VERTICAL	VERTICAL

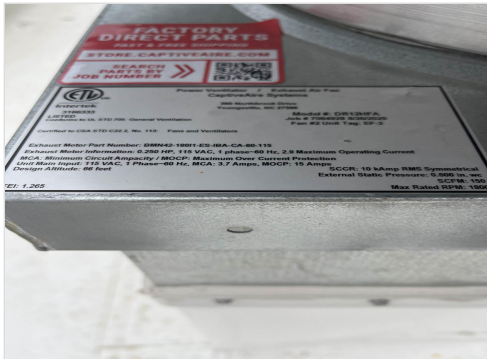
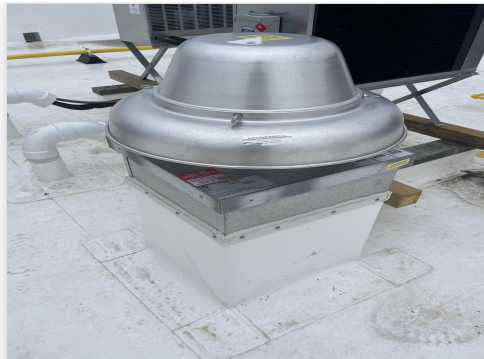
Unit Data - PHOTO LOG

Asset: EF2

Unit Data		
	Design	Actual
MFG	CAPTIVE-AIRE	CAPTIVE-AIRE
Model Num	DR12HFA	DR12HFA
Serial Num	-	7084928
Type	DOWNBLAST	DOWNBLAST
Configuration	VERTICAL	VERTICAL

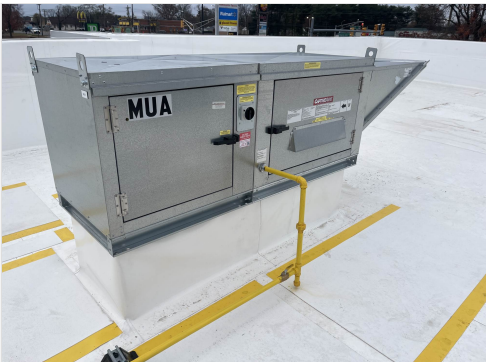
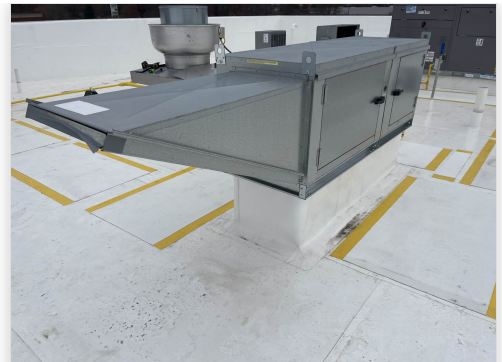
Unit Data - PHOTO LOG

Asset: MAU1

Unit Data		
	Design	Actual
MFG	CAPTIVE-AIRE	CAPTIVE-AIRE
Model Num	A1-D.250-15D	A1-D.250-15D
Serial Num	-	7084928
Type	MAU	MAU
Configuration	VERTICAL	VERTICAL
