Report: TAB Report
Function: Test, Adjust, & Balance
Date: 06/25/2025
Completed By: National TAB

06-23-25 WAWA #8159 NEWTOWN, PA

Project: 06-23-25 WAWA #8159 NEWTOWN, PA

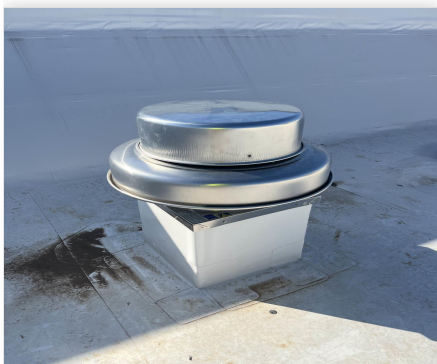
Issue Name : EF-2 Flow
Description : Ef-2 is not operating at design flow. Fan is at max speed and Under FLA. At the current static pressure the fan is not capable of 1400CFM. Final flow with grilles balanced proportionally low 1121 CFM. Tried removing the backdraft damper and removing the speed control to rule out restriction and confirm max speed, there was no change In CFM.
Created By : National TAB **Assigned To :** National TAB - Tyler Youells
Status : Open
Priority : High **Asset Tag :**
Originated Date : 06/25/2025 - Tyler Youells - National TAB

[1] FAN IS NOT ACHEIVING DESIGN FLOW AT FULL SPEED AND CURRENT STATIC PRESSURE. CONSULT EOR IF FAN IS NEEDED TO BE UPSIZED.

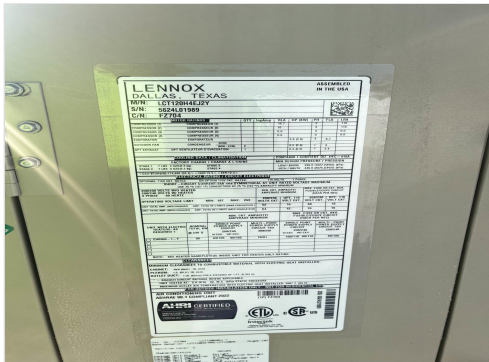
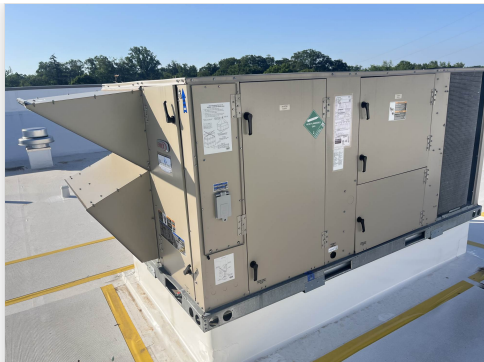
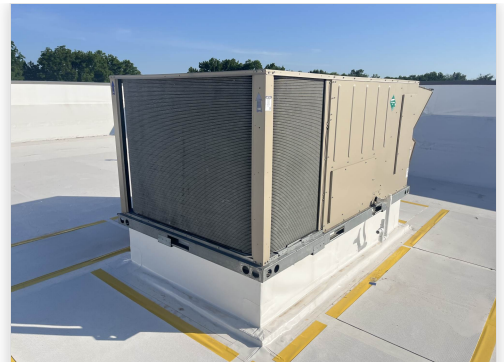
Unit Data - PHOTO LOG

[1] UNIT SCHEDULED FOR 3100CFM/ CONNECTED LOAD IS 3700CFM. AT 3100 CFM THE UNIT WOULD BE OUT OF THE RECOMMENDED 350-400CFM/TON THEREFORE UNBIT WAS BALANCED TO THE CONNECTED LOAD

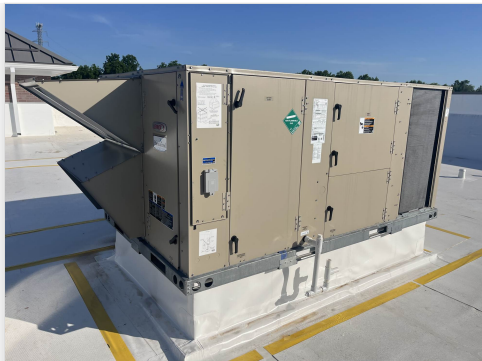
Unit Data - PHOTO LOG

[1] UNIT IS SCHEDULED FOR 4800CFM/ CONNECTED LOAD 5000CFM. 5000 IS WITHIN 5% OF ORIGINAL INTENT SO UNIT WAS BALANCED TO THE CONNECTED LOAD.

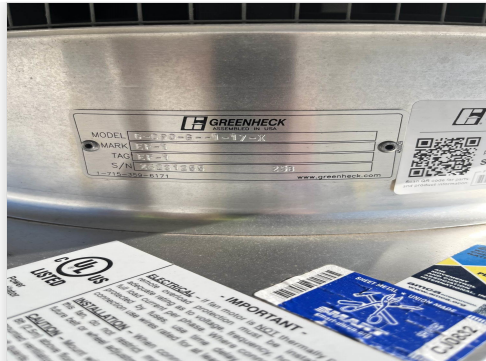
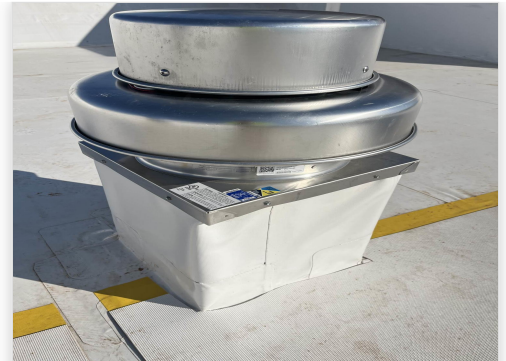
Unit Data - PHOTO LOG

Notes:
[1] CONNECTED LOAD 400CFM, BALANCED TO CONNECTED LOAD

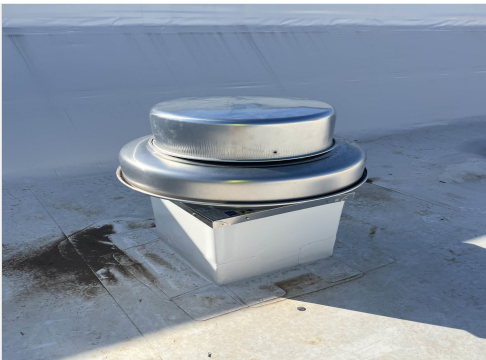
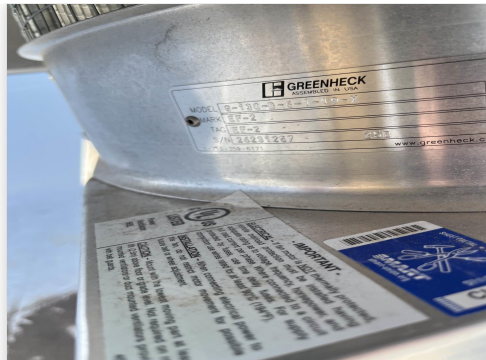
Unit Data - PHOTO LOG

EF-2 Speed controller was removed to ensure 100% fan speed
